**BEFORE INDEPENDENT HEARING COMMISSIONERS
IN CHRISTCHURCH**

IN THE MATTER of the hearing of submissions on Plan Change 14 (Housing
and Business Choice) to the Christchurch District Plan

**STATEMENT OF PRIMARY EVIDENCE OF CLARA CAPONI ON BEHALF OF
CHRISTCHURCH CITY COUNCIL**

HERITAGE ENGINEERING

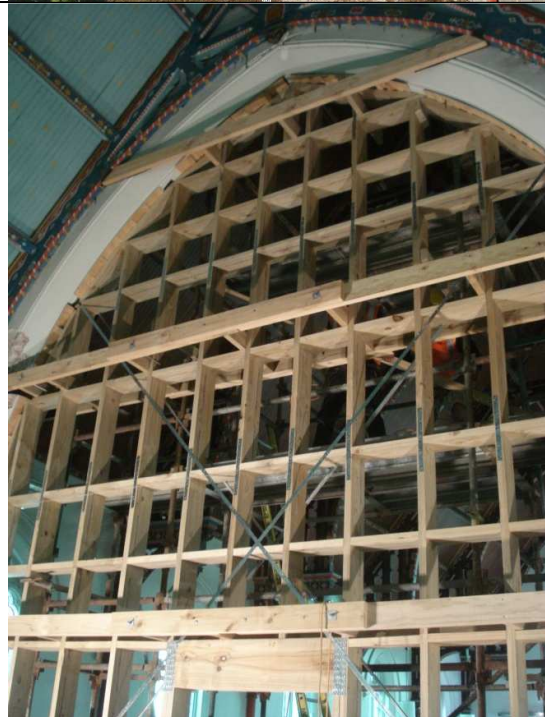
The chancel arch which was propped after February earthquake.

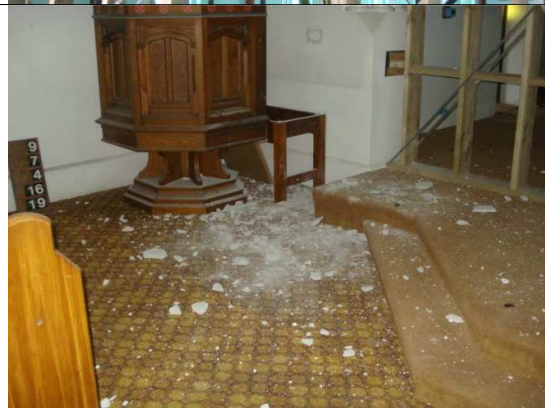
Plaster has fallen off the propped chancel arch during the 13 June earthquake.

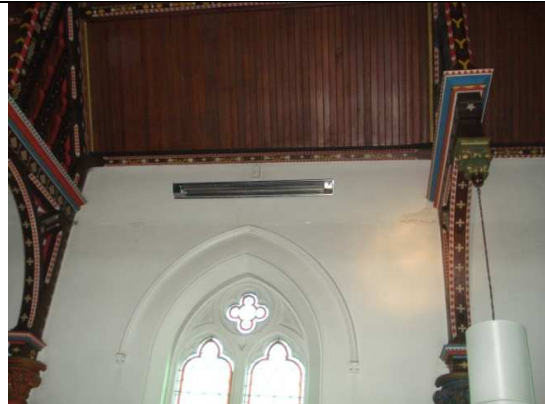
Damage to top of north wall.

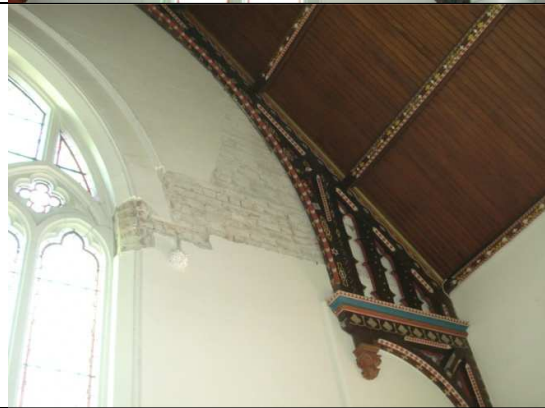
Damage to interior brick skin of the west gable end wall

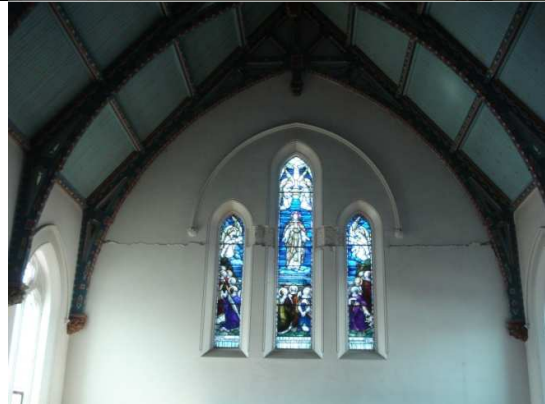
Horizontal crack at eaves level in the east gable end wall; similar crack appeared in the west end gable wall.

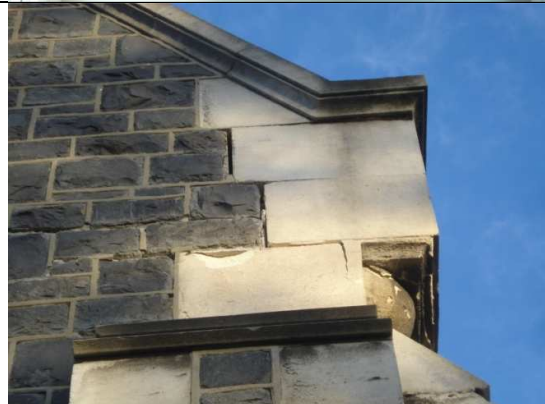
Displaced stonework at east gable wall.

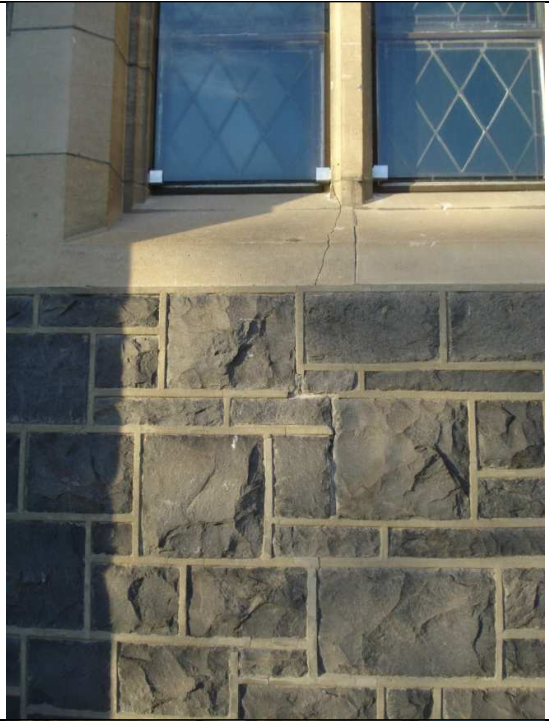
Vertical cracks below window on the north wall.

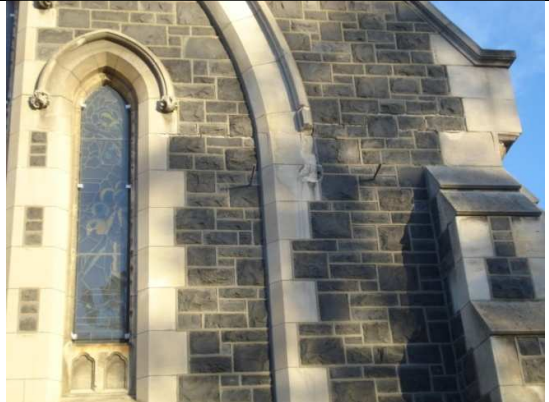
The horizontal crack at east gable.

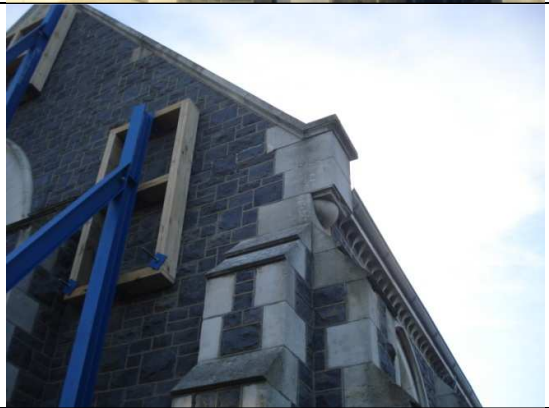
The propped west gable.

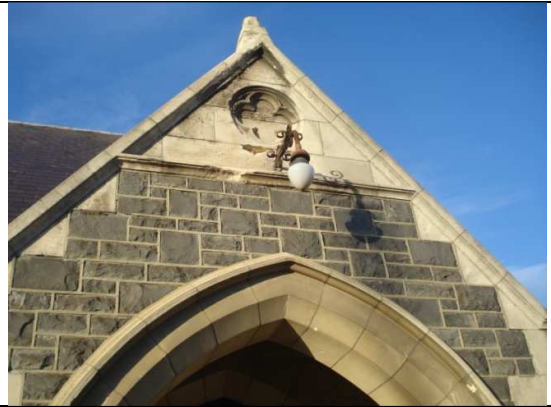
Slight chipping at the base of the north gable.

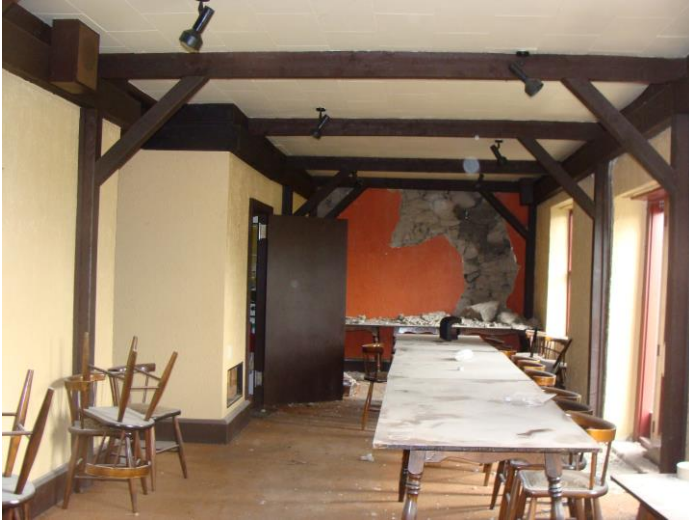
The building has suffered from shaking damage from the earthquake swarm beginning on 4th September 2010. This is evidenced by movement cracking to the external walls principally at the corners and adjacent to openings. Inside the building the plaster and some of the stone rubble has loosened and in some places fallen as shown in the photo below.

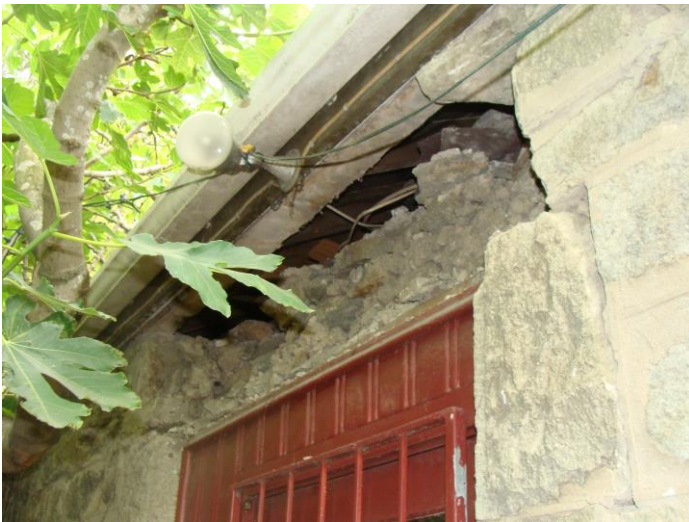
Externally the most severe damage has occurred above the entry door on the western side of the building, where the stone lintel has dislodged and fallen. The photo below shows the area where the stone lintel was and the variable nature of the stone used in the wall with the inner and outer faces being large and worked and the rubble infill being small and un-worked with some mortar bonding the rubble.

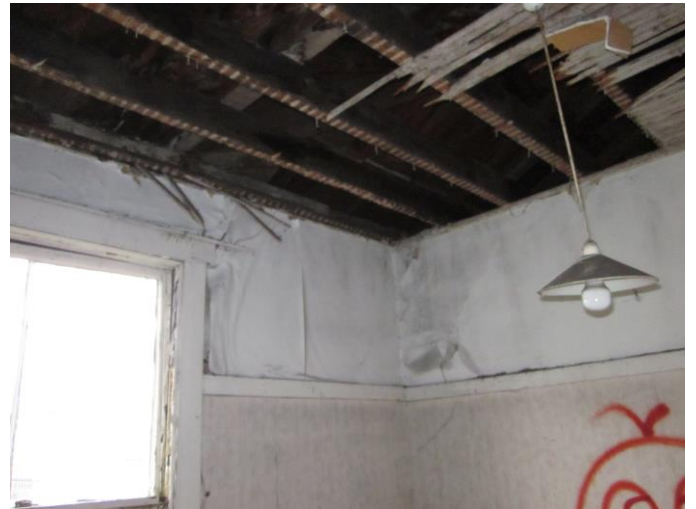
Damaged ceilings, walls/ mould /moisture and weather penetration damage

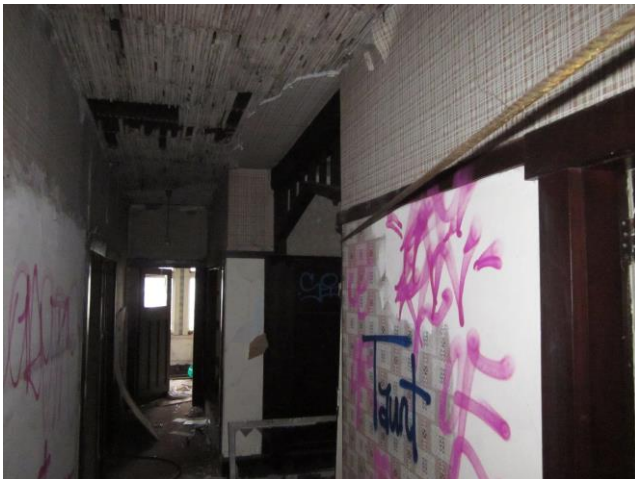
Damaged ceilings, walls/ mould /moisture and weather penetration damage

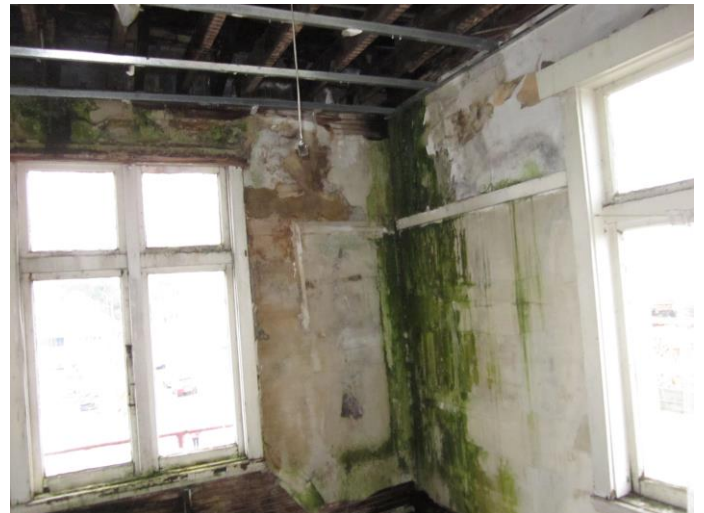
Damaged ceilings, walls/ mould /moisture and weather penetration damage

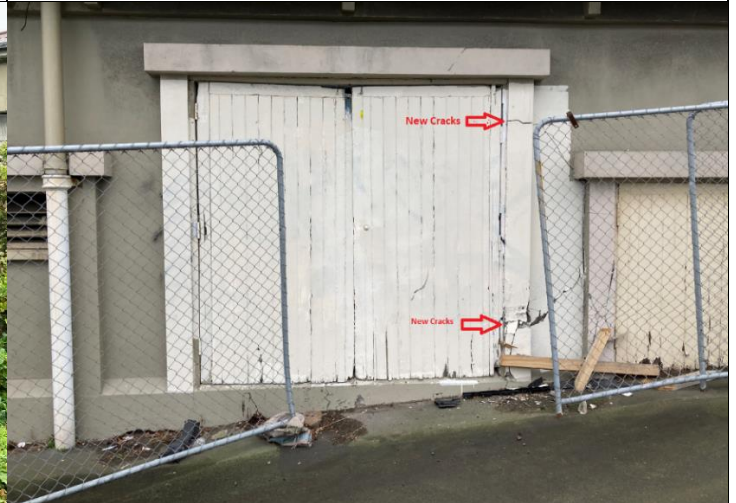
Photo 6 – View from East wall with new cracks.

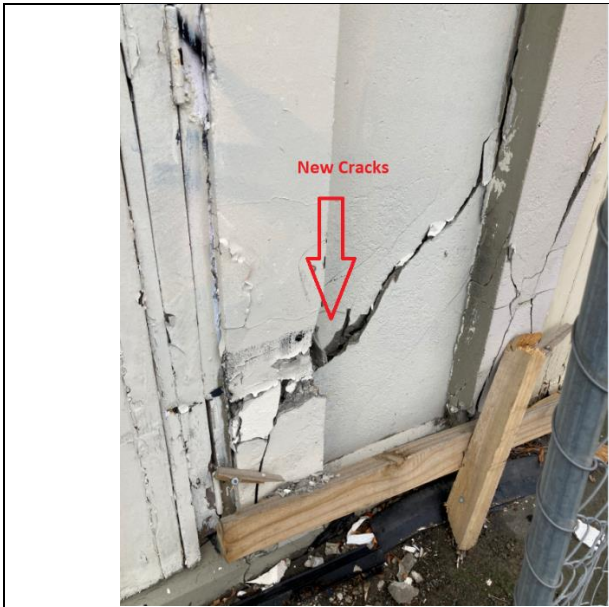
Photo 7 – View of new cracks at East wall

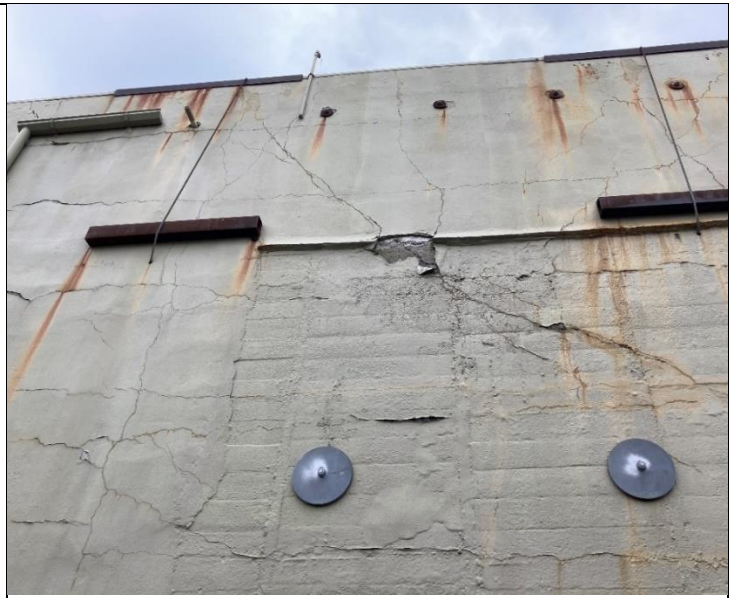
Photo 8 – View of concrete spalling at West wall (in close proximity to the neighbor driveway)

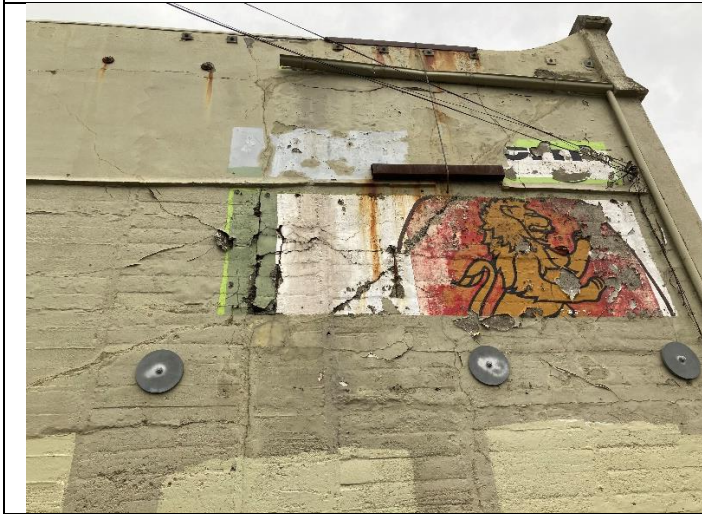
Photo 9 – View of concrete spalling at West wall (in close proximity to the neighbor driveway)

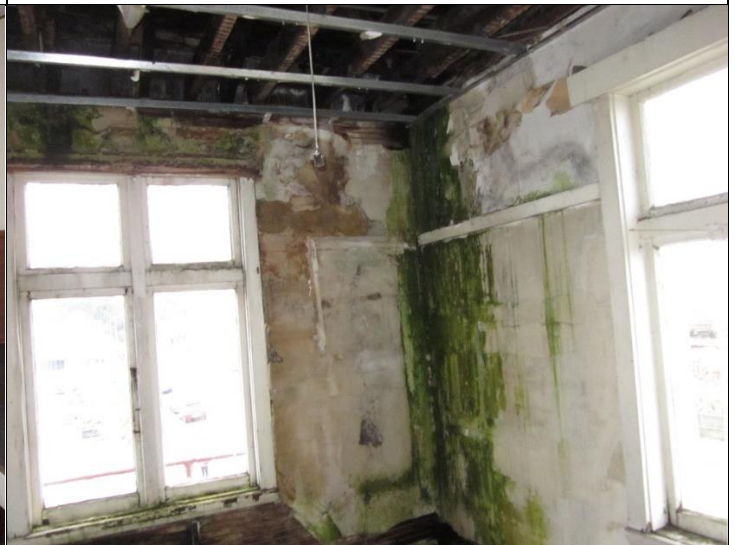
Photo 12 – View from interior – Visible water damaged on the roof and wall
