**STATEMENT OF PRIMARY EVIDENCE OF PHILIP NEVILLE GRIFFITHS ON  
BEHALF OF CHRISTCHURCH CITY COUNCIL**

**QUALIFYING MATTER: HERITAGE (HERITAGE SITES)**

**Consent Documentation for  
Remediation of St. James  
Church, Riccarton**

**Report ref:** 213970  
23 April 2013  
Revision 1

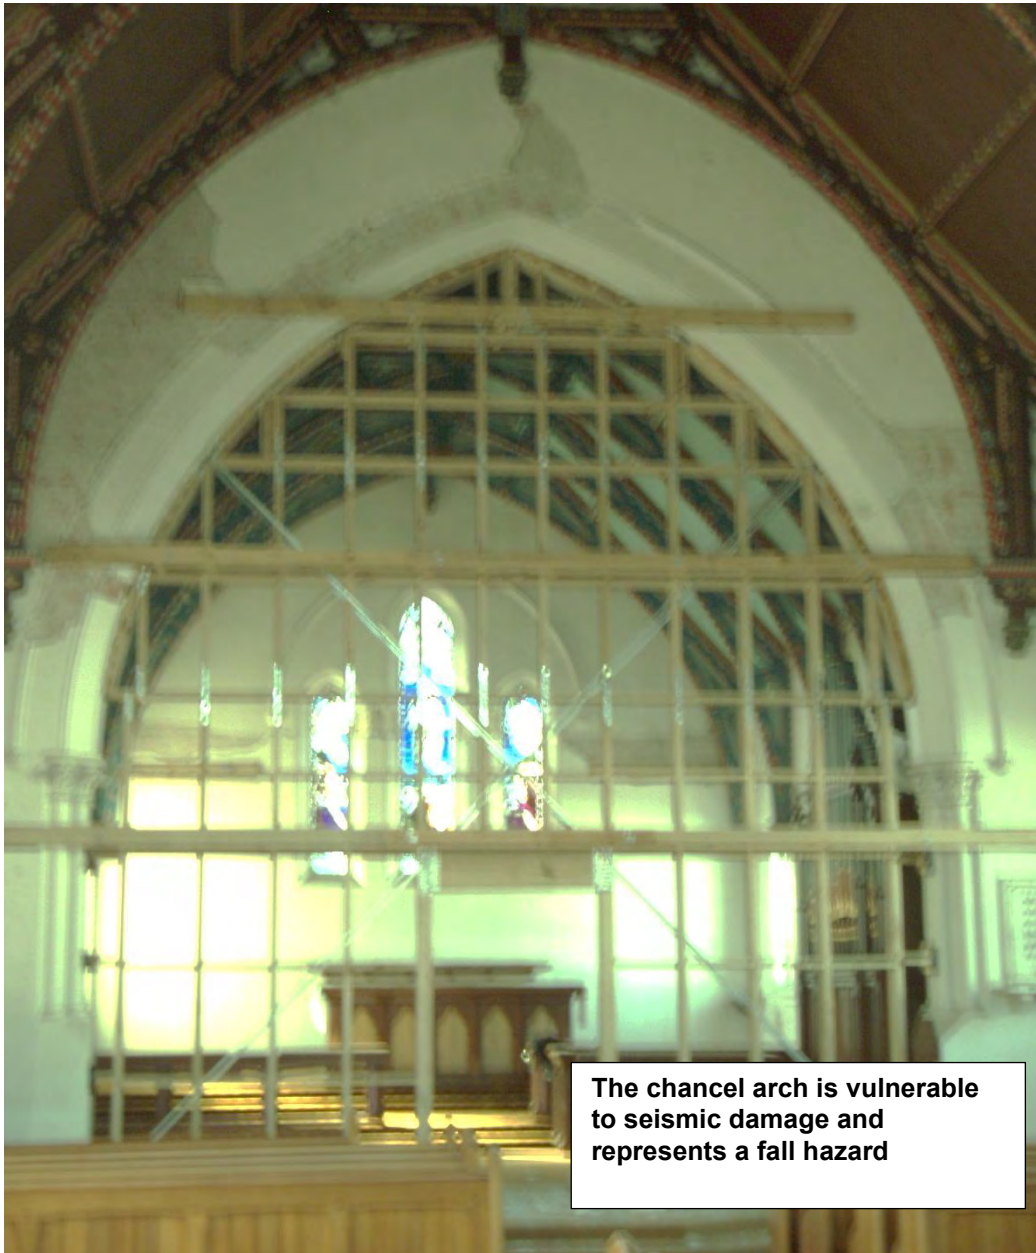
**Photo 1 – General view of chancel arch (timber propped)**

**The chancel arch is vulnerable to seismic damage and represents a fall hazard**

### **CHANCEL ARCH DAMAGE REPAIR INCLUDING STRENGTHENING TO 34% NBS:**

Repair and strengthen the chancel arch to 34%NBS Strength using one of the following methods.

- Prop roof beams and remove timber truss from sanctuary face of arch wall.
- Strip paint and plaster from arch surfaces to receive fabric.
- Repair cracks to masonry using low pressure epoxy injection.
- Install Sika glass fibre string anchors to predrilled holes in side faces of chancel arch.
- Install sika wrap 930G glass fibre fabric to faces of masonry
- Install helifix ties.
- Make good plasterwork to architect's requirements.
- Reinstate timber beam to Sanctuary face of arch.

Repair cracking and strengthen arch to 67% NBS using one of the following methods.

- Option 1: (Sketch SK01) Install post tensioned rods to keep the arch in compression and prevent blocks dislodging during a seismic event. Stainless steel rods are installed on both faces of the arch and would be exposed to view. The use of concealed steel strands drilled through the centre of the wall, in lieu of exposed strands, is not considered a viable alternative because the strands have to cross each other in a confined space. The potential down side to the use of post tensioned rods is the reduction of prestress over time due to creep. Periodic re-tensioning will likely be required. Option 1 is preferred by the CCC Heritage Engineer

- Option 2 and 3: (Sketches SK02 and SK03). Install steel support beams, shaped to the profile of the arch, to provide support to the arch and prevent blocks dislodging during a seismic event. These may not be attractive options, even if they could be concealed, because of the heritage designation of the church, but they do offer more positive support against fall hazards

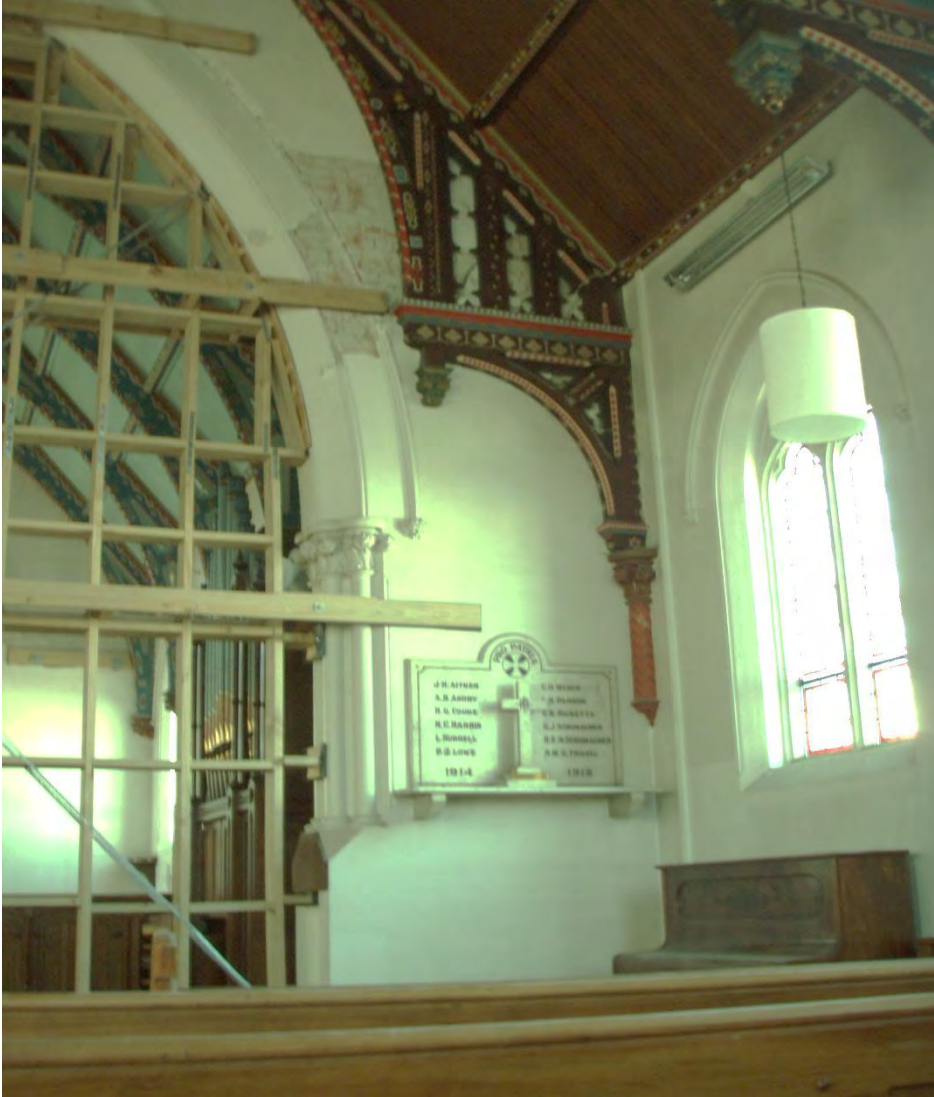
Photo 1a – Chancel arch, render damage and cracking at nave wall eave level

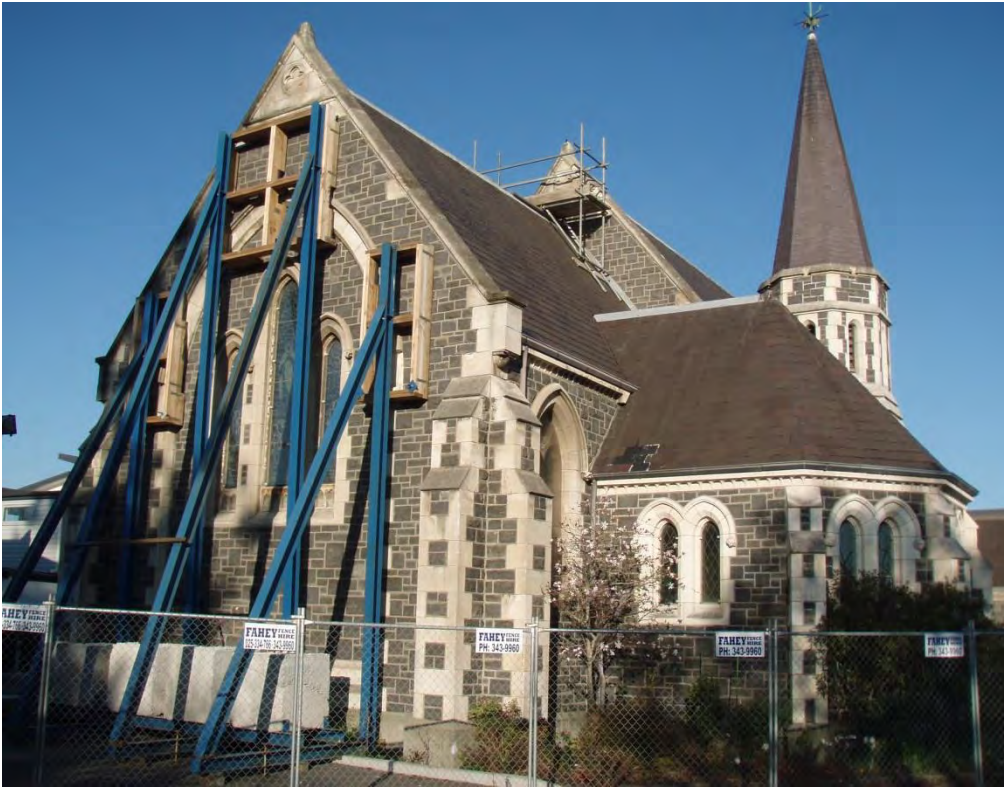
Photo 2 – Exterior view of east gable showing propping (west gable is similar)

### **EAST GABLE WALL DAMAGE REPAIR INCLUDING STRENGTHENING TO 34% NBS**

Damaged or loose render is to be removed, especially where it is a potential fall hazard, and replaced with an approved proprietary product such as SIKA Monotop 412N, refer to note on SK - 01. This applies to all areas of the church.

- Option 1: See SK-05. Installation of post tensioned stainless vertical steel rods on the interior and exterior of the gable wall. M25 bars can be reduced to M20 bars.
- Option 2: See SK-04. Installation of 250UC columns on the inside faces of the gable walls.
- Option 3: Installation of post tensioned stainless vertical steel rods through the centre of the wall is possible. It would require 2 M20 stainless steel threaded rods on either side of the window, within the thicker section of wall. For this option a concrete capping beam would be required to the top of the wall to fix the core drilling rig. Wet drilling would be required to minimize vibration. The effect of wet drilling on surrounding timber and plaster work should be considered.

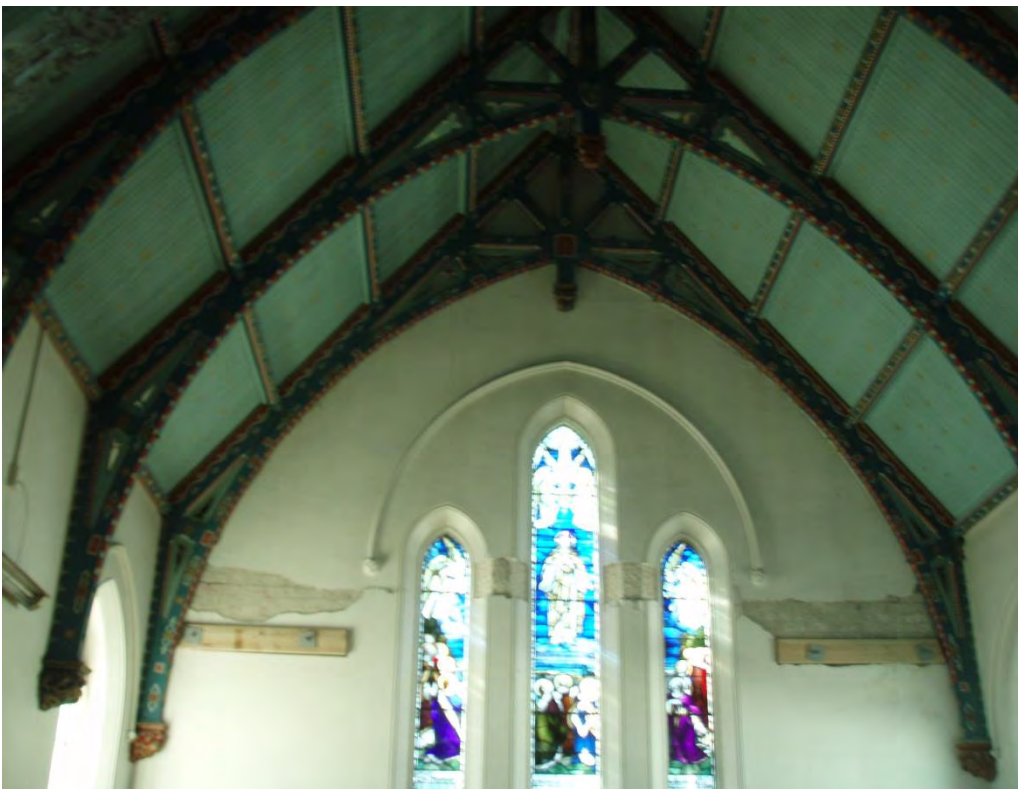
Photo 2a – Interior view of east gable – note cracking at nave wall eave level

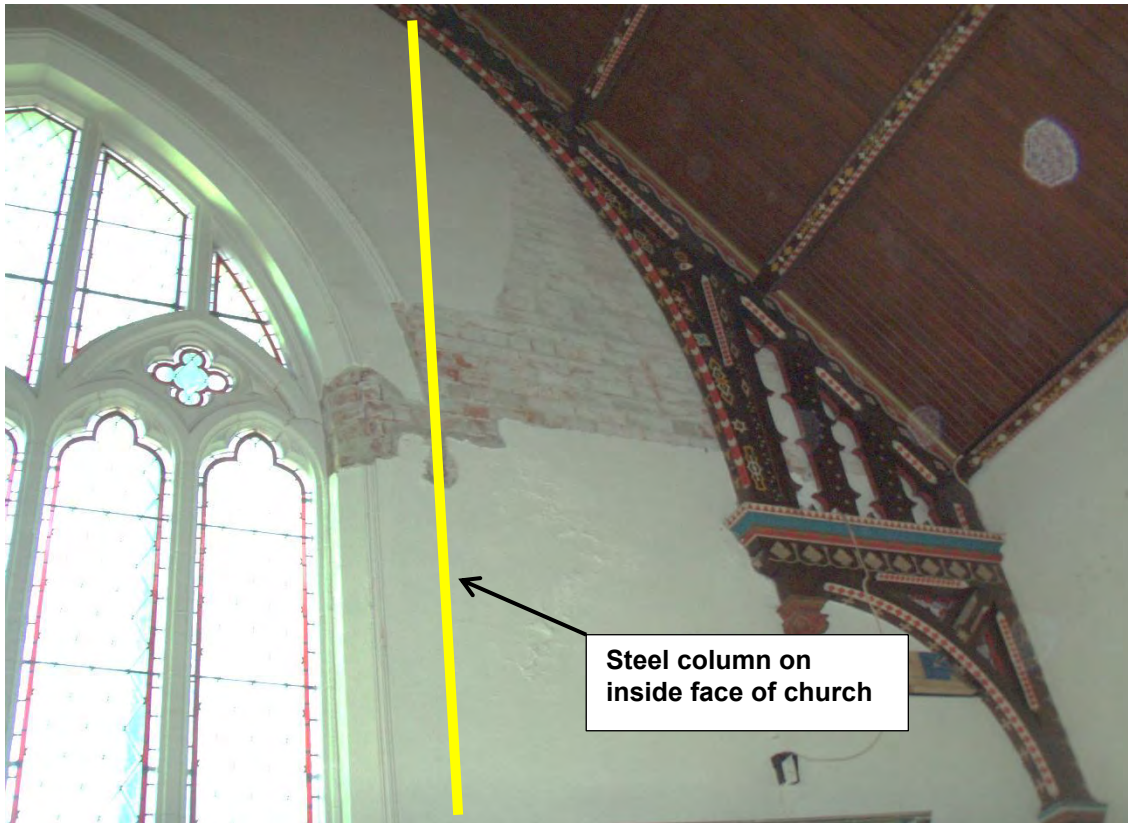
**Photo 2b – Interior view of west gable showing render damage (masonry cracking exists but is not visible on this photo)**

### **WEST GABLE WALL DAMAGE REPAIR**

The out of plan strength of the existing gable wall panel is above 34% NBS strength, however some work is required to repair the crack and damaged plaster.

Damaged or loose render is to be removed, especially where it is a potential fall hazard, and replaced with an approved proprietary product such as SIKA Monotop 412N, refer to note on SK - 01. This applies to all areas of the church.

If no strengthening work is to be undertaken, the eaves level cracking should be stabilised using the detail shown on sketch SK-11.

- Option 1: See SK-05. Installation of post tensioned stainless vertical steel rods on the interior and exterior of the gable wall.
- Option 2: See SK-04. Installation of 310UC or 250UC columns on the inside faces of the gable walls. This is an intrusive solution, the columns will be visible even if they were to be encased, however, it is a more positive support than Option 1. CCC's Heritage Architect prefers this option because the exterior fabric of the church remains unchanged

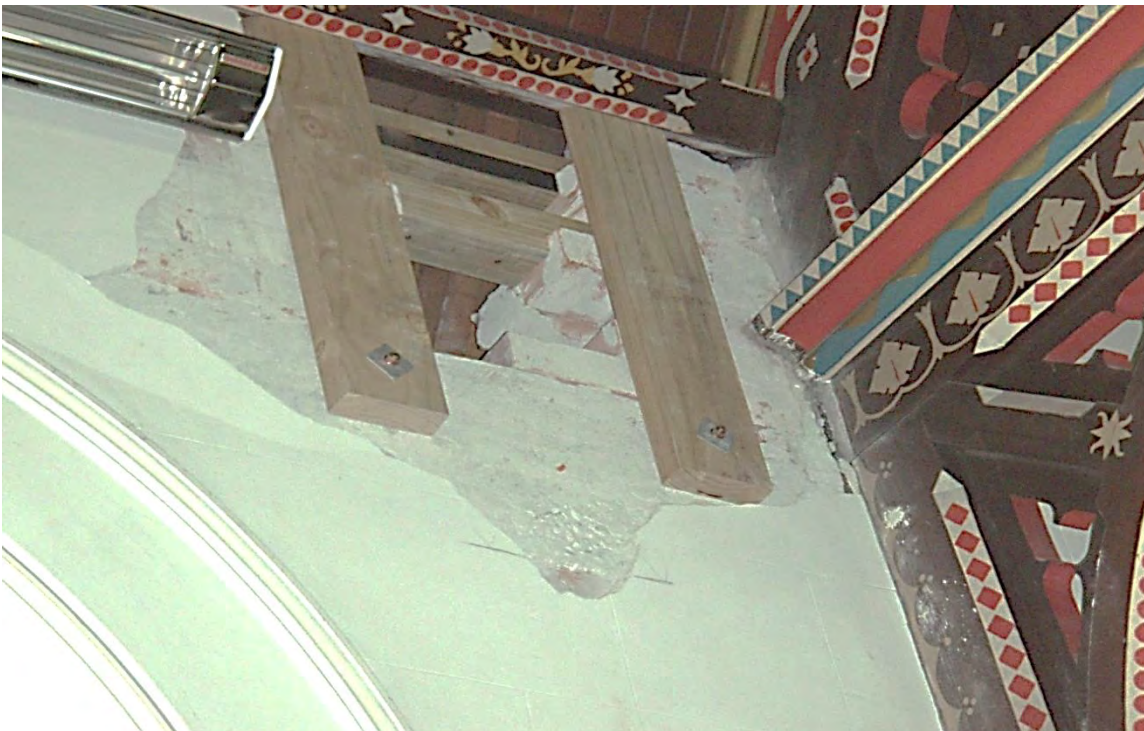
Photo 3a – brick work along top of side walls (opened for investigation purposes)

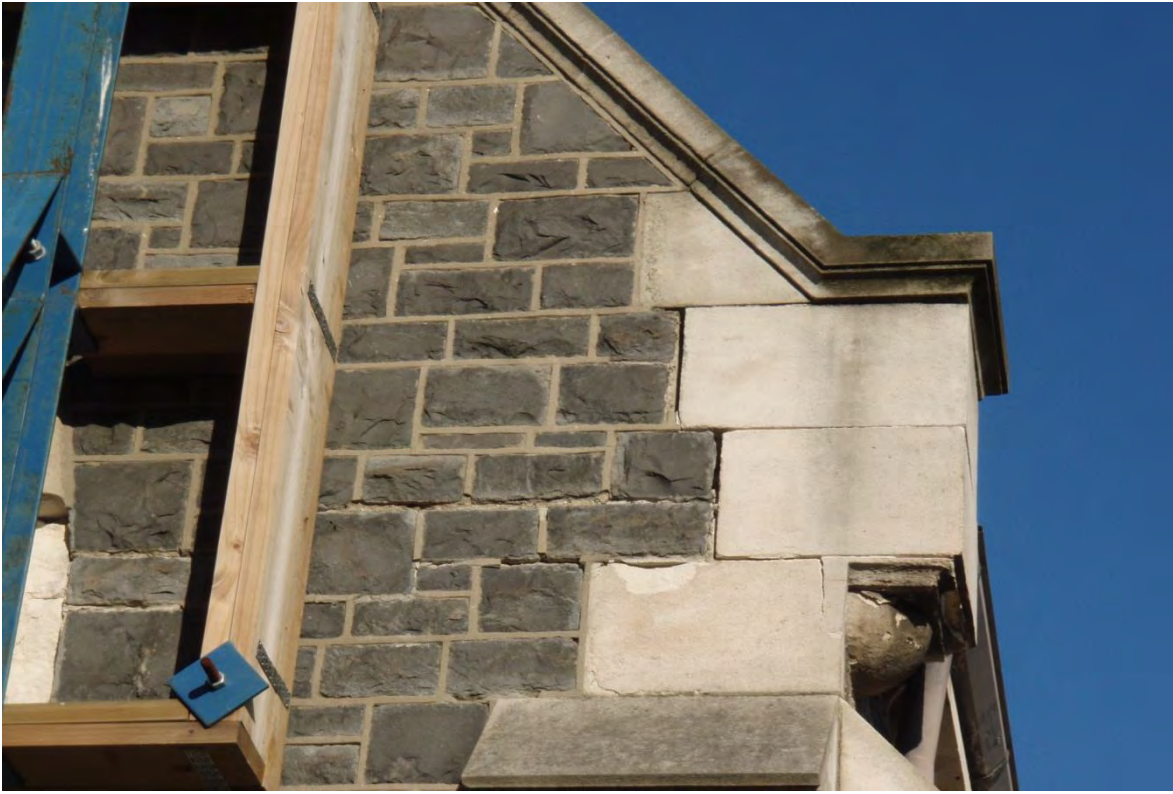
**Photo 4 – Loose masonry and cracking on east gable wall, but random repair is required throughout the church walls and chancel arch**

This is an earthquake damage repair item of work.

- The extent of work and method of repair is to be agreed on site with the Engineer and Architect
- Repair of stonework will depend on extent of damage, but could include the replacement of stone, stitching with Helifix anchors, raking and re-pointing mortar joints, low pressure cement grouting to fill cracks, or possibly epoxy grouting (using Sikadur Injectokit-TH or similar)

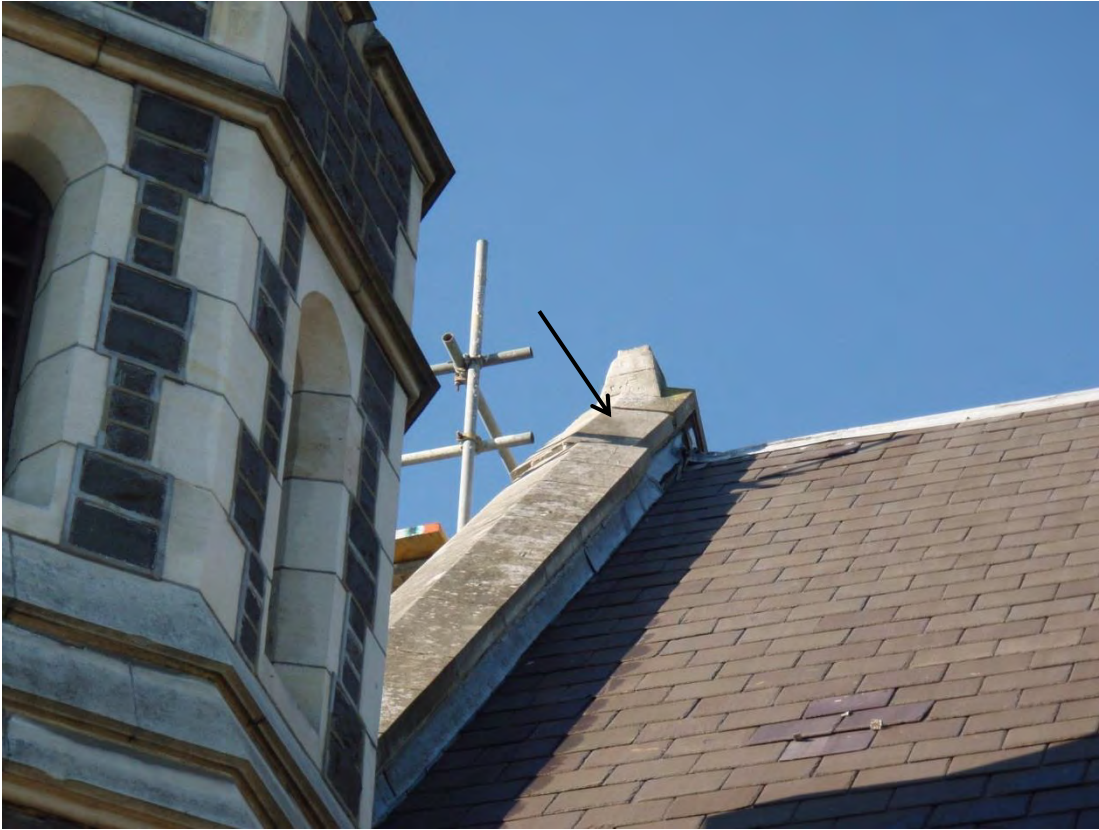
Photo 5 – Dislodged capping stones over chancel arch

This Item of work comes under the categories of damage repair and of strengthening. A comprehensive approach is required to mitigate against fall hazards, therefore the scope of works cannot be divided into the two categories.

- All parapets, gable end wall and chancel arch, are to be anchored with Helifix anchors similar to that shown on SK - 01
- Crosses are to be replaced with light weight replicas if acceptable to the church and Heritage Engineer. If not, the existing crosses will need to be anchored in place and strengthened to mitigate a fall hazard (Engineer to provide details if required)

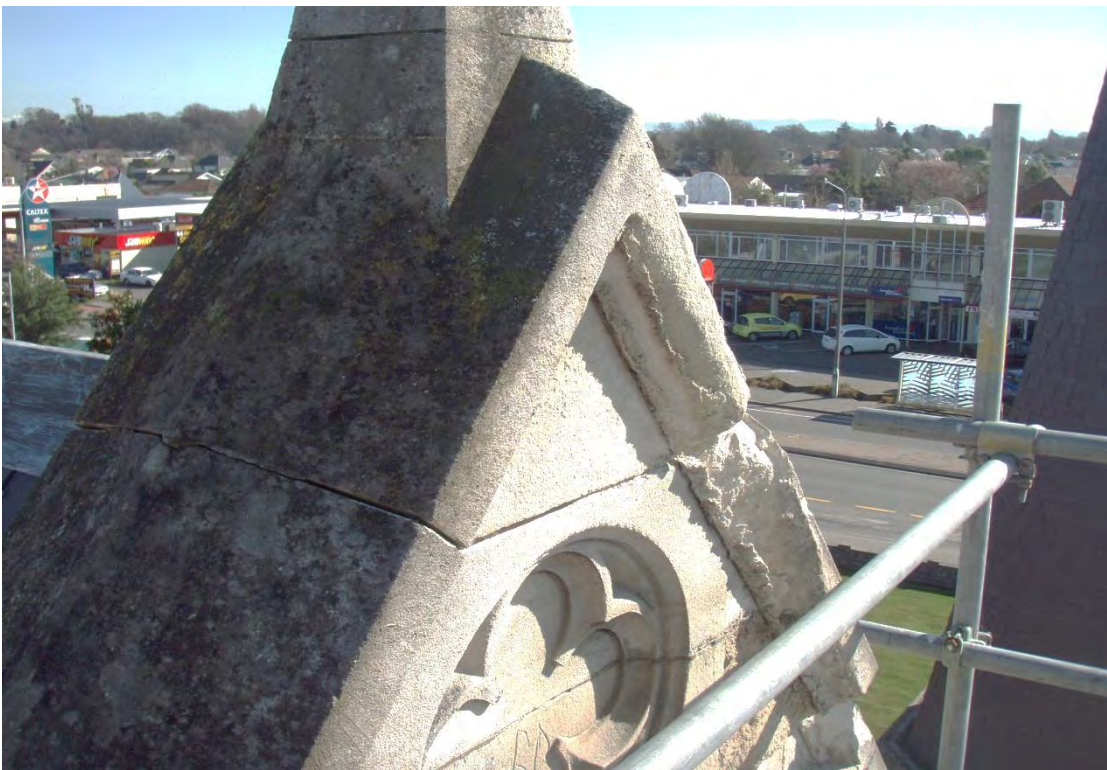
Photo 5a – Capping stone damage over chance arch

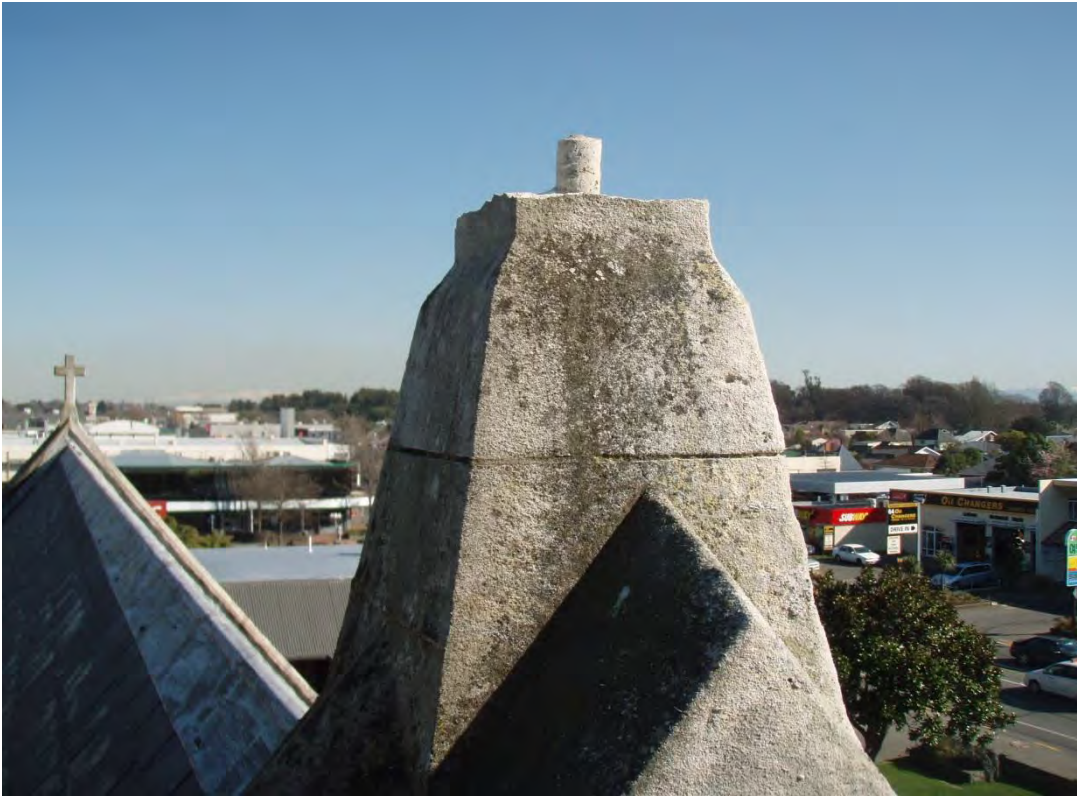
**Photo 5b – view at roof level looking from chance arch (cross support will need stitching)**

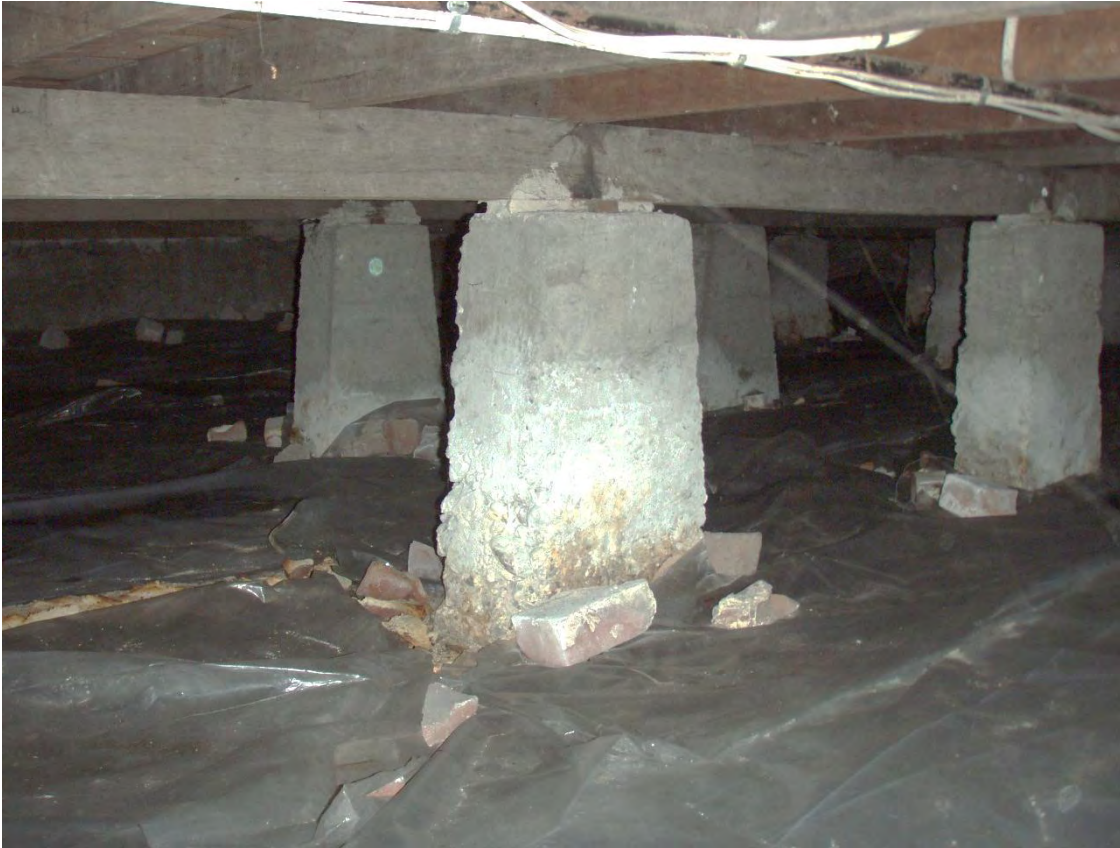
**Photo 6 – General view under floor**

This is an earthquake damage repair item of work.

- For lifts greater than 50mm at any support, new supports will be required to be fitted that may be connected directly to the existing bearers.
- Supports that have been lifted can be cut to the required height or the pile replaced.

- Inspect all supports to ensure their condition is acceptable (no rot, properly bearing) and supports and fixings are in accordance with NZS 3604 – Timber Framed Buildings

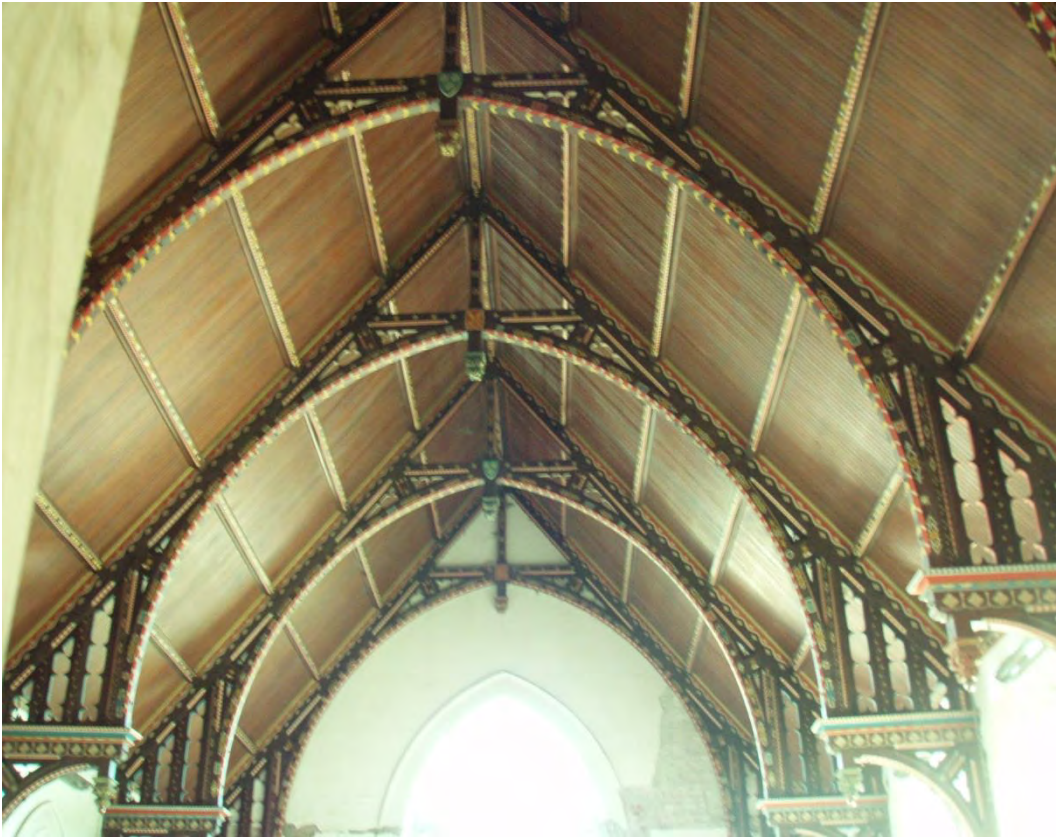
**Photo 7 – Interior wood work**

This is an earthquake damage repair item of work.

- All timber work, especially the rafters are to be inspected by the Contractor for damage, especially to the bolted joints
- Work may involve resolving alignment issues, retightening bolts or replacing damaged bolts or timbers
- There could be remediation work required to connections between the roof and the side walls, gable end walls and chancel arch. During remediation work the Engineer is to be provided access to inspect the existing connections for adequacy

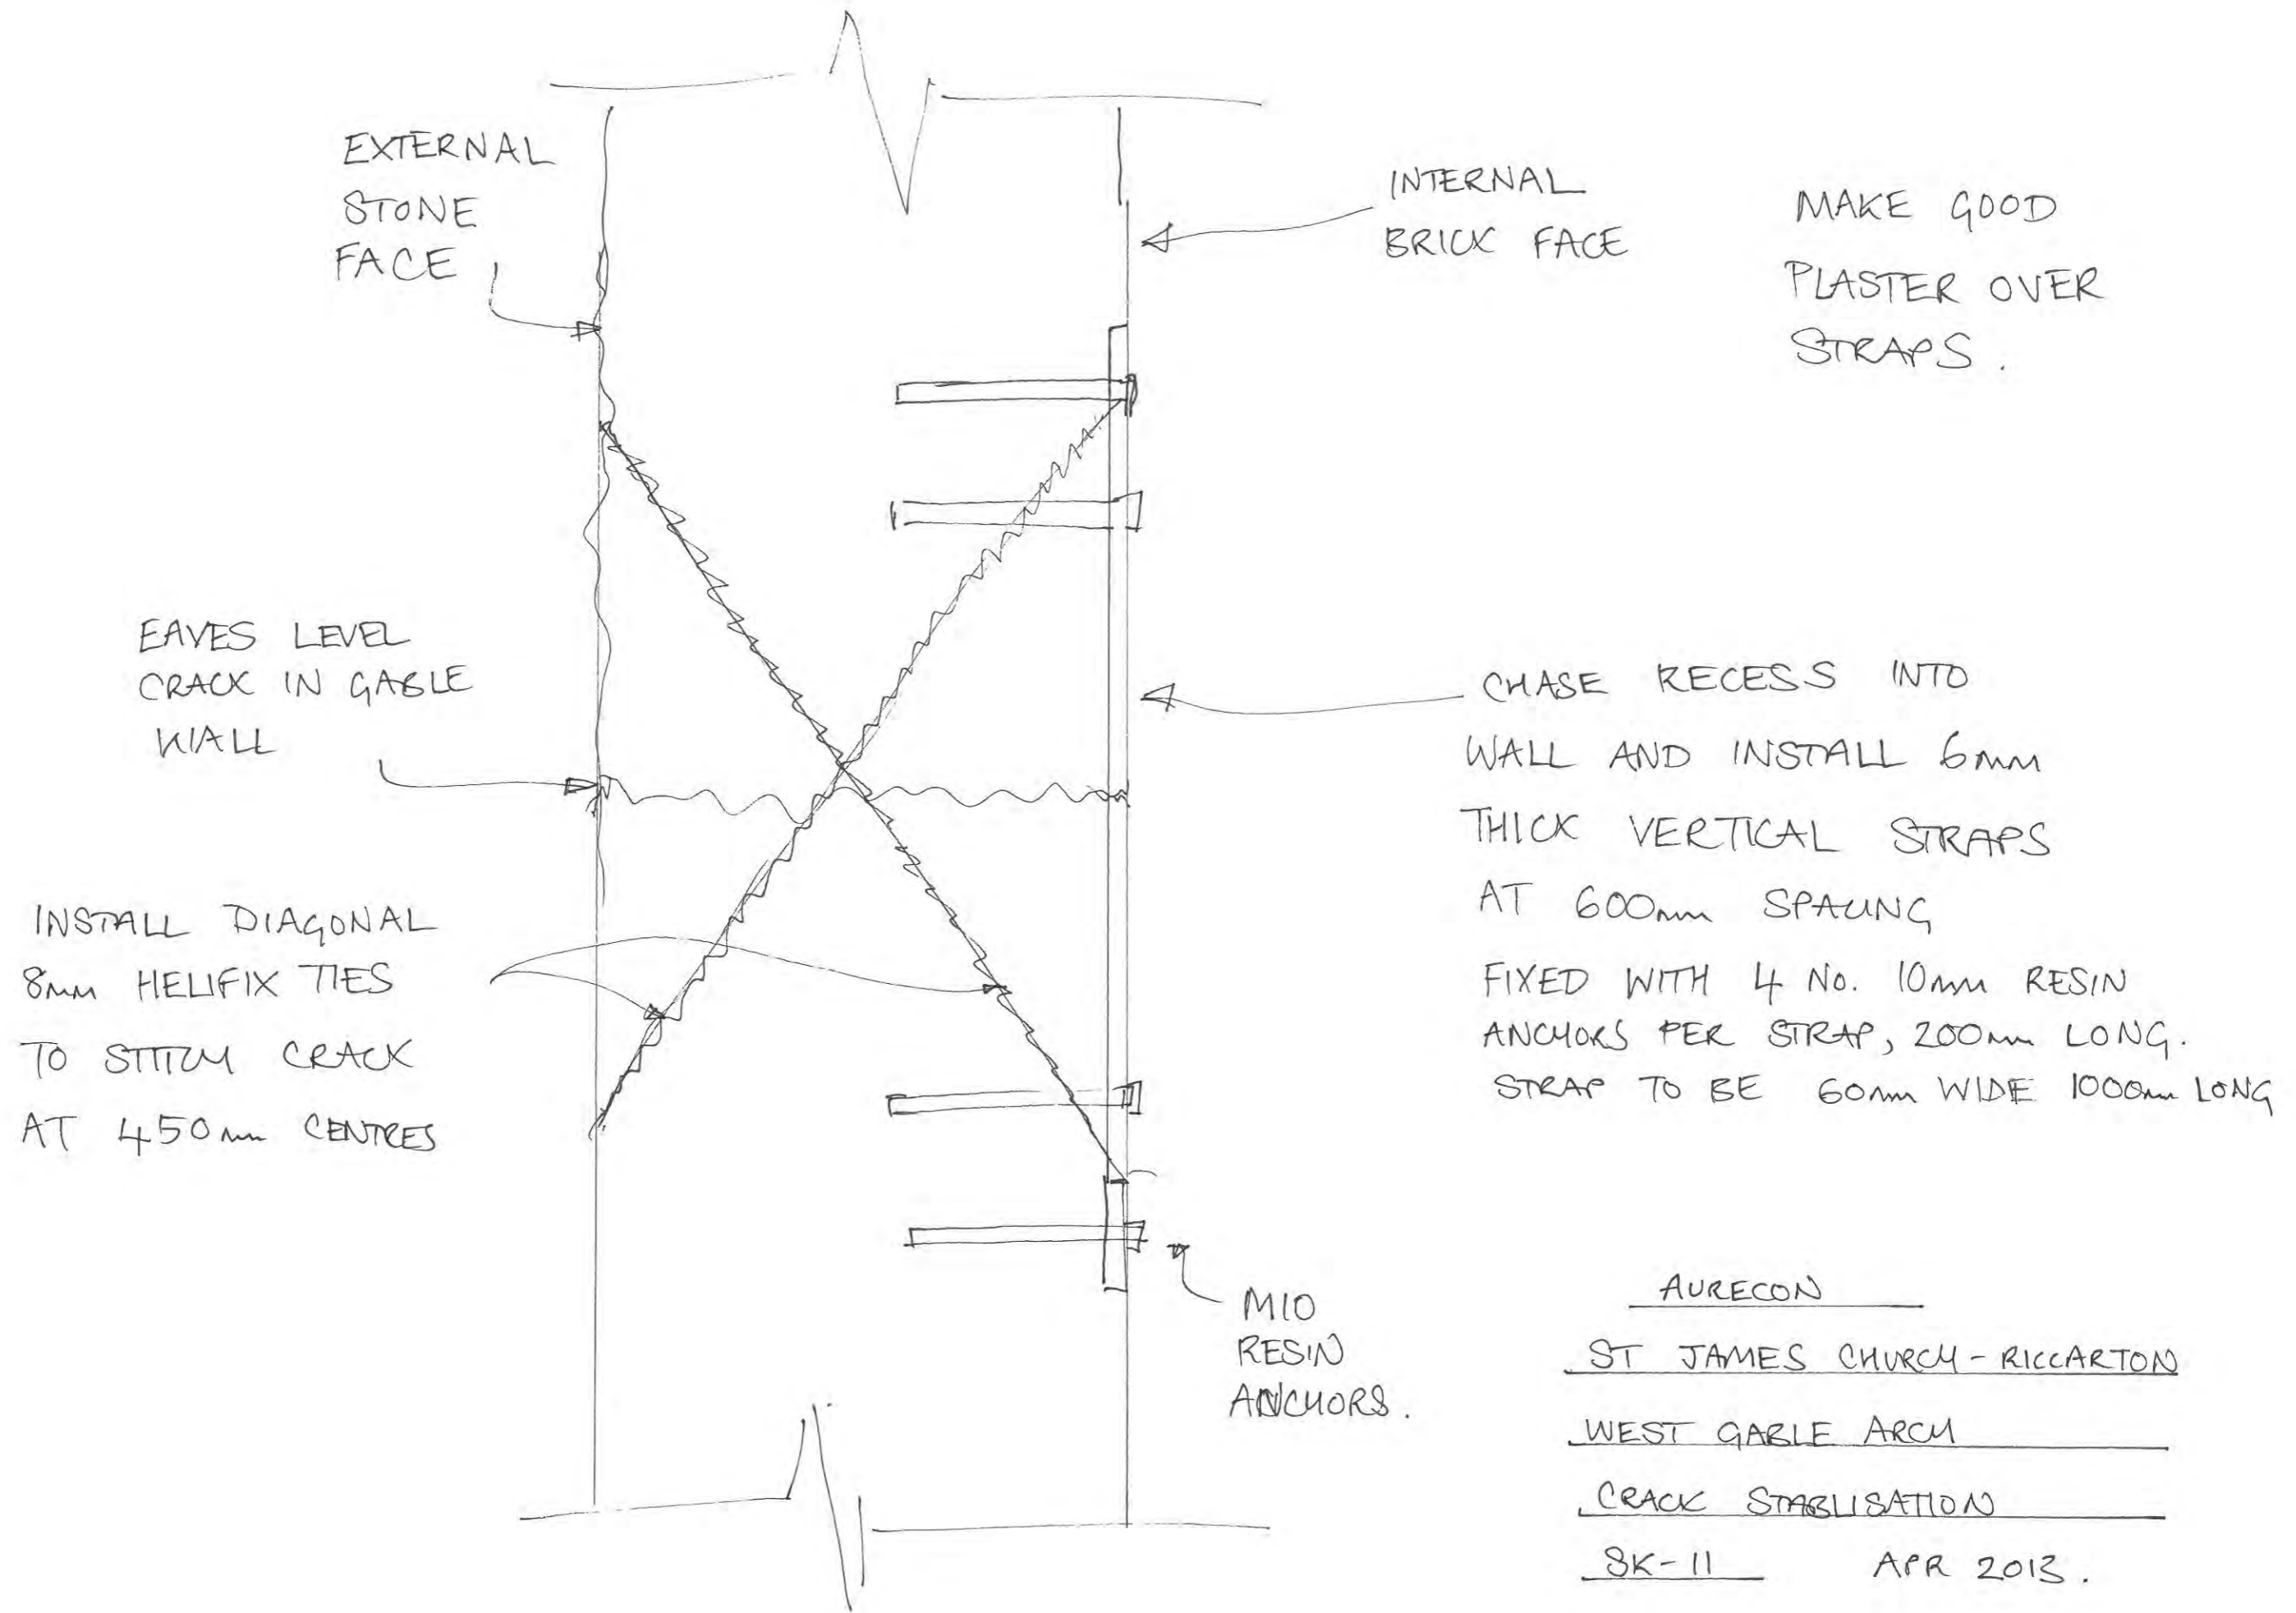
AURECON  
ST JAMES CHURCH - RICcarton  
WEST GABLE ARCH  
CRACK STABILISATION  
SK-11      APR 2013.

EAVES LEVEL  
CRACK IN GABLE  
WALL

INSTALL DIAGONAL  
8mm HELIFIX TIES  
TO STITCH CRACK  
AT 450mm CENTRES

10  
RESIN  
ANCHORS.
