IN THE MATTER of the hearing of submissions on Plan Change 14 (Housing and Business Choice) to the Christchurch District Plan

**STATEMENT OF PRIMARY EVIDENCE OF STEPHEN JAMES HOGG ON
BEHALF OF CHRISTCHURCH CITY COUNCIL**

HERITAGE ENGINEERING

Dated: 11 August 2023

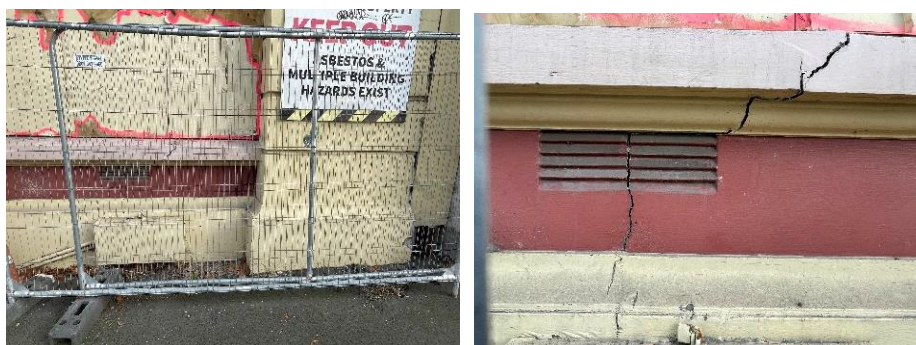
A barricade may be required at some stage. As noted above, a barricade is in place, albeit hard up against the building and not 1m away from the building as is the suggested minimum distance should small debris fall from the building.

Quoin recommends a closer inspection be completed to assess if any material is loose and this should include the close inspection noted in (b) above.

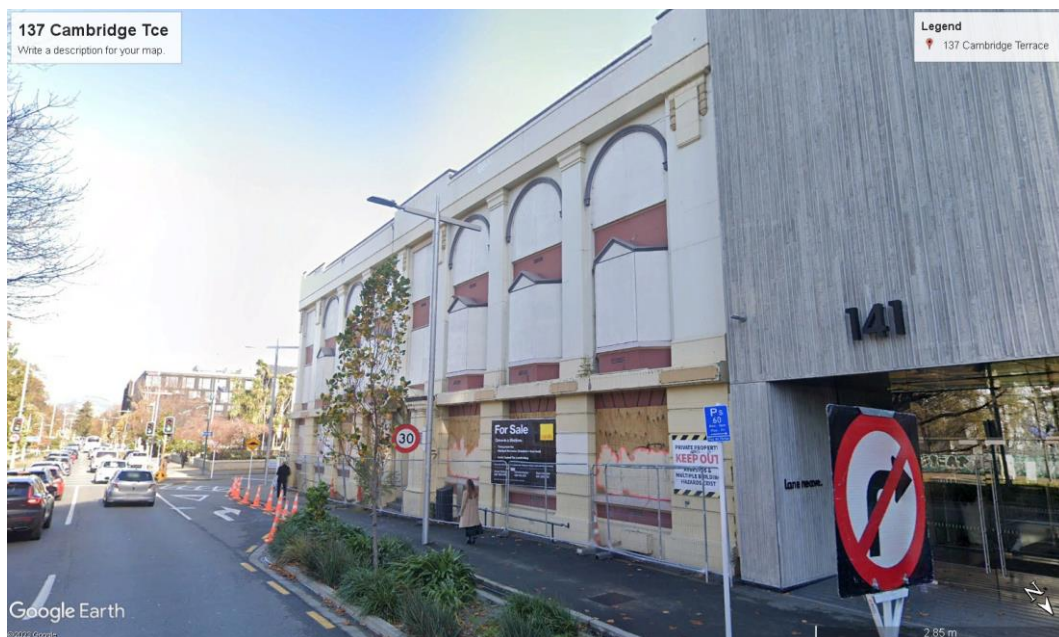
Figure 4 Google Earth photos of building east elevation – Cambridge Side

The existing concrete elements have major damage with multiple cracks running through the columns and walls. The damage started with the earthquakes in 2010-2011 as noted in the original reports. There has been ongoing deterioration of the elements due to water intrusion and lack of maintenance.

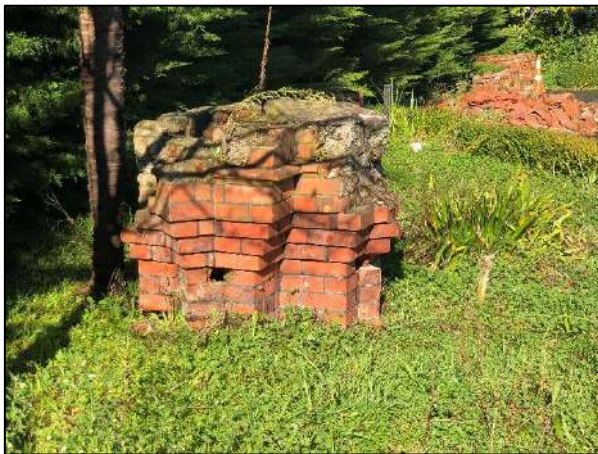
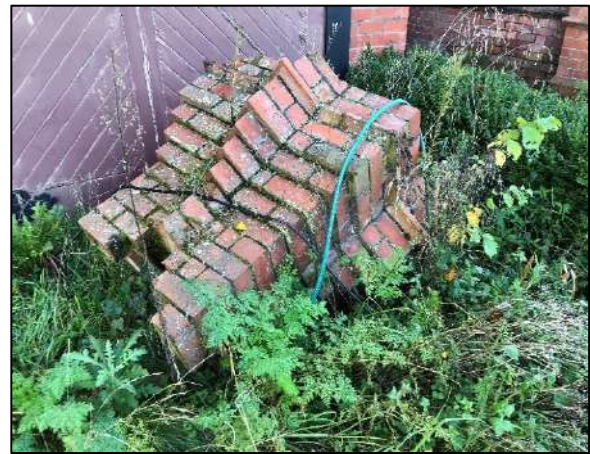
Fallen chimney tops.

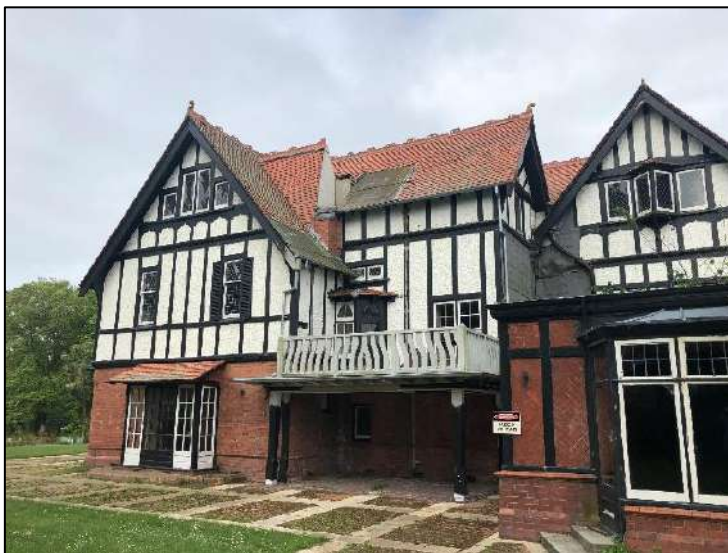
West elevation (left). Note plywood patch on roof indicating former location of chimney.

West elevation (right). Note failure of internal gutter resulting in extensive internal water damage.

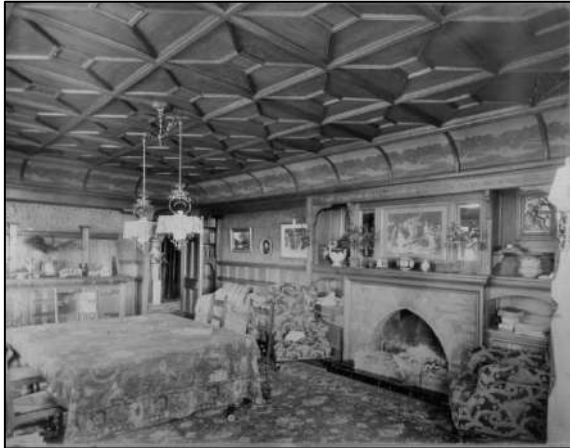
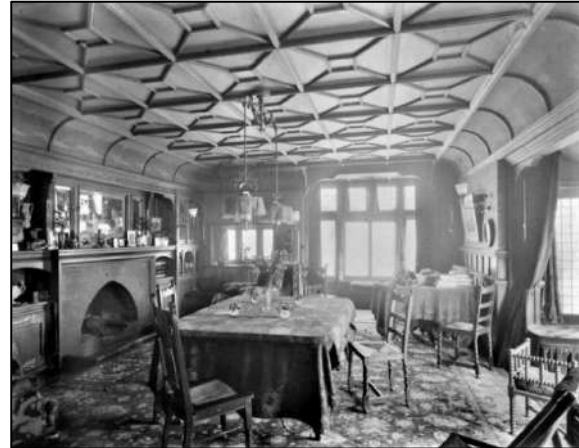
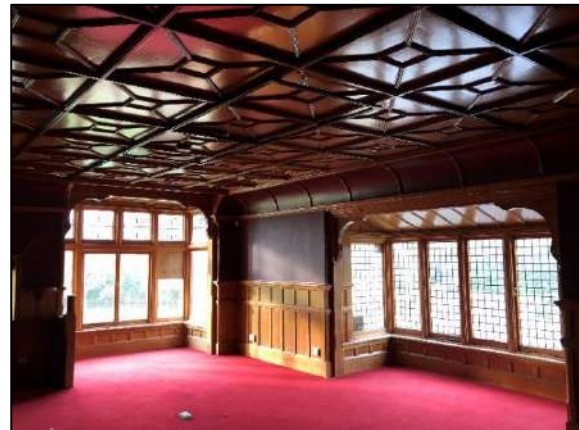
Defects as a result of the earthquakes include cracks in the plaster wall linings and movement between the bricks in the fireplace. Other defects include sun damage to varnished surfaces and bowing leadlight windows

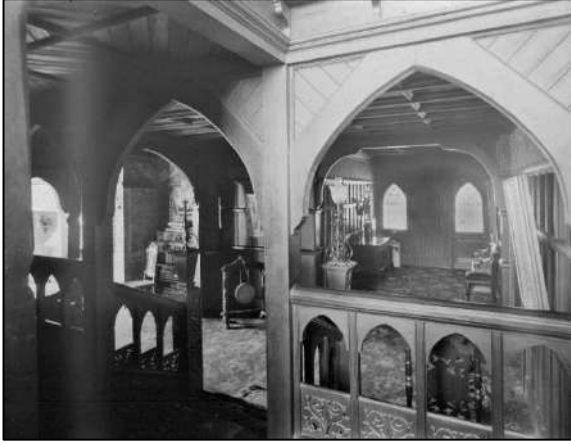
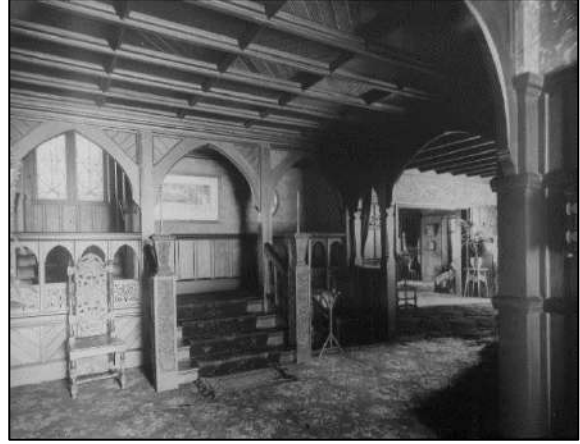
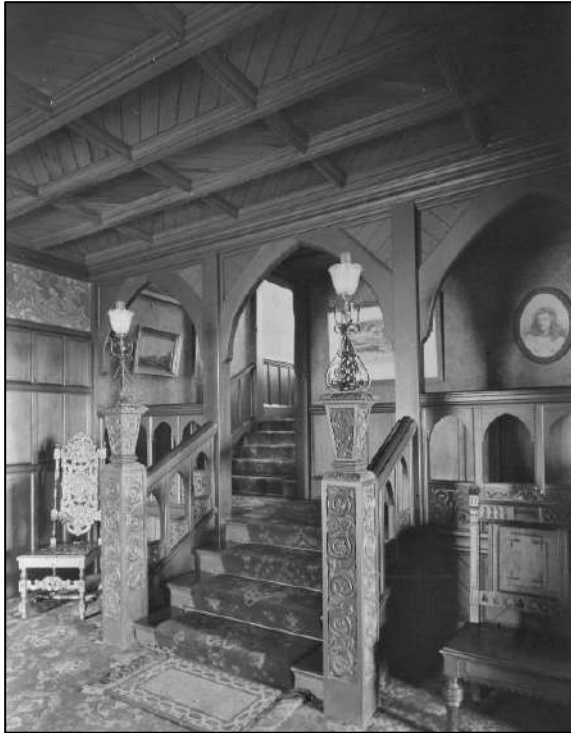
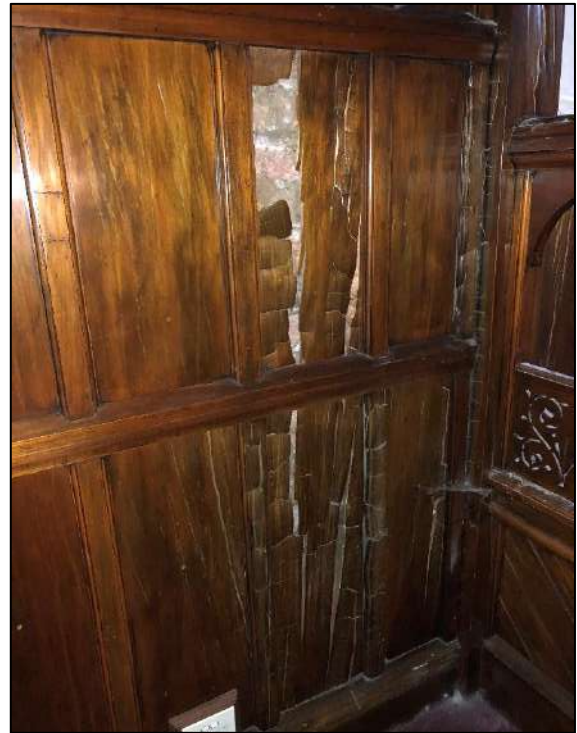
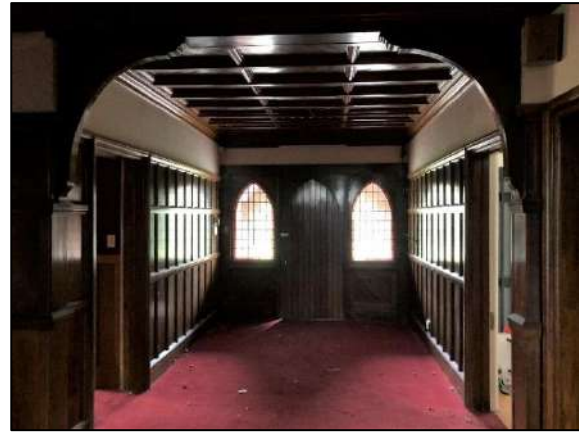
Defects as a result of the earthquakes include extensive water damage to wall panelling and trim due to roof leaks after an internal gutter between the two gables on the western façade failed.

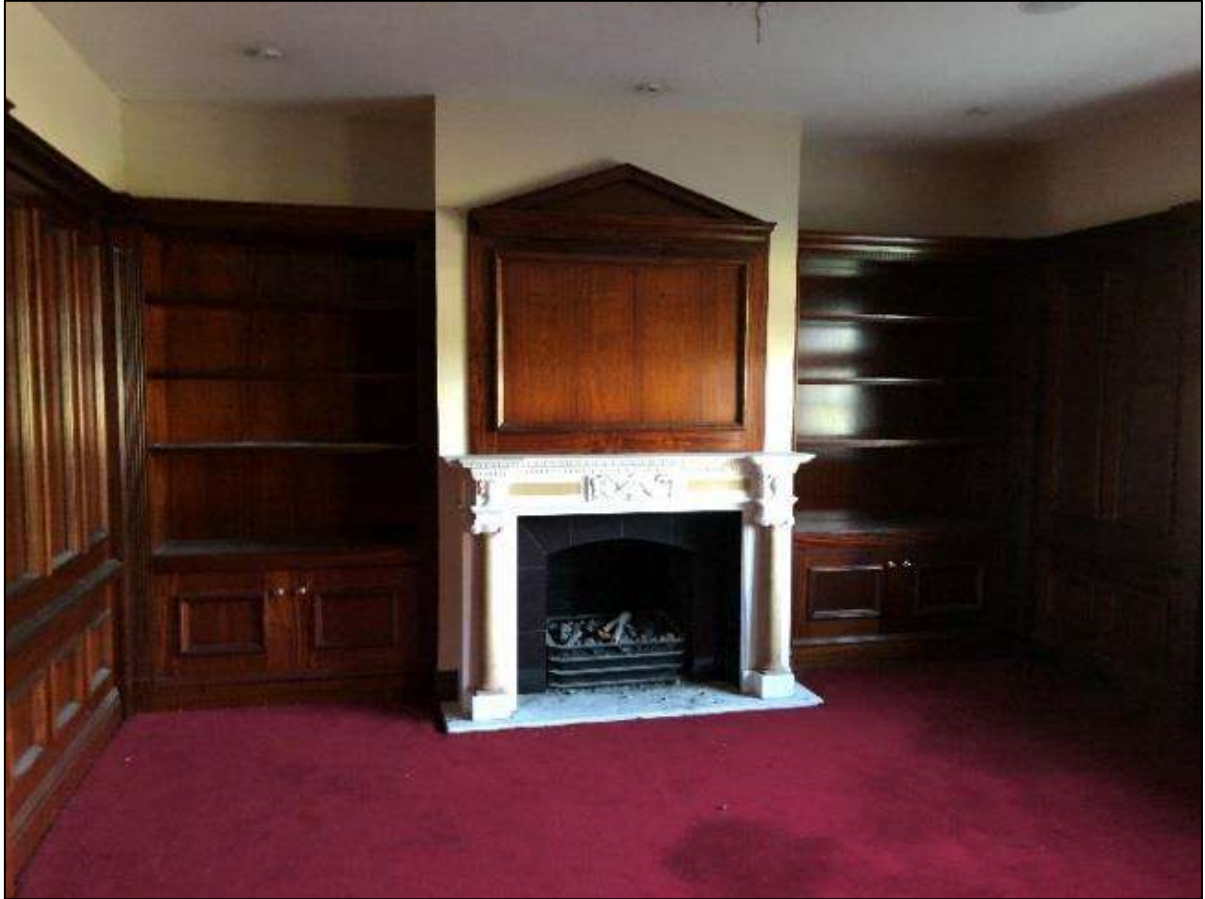
Minor defects only are present in this area including cracks in ceiling and wall surfaces.

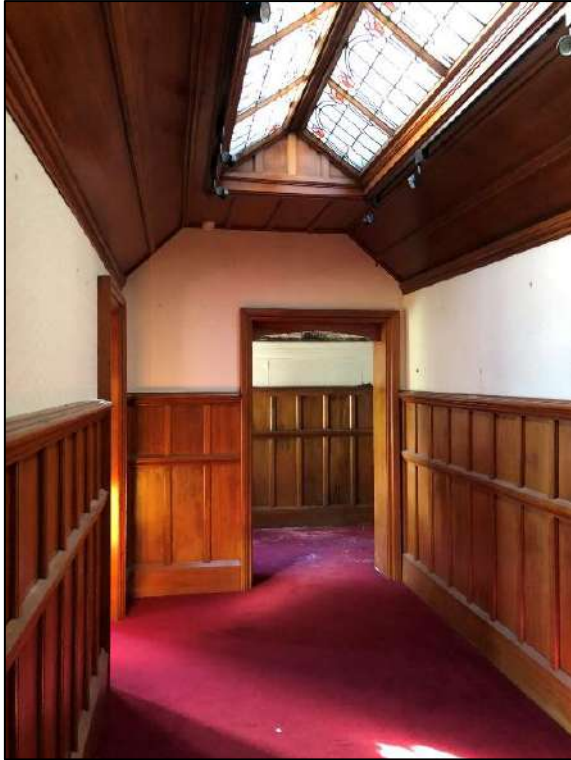
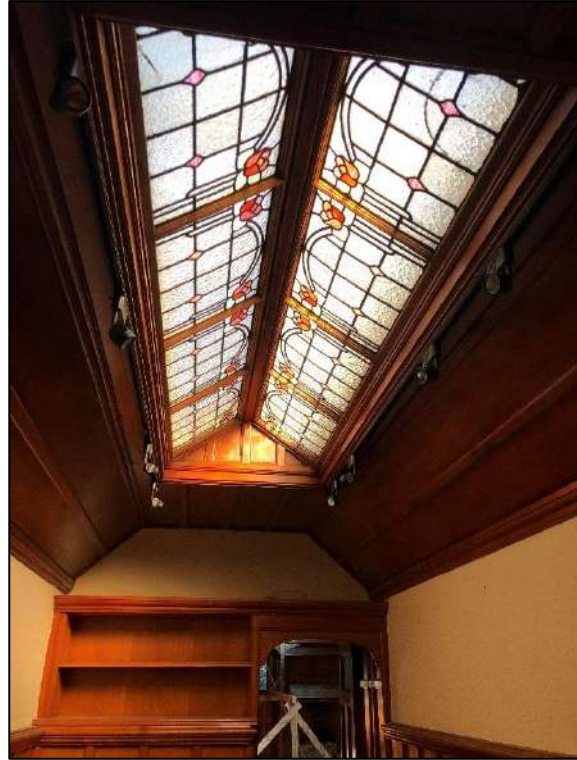
This area has sustained minor damage as a result of a possible roof leak.

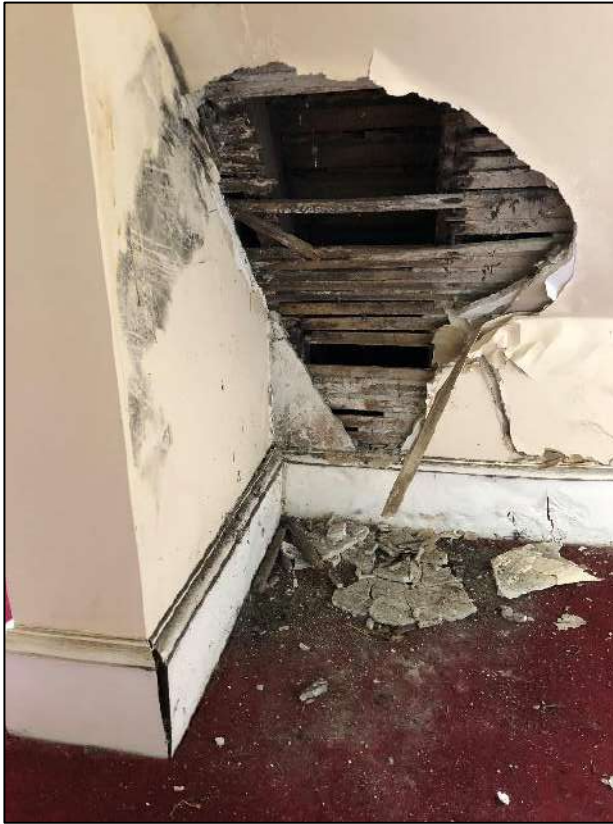
Defects as a result of the earthquakes include extensive damage to the ceiling and plasterboard wall surfaces due to roof leaks after a chimney collapsed and fell through the roofs. Some evidence of movement is apparent between the tiles and the bricks to the fireplace.
