**BEFORE INDEPENDENT HEARING COMMISSIONERS
IN CHRISTCHURCH**

TE MAHERE Ā-ROHE I TŪTOHUA MŌ TE TĀONE O ŌTAUTAHI

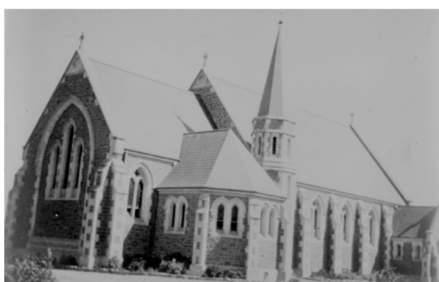
Figure 1: St James' Church from the northeast, photographed by James D. Richardson. The date of the image is unknown but, as Richardson died in 1942, it is assumed to be c.1924-1940. Source: Auckland Libraries

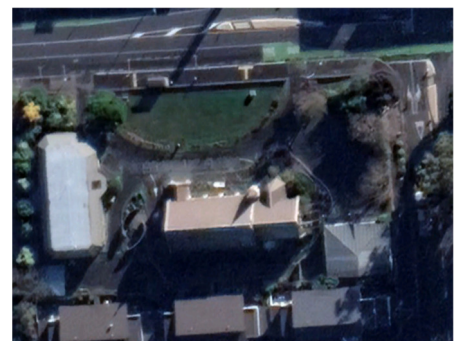
Figure 10: Current aerial photo of St James' Church. Source: Google Earth

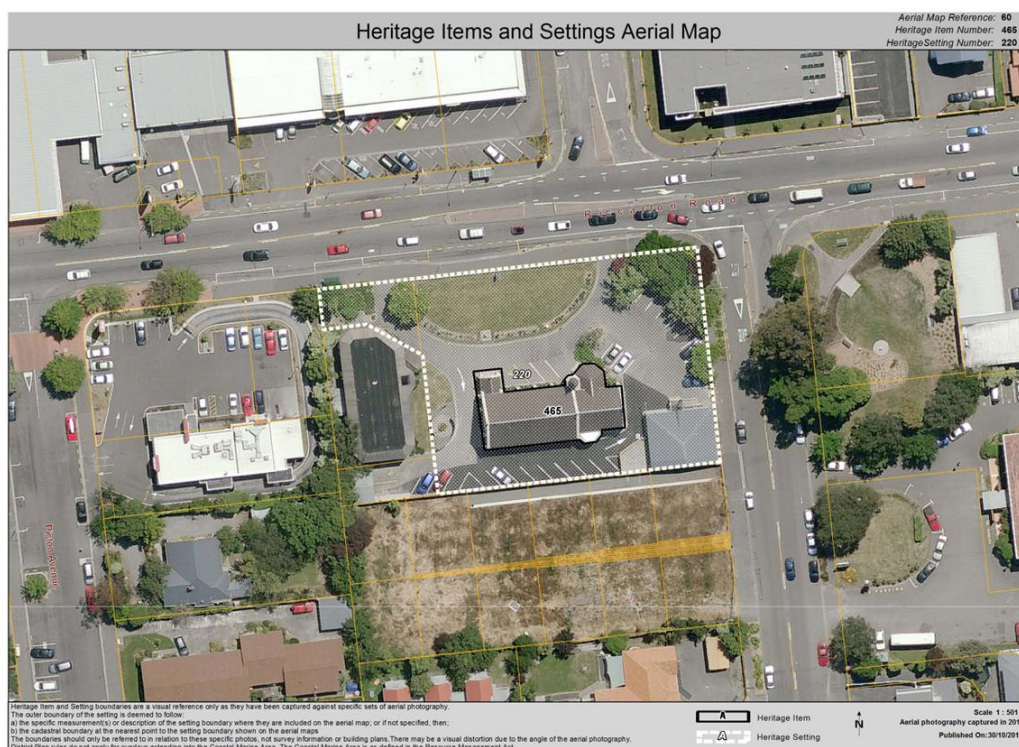
Figure 1: The heritage item and setting on the Site, Heritage Items and Settings Aerial Map, Appendix 9.3.7.7 Christchurch District Plan.

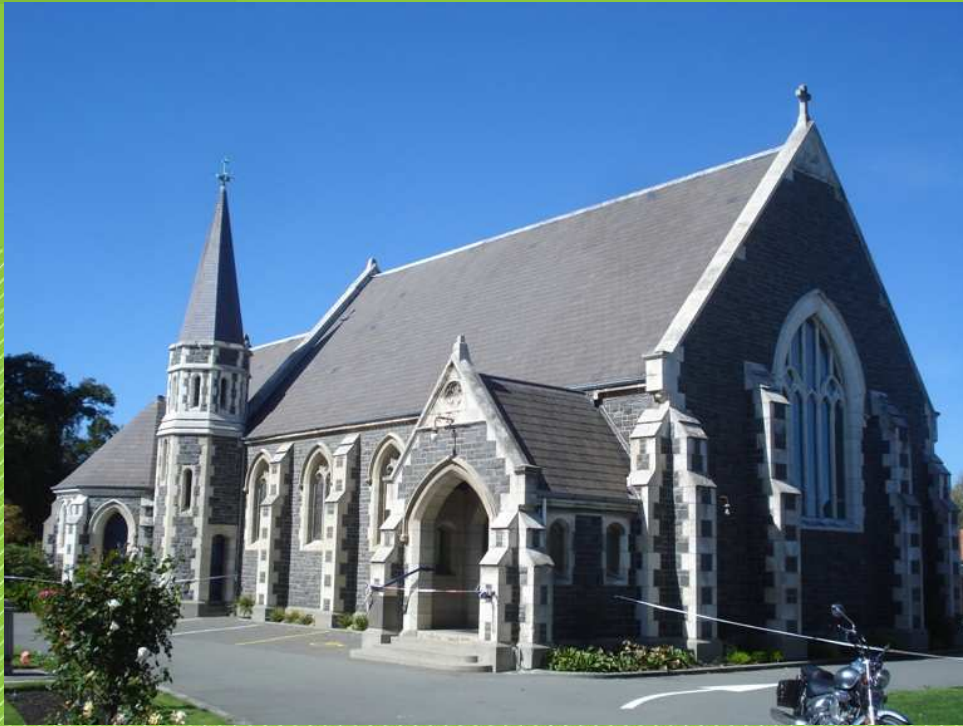
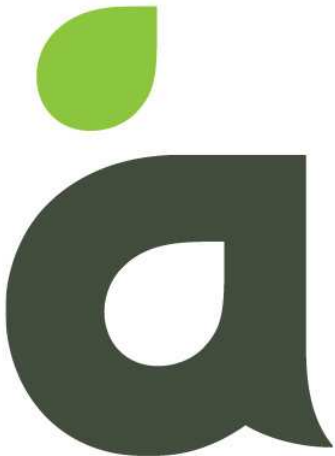
**St James Church,
Riccarton**

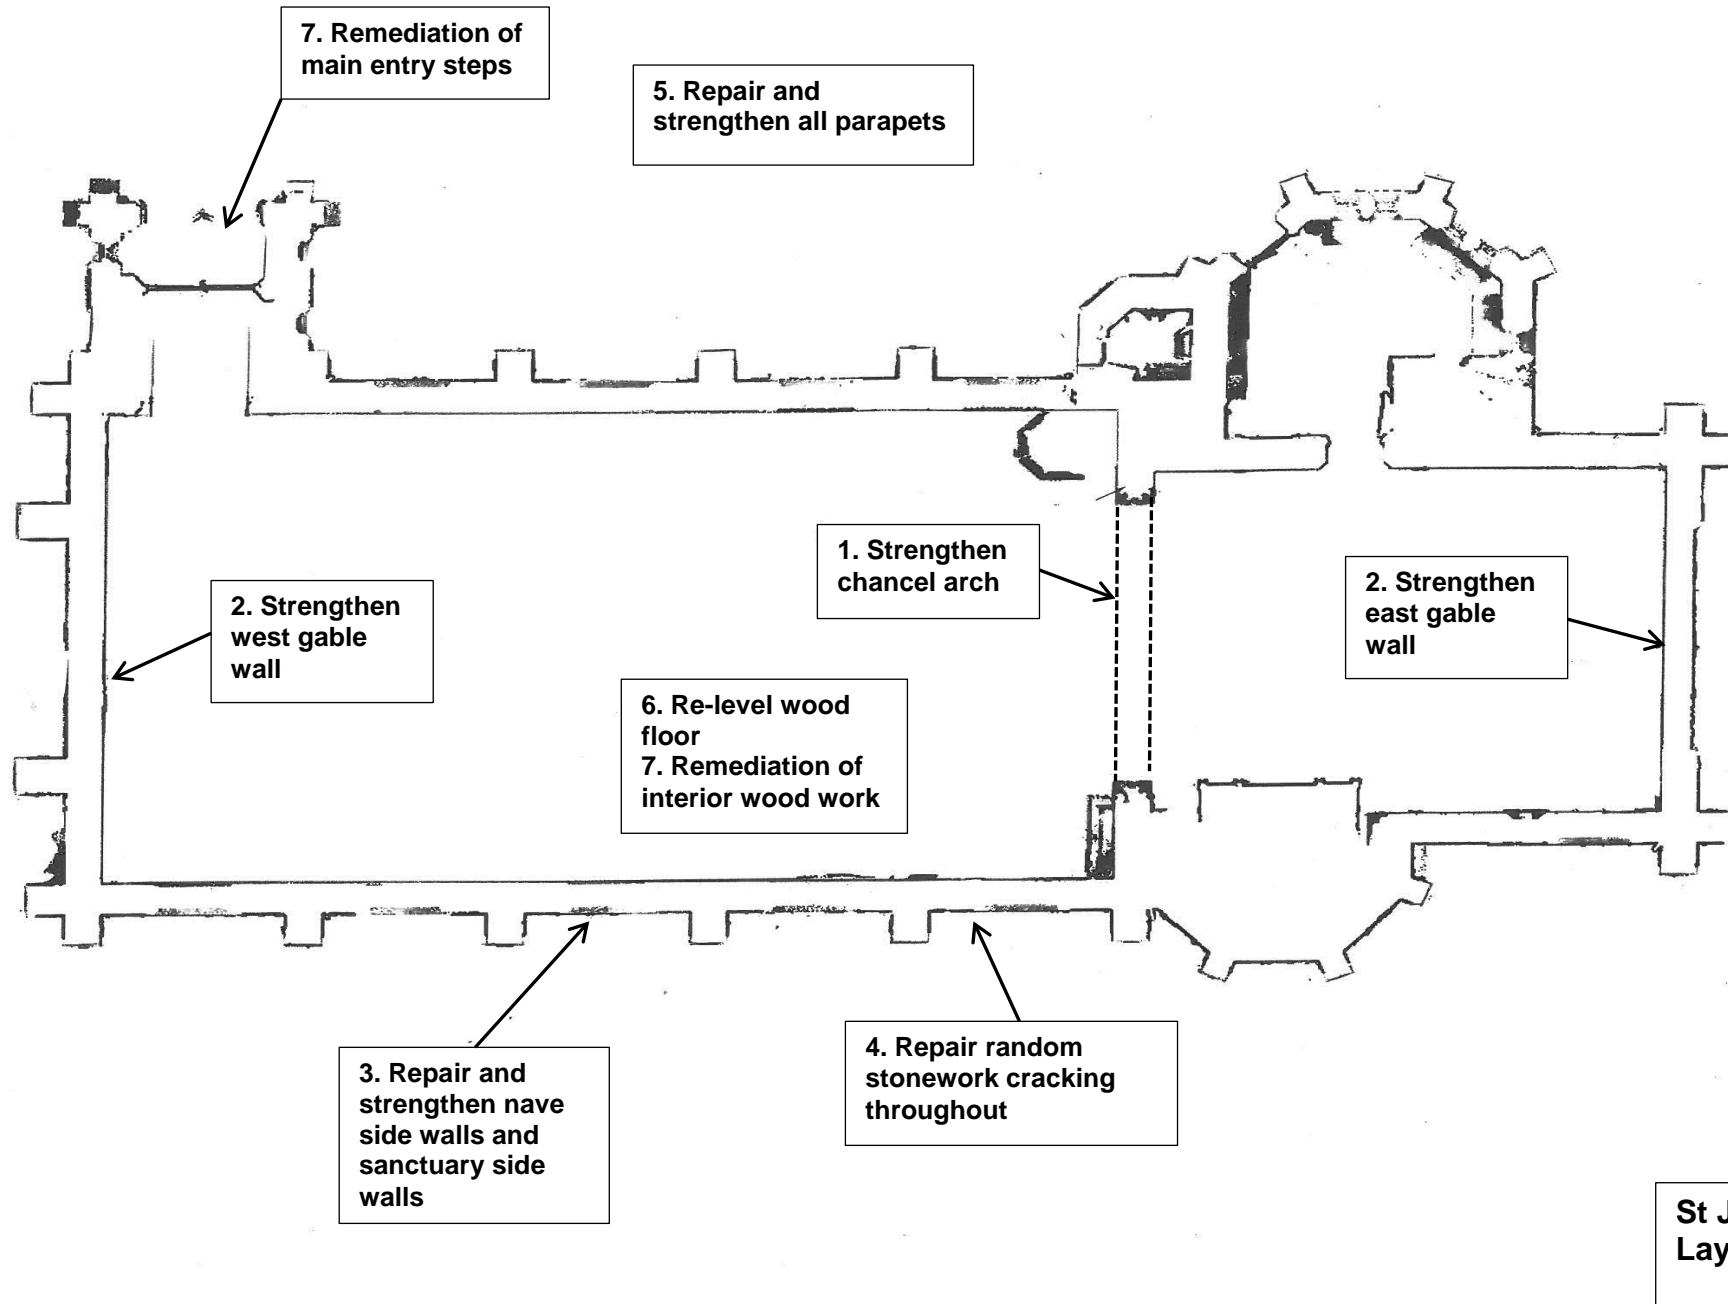
Scope of Work cont'd

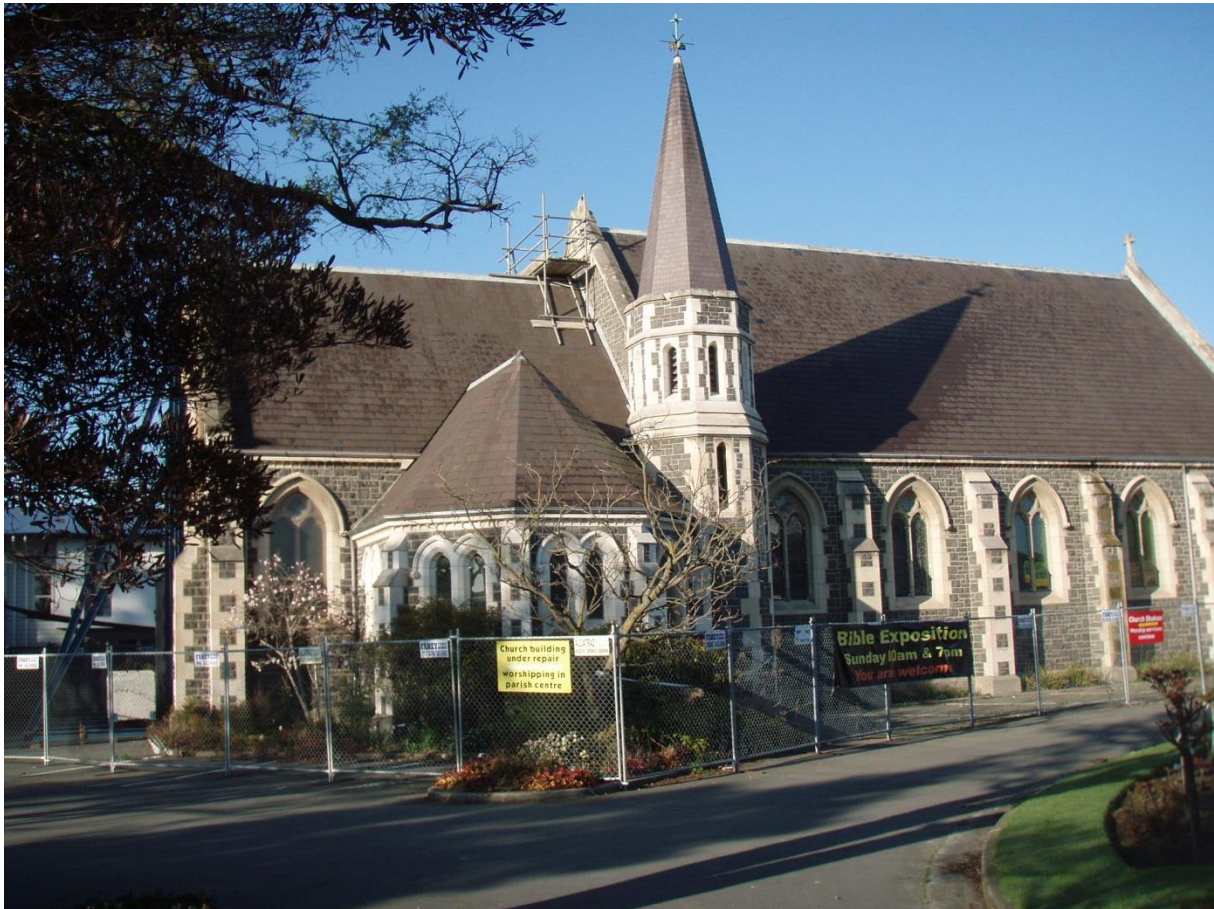
General view of St James Church (information only)

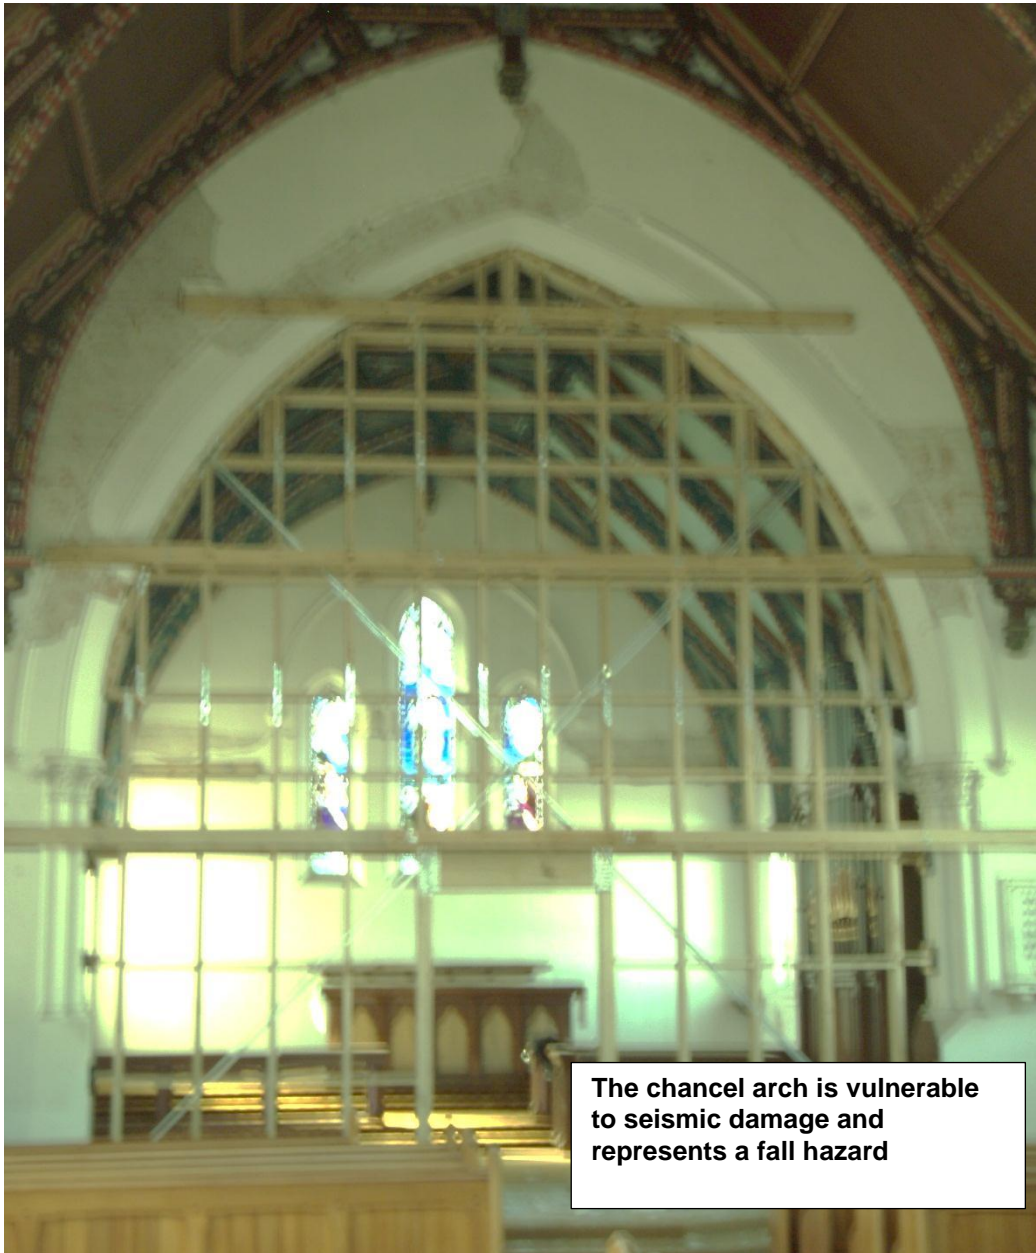
The chancel arch is vulnerable to seismic damage and represents a fall hazard

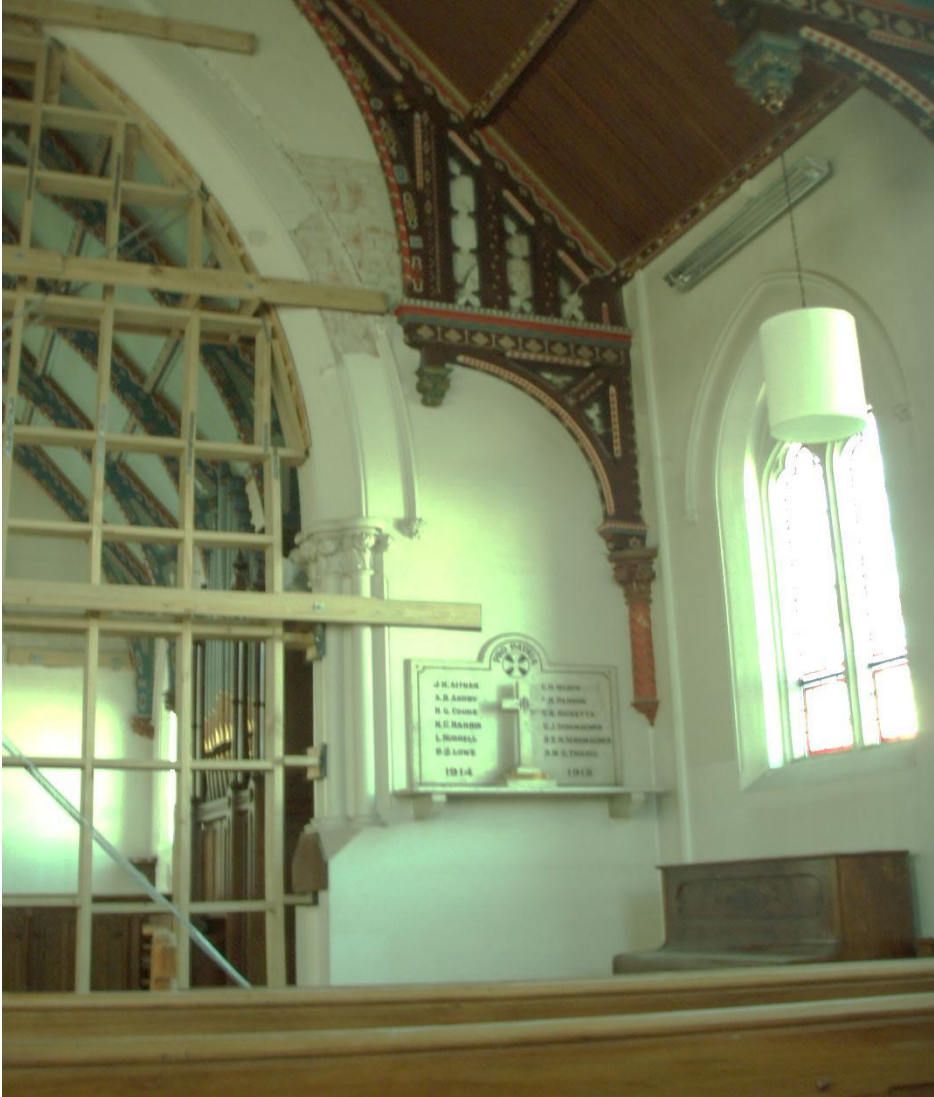
Photo 1a – Chancel arch, render damage and cracking at nave wall eave level

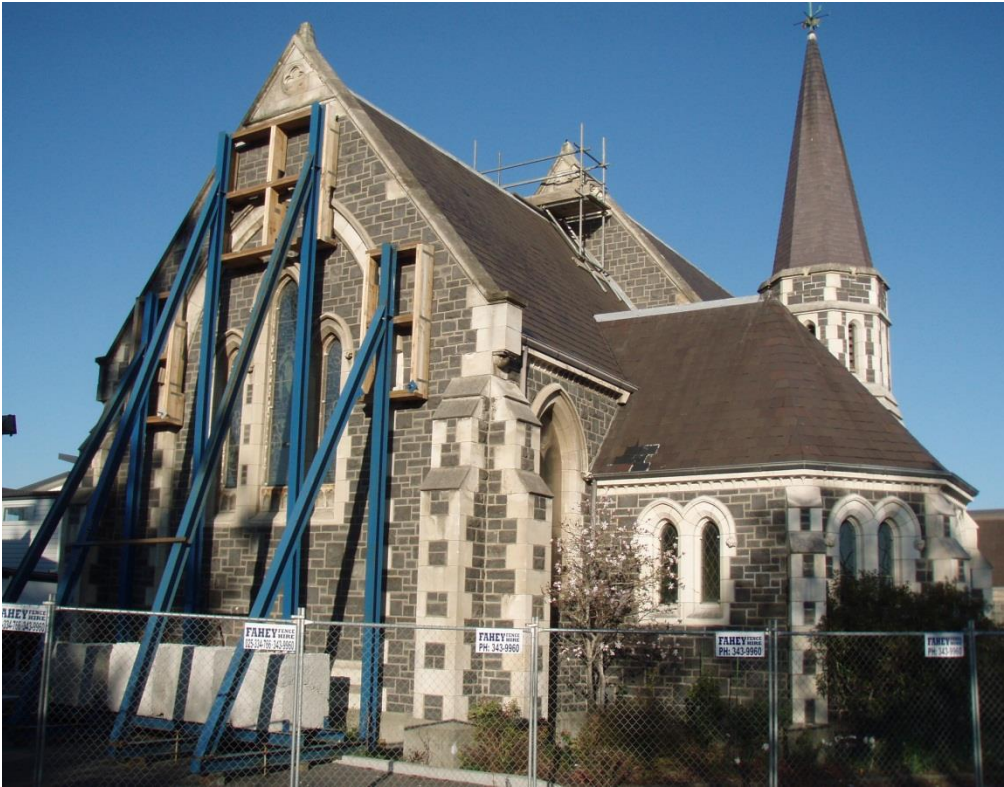
Photo 2 – Exterior view of east gable showing propping (west gable is similar)

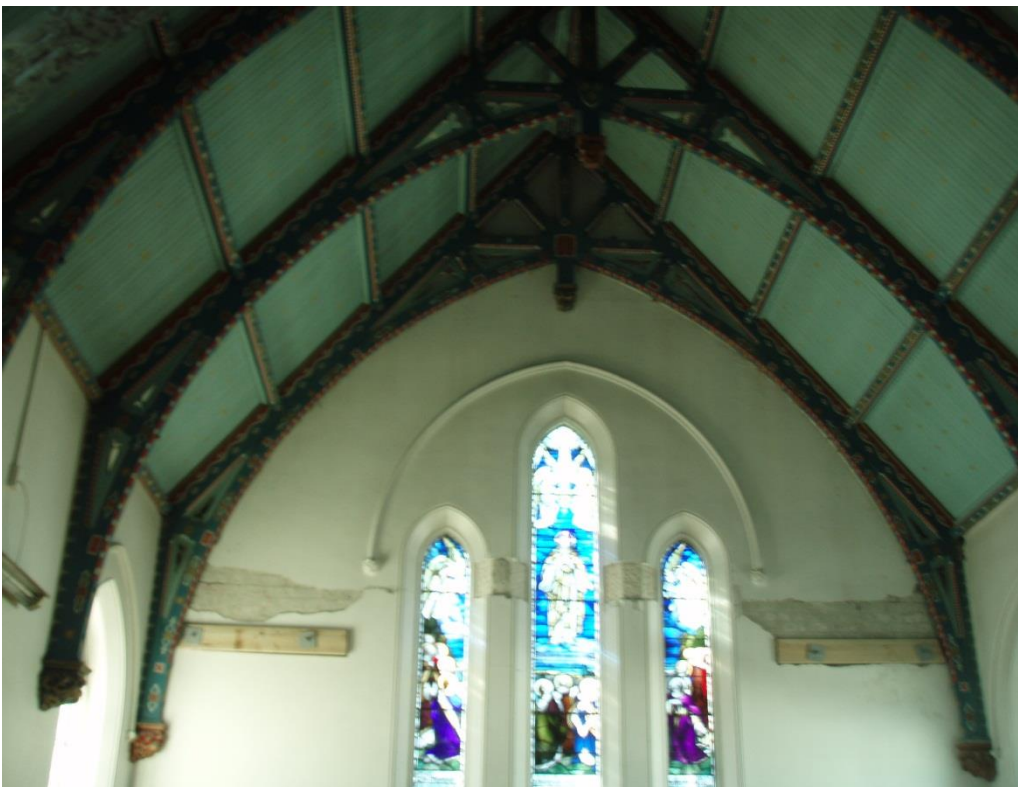
Photo 2a – Interior view of east gable – note cracking at nave wall eave level

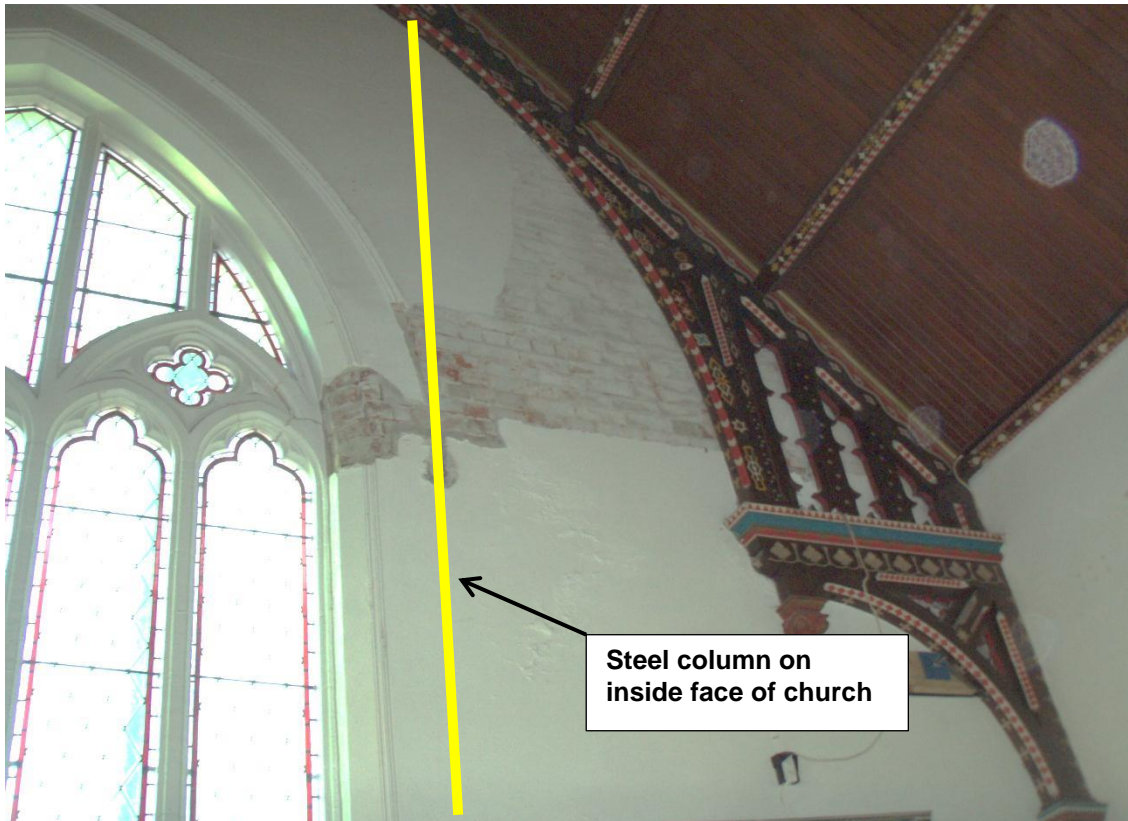
Photo 2b – Interior view of west gable showing render damage (masonry cracking exists but is not visible on this photo)

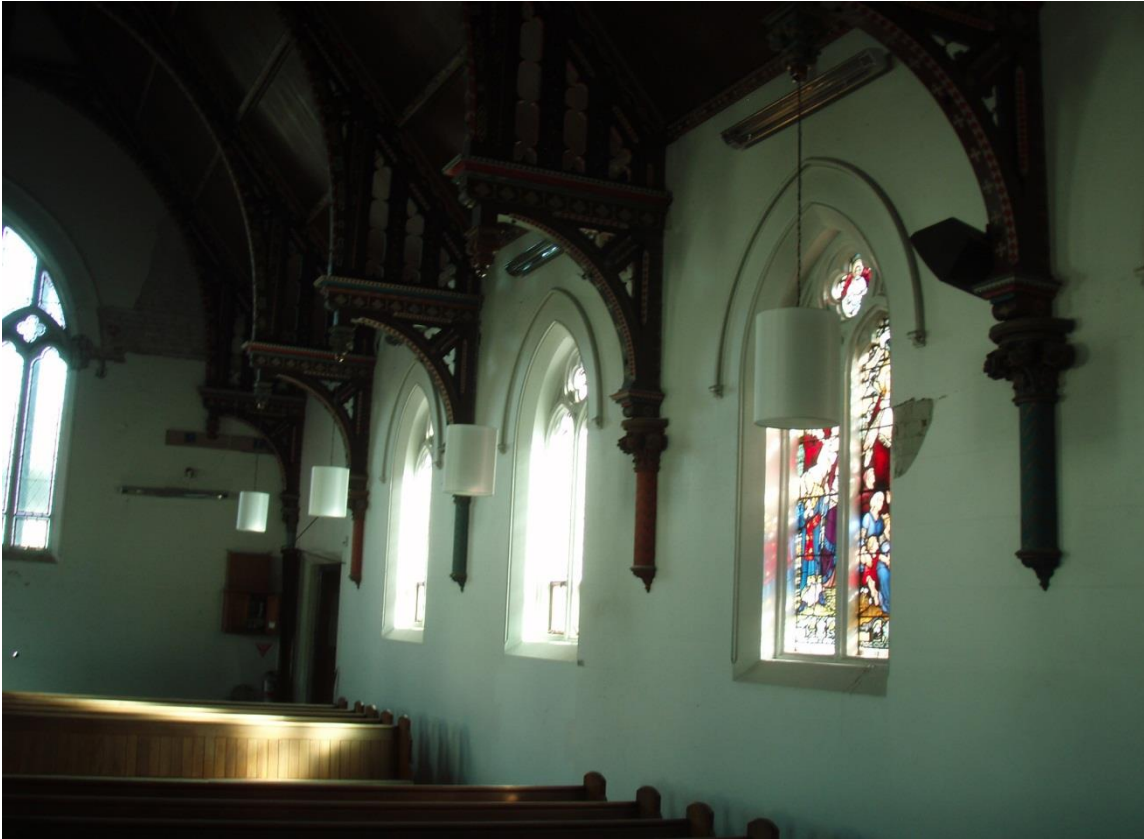
Photo 3 – general view of nave side walls

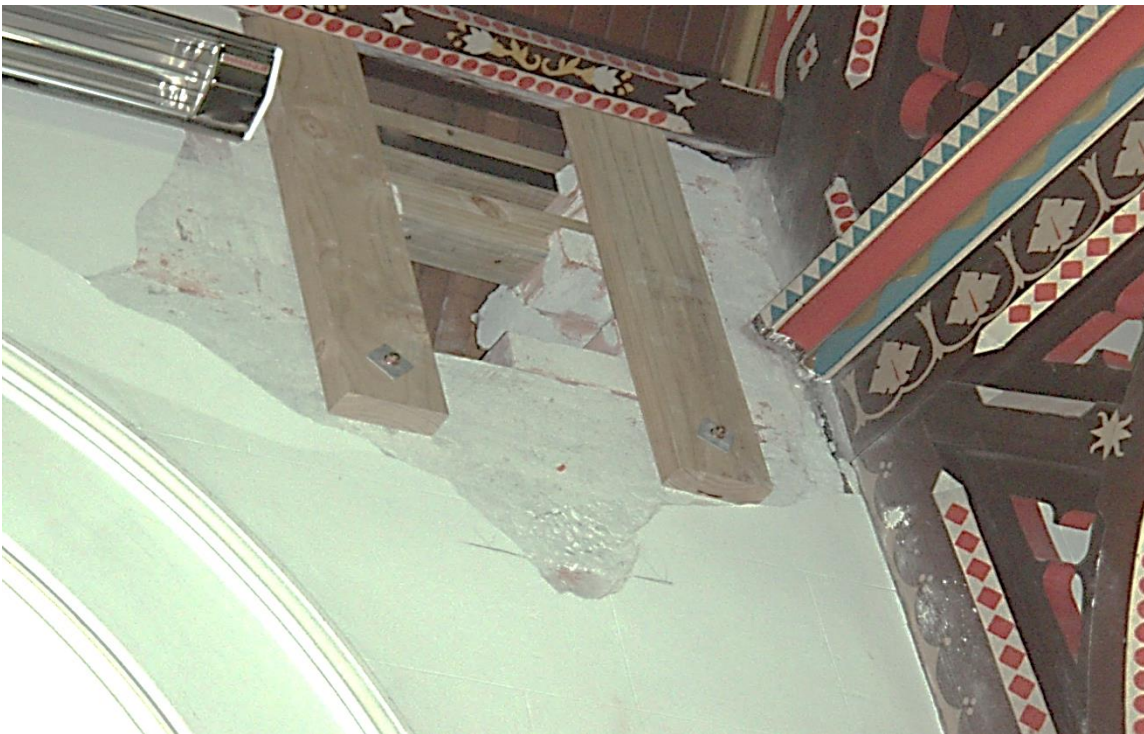
Photo 3a – brick work along top of side walls (opened for investigation purposes)

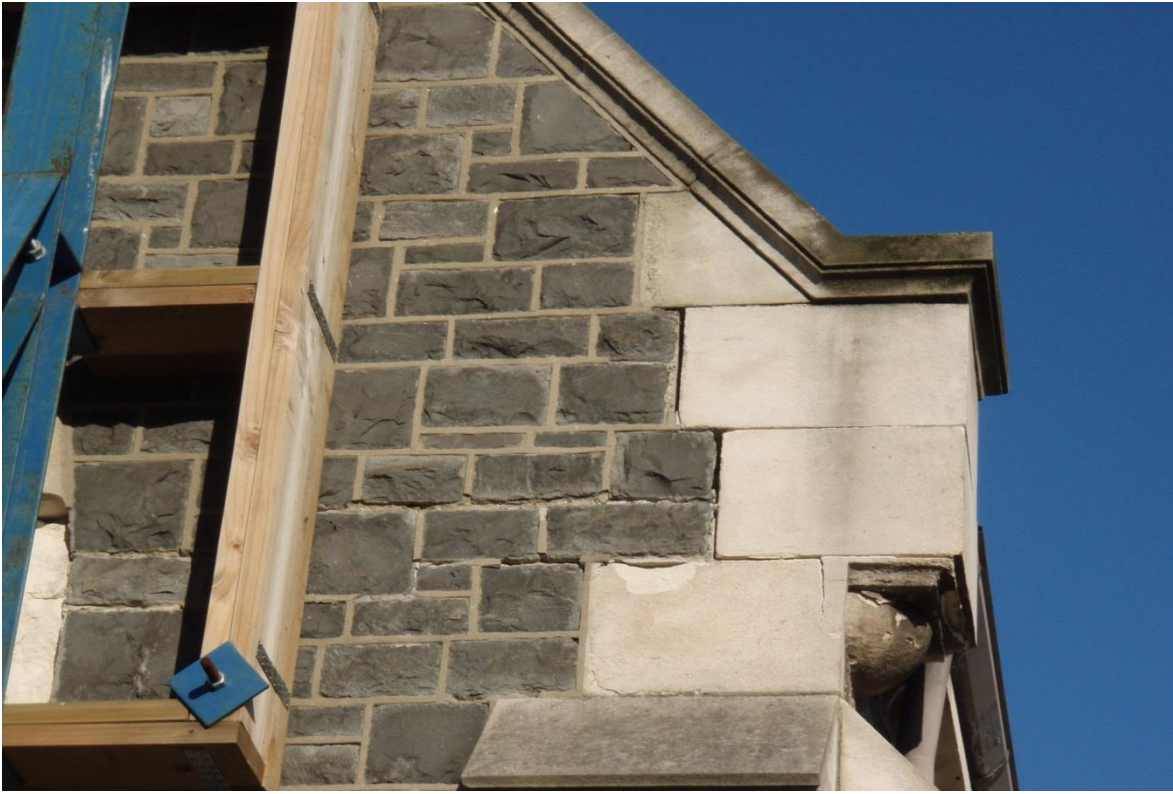
Photo 4 – Loose masonry and cracking on east gable wall, but random repair is required throughout the church walls and chancel arch

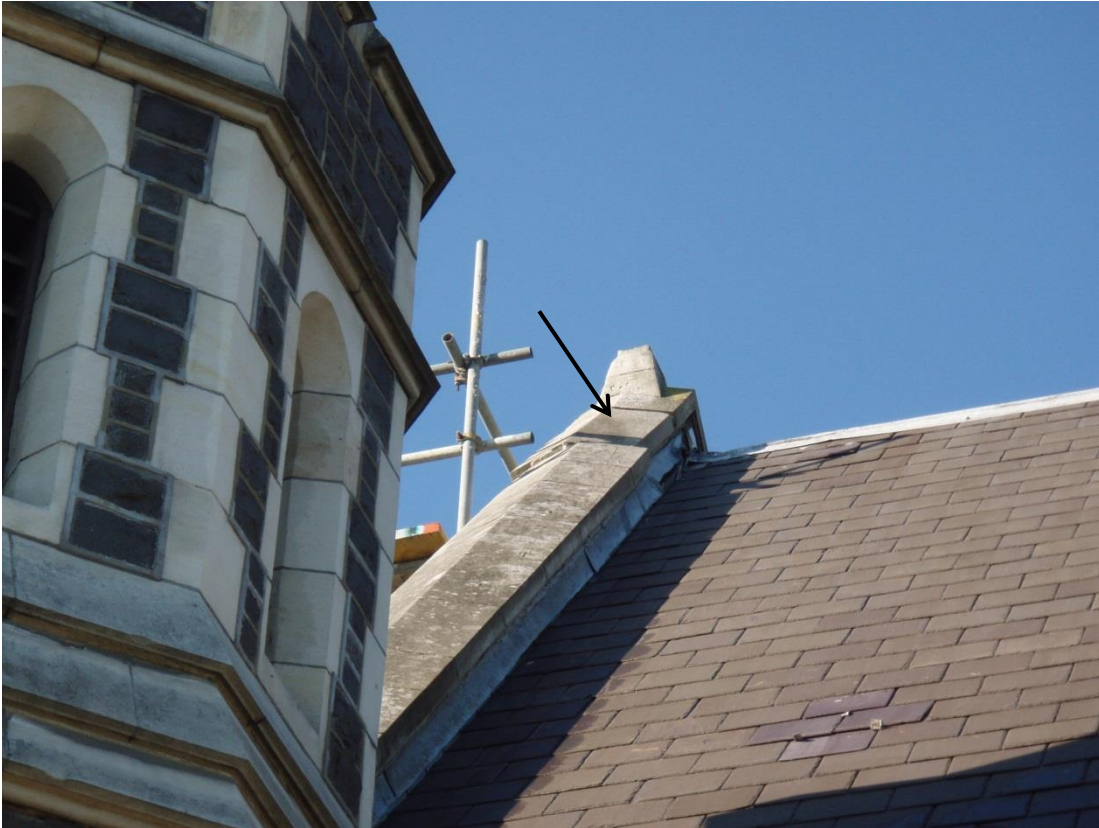
Photo 5 – Dislodged capping stones over chancel arch

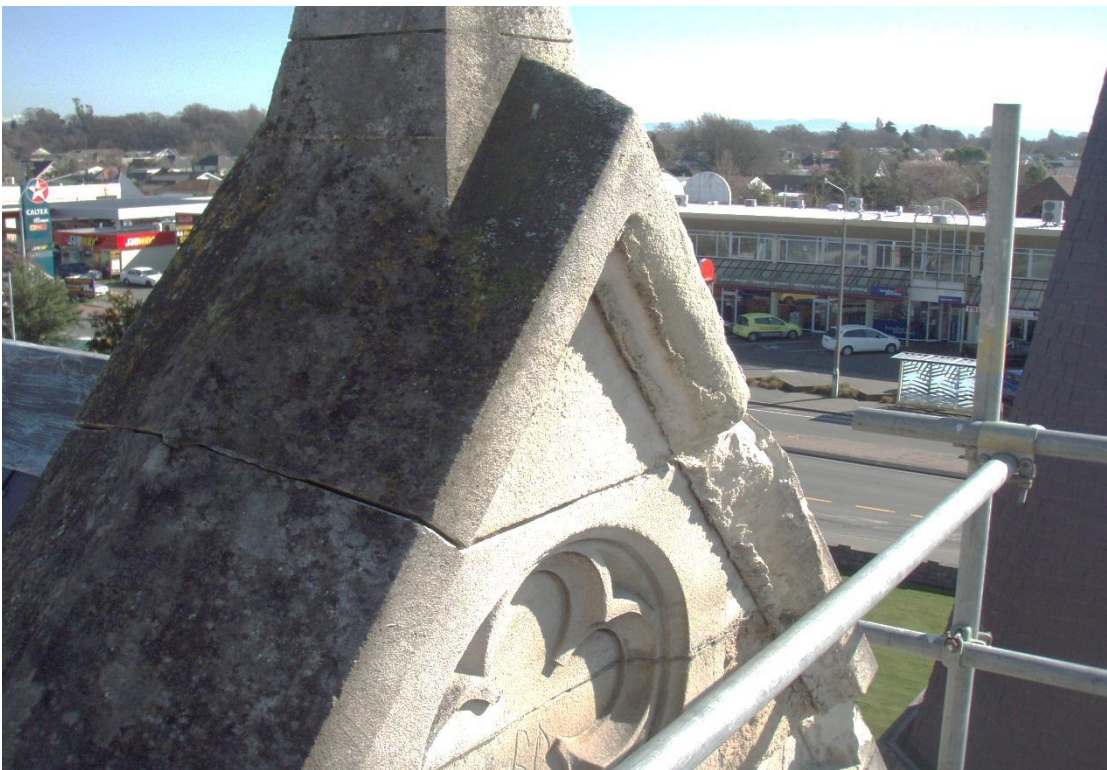
Photo 5a – Capping stone damage over chance arch

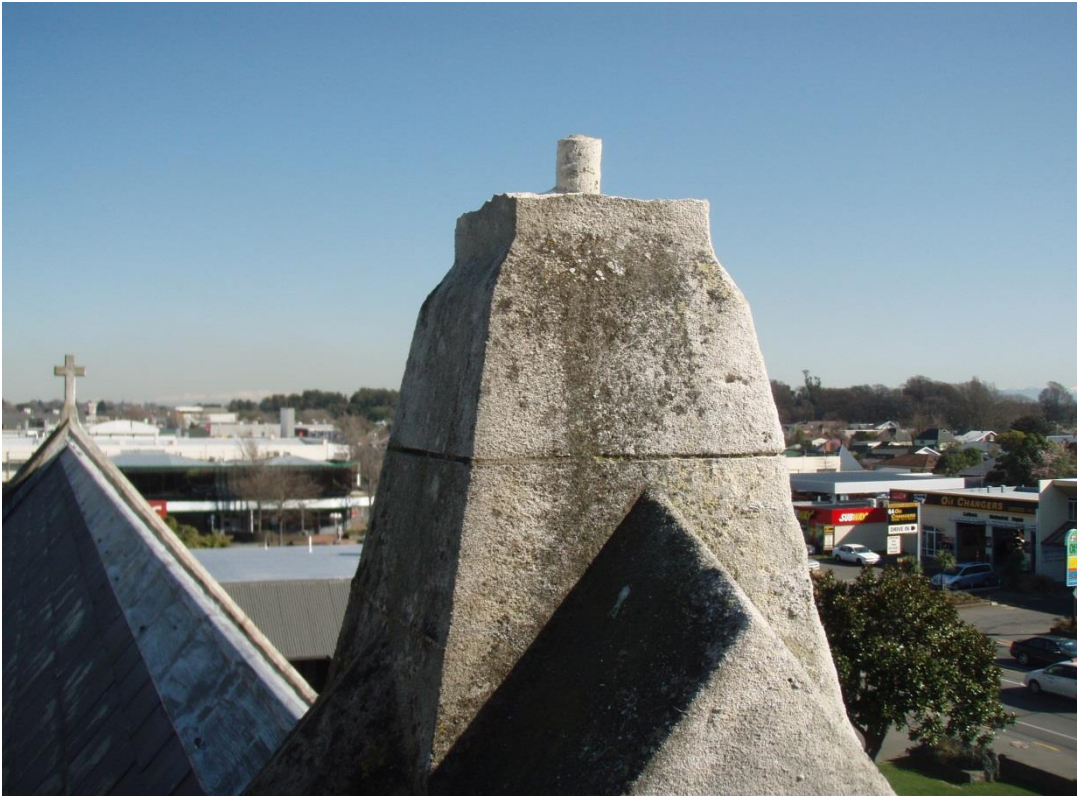
Photo 5b – view at roof level looking from chance arch (cross support will need stitching)

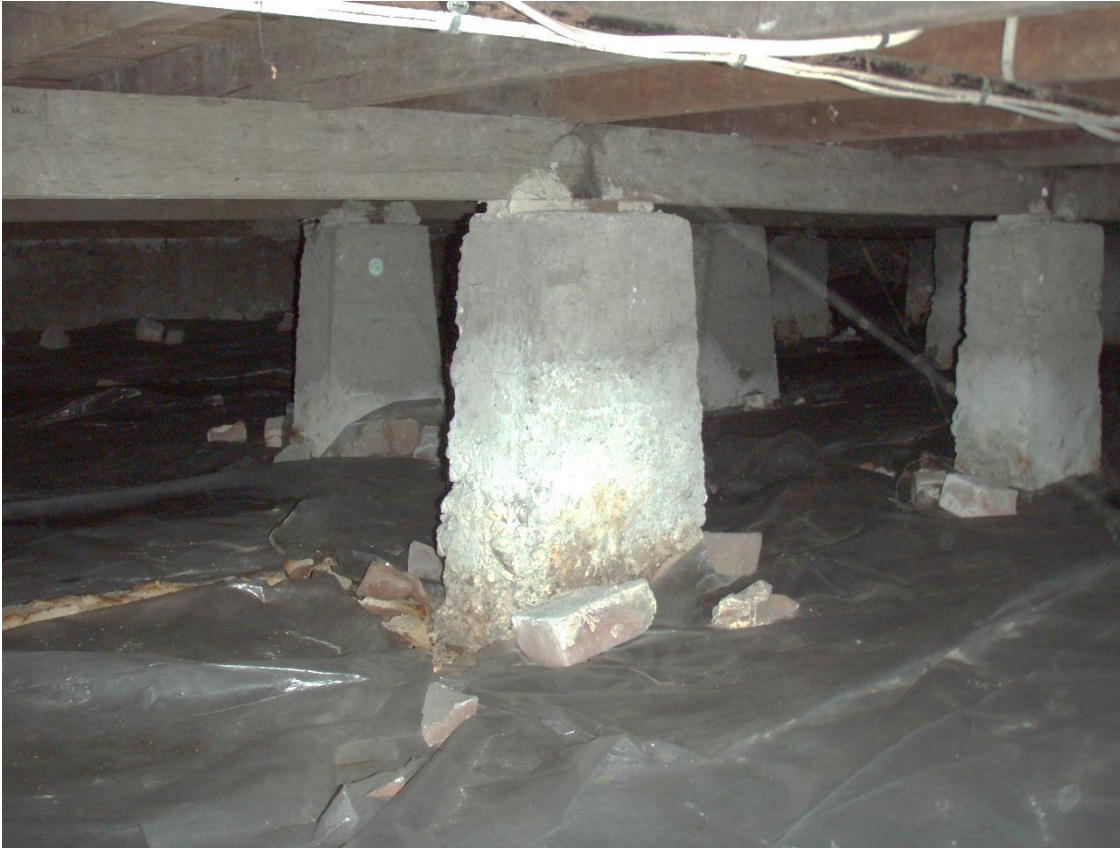
Photo 6 – General view under floor

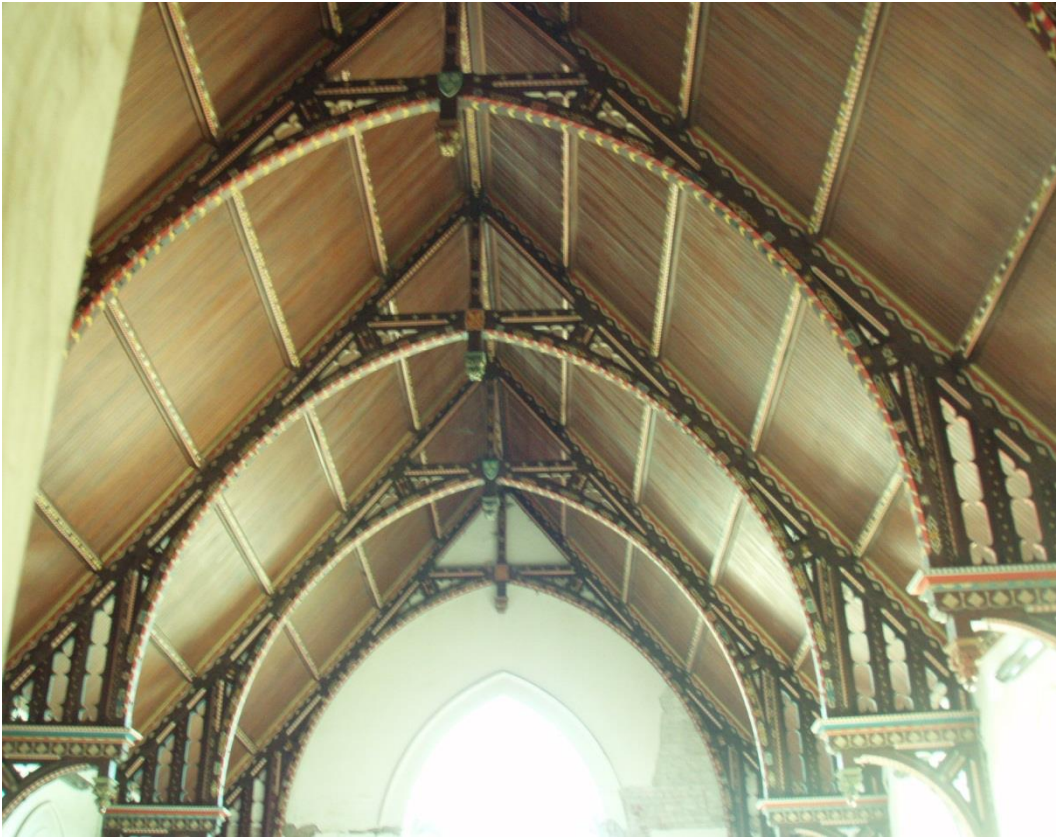
Photo 7 – Interior wood work

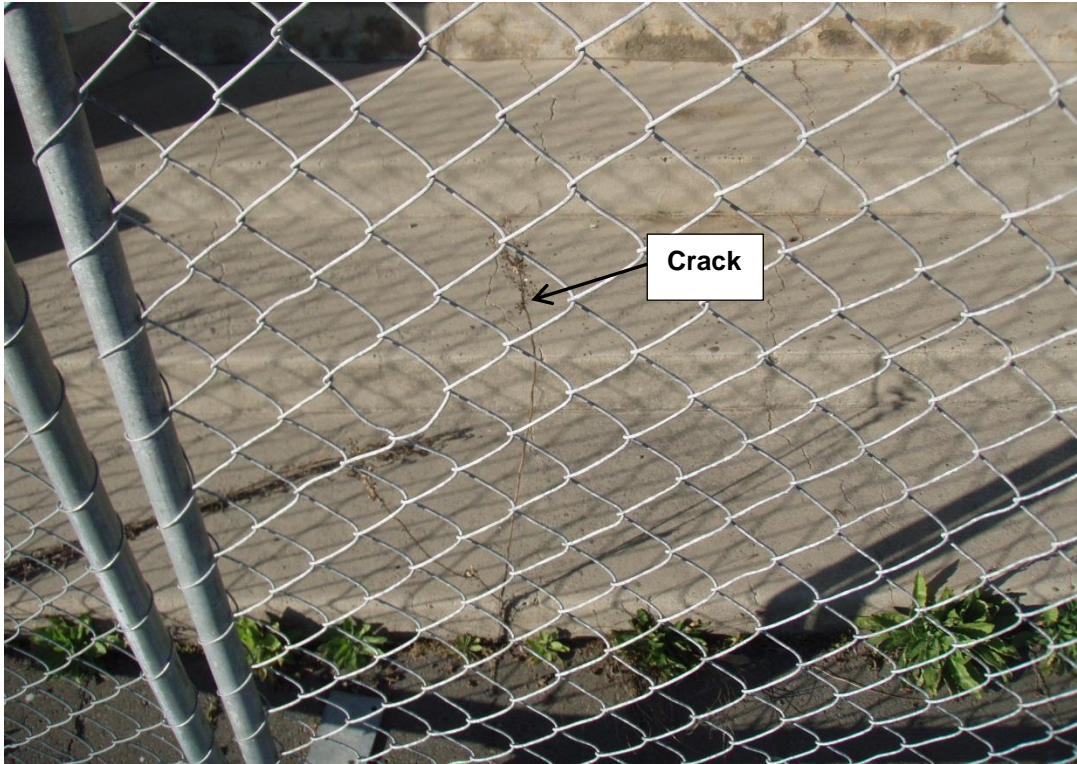
Photo 7a – Cracks in main entry steps

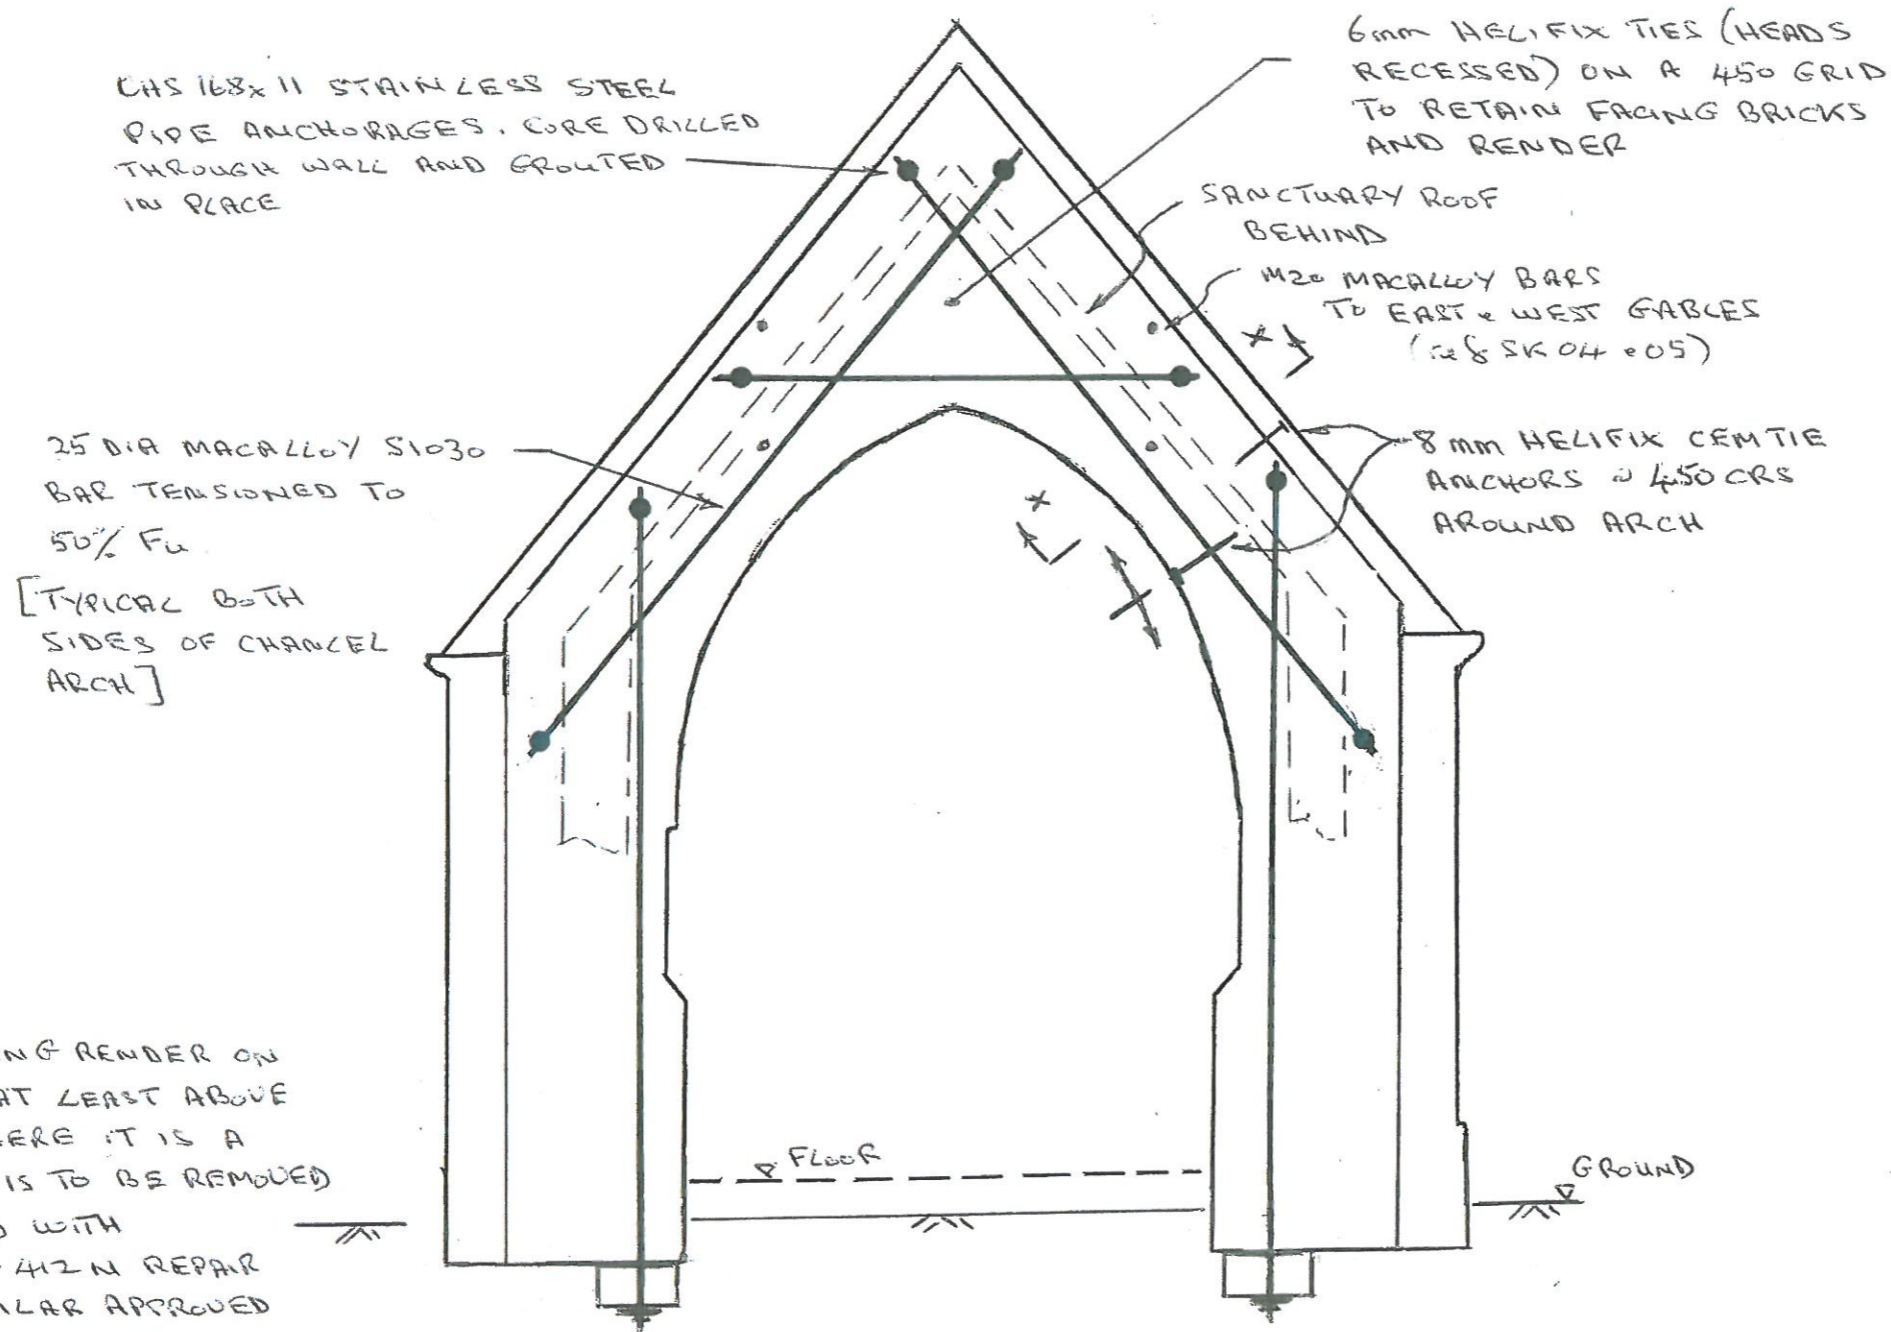
CHS 168x11 STAINLESS STEEL PIPE ANCHORAGES, CORE DRILLED THROUGH WALL AND GROUTED IN PLACE

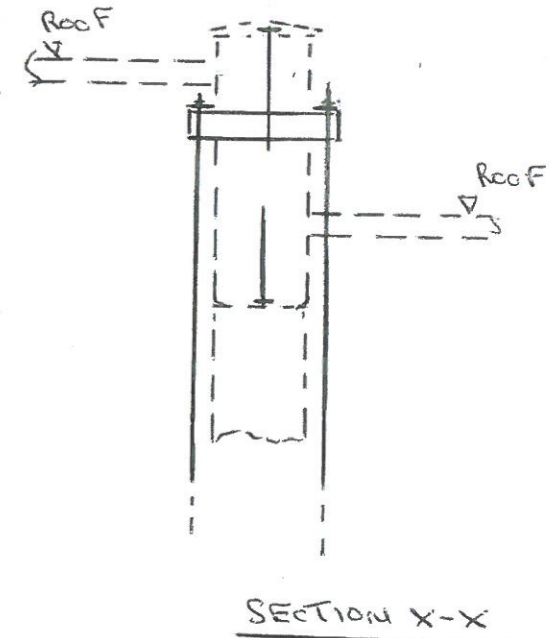
CRACK REMEDIATION IS REQUIRED PRIOR TO OTHER WORK ON THE CHANCEL (REFER TO SCOPE OF WORK ITEM 4)
