**BEFORE INDEPENDENT HEARING COMMISSIONERS
IN CHRISTCHURCH**

TE MAHERE Ā-ROHE I TŪTOHUA MŌ TE TĀONE O ŌTAUTAHI

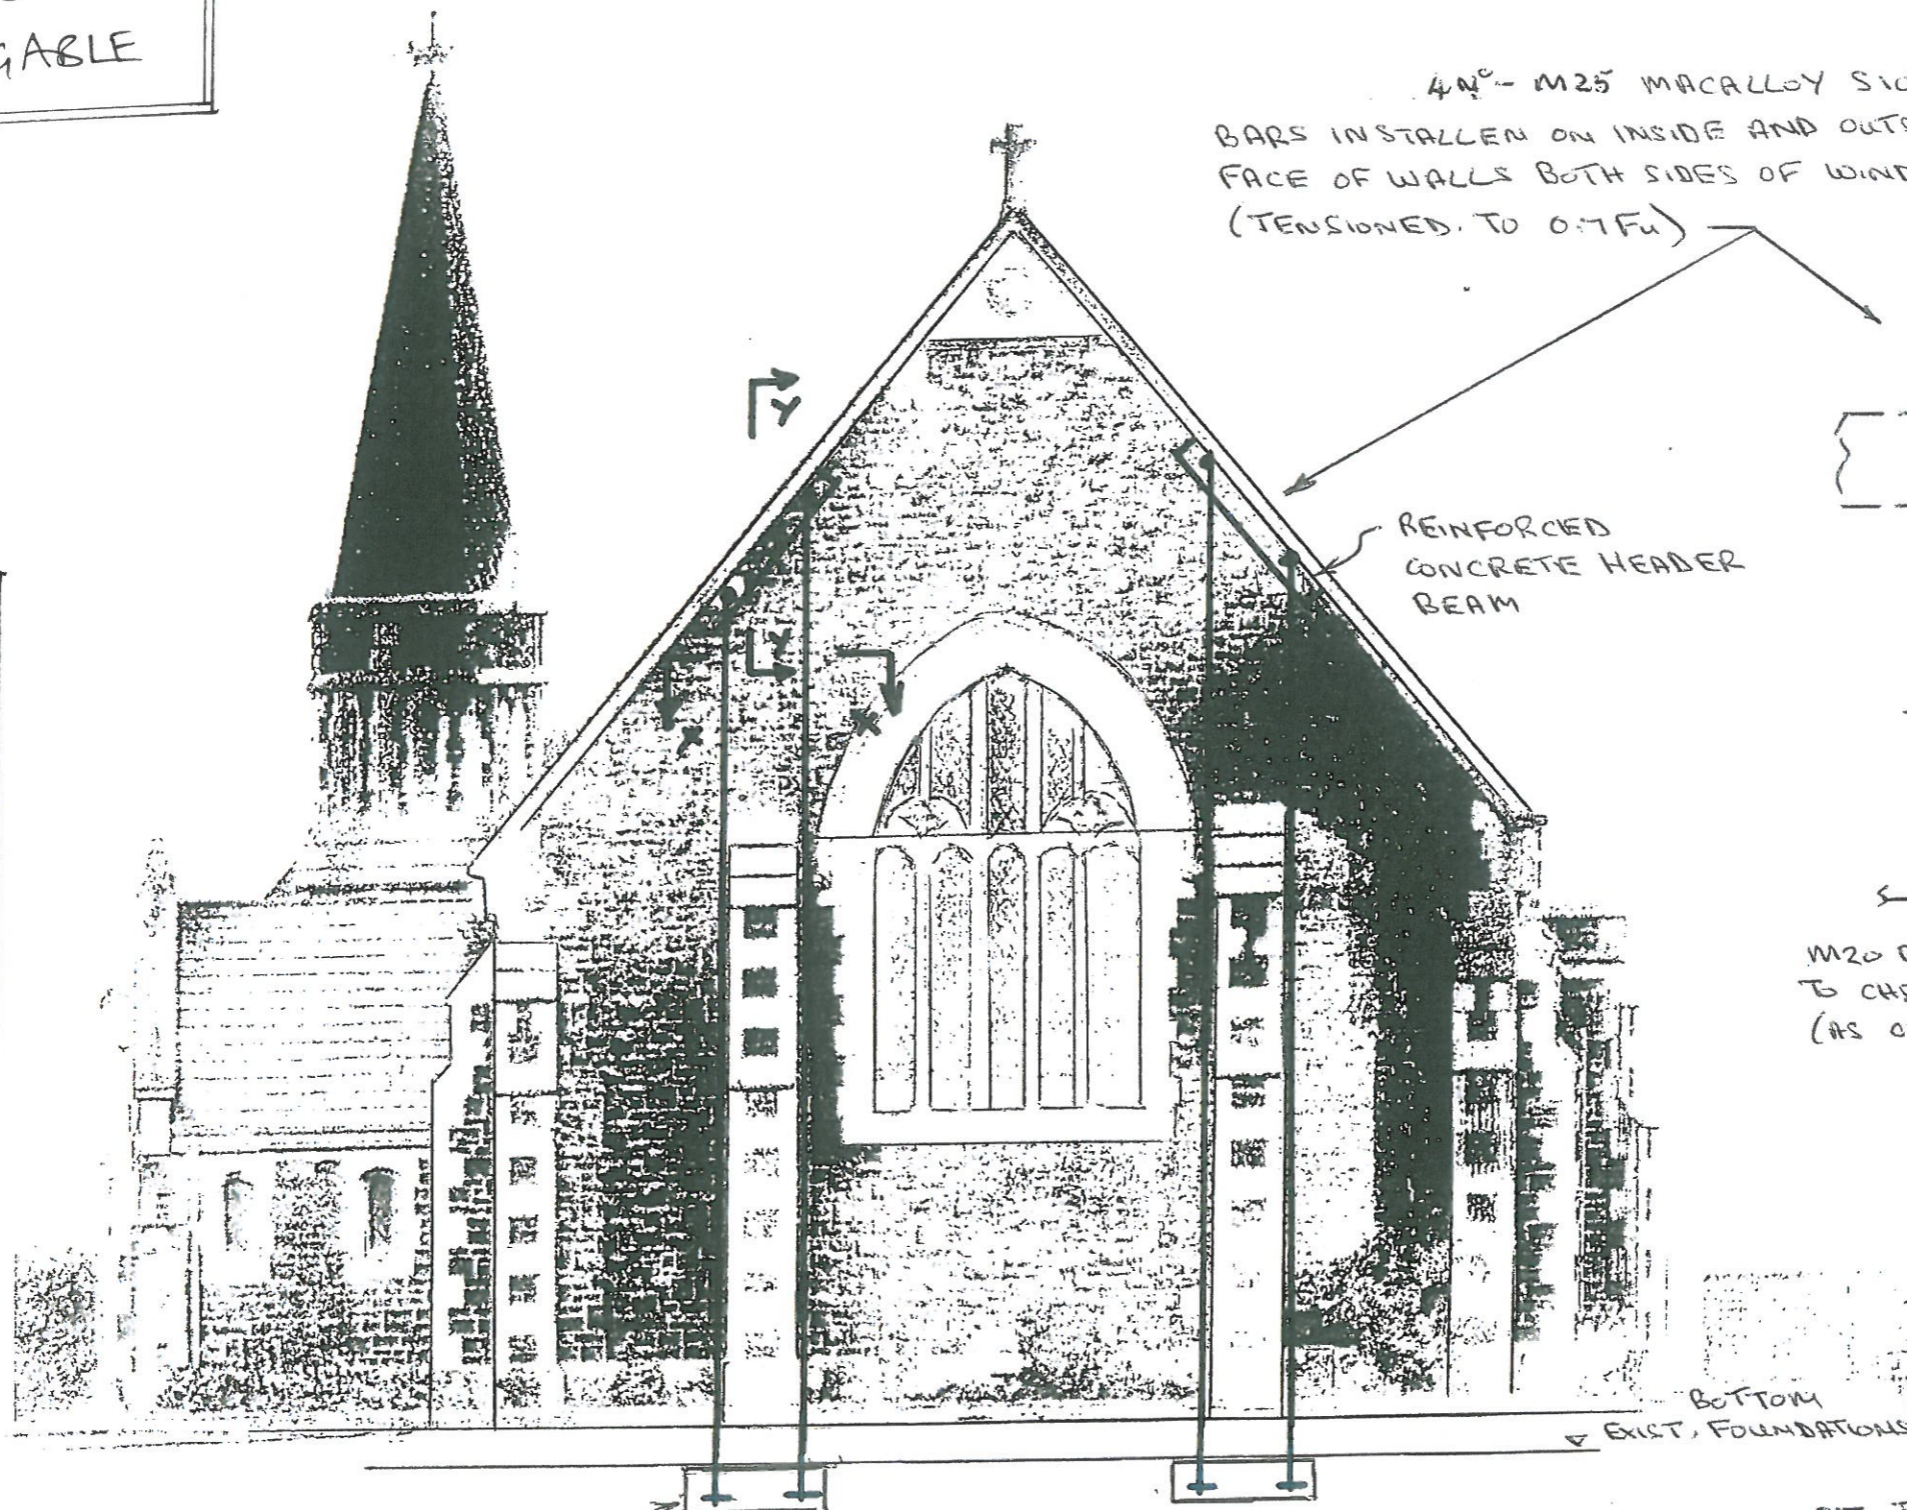
NEW FOUNDATION (PT BAR DEAD END)

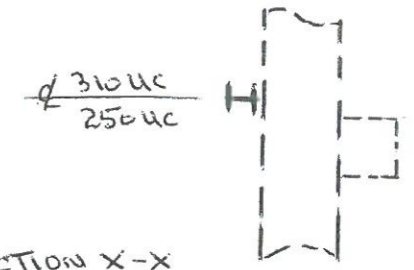
FOR EAST GABLE
37% STRENGTHENING
USE 250 UC.

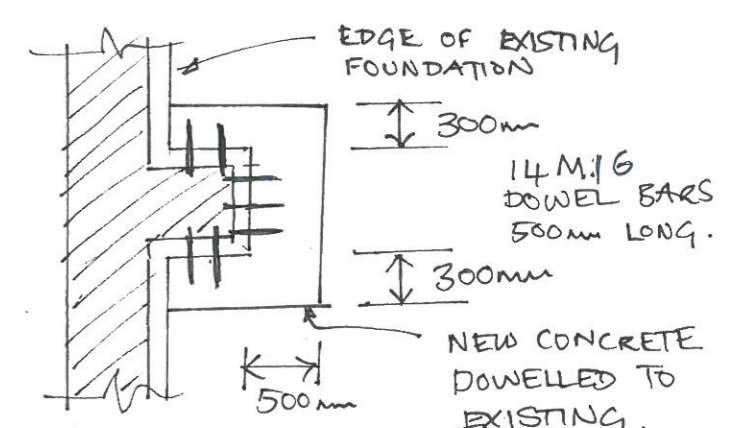
FOUNDATION PLAN (ALTERNATIVE TO CROSS TIES)

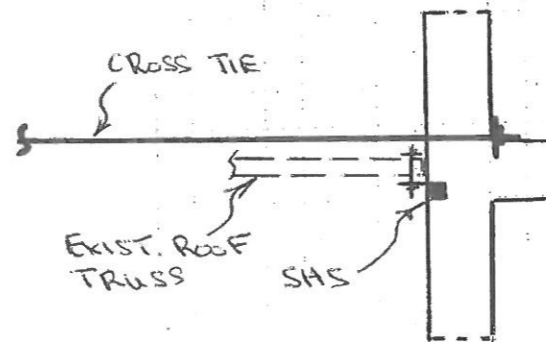
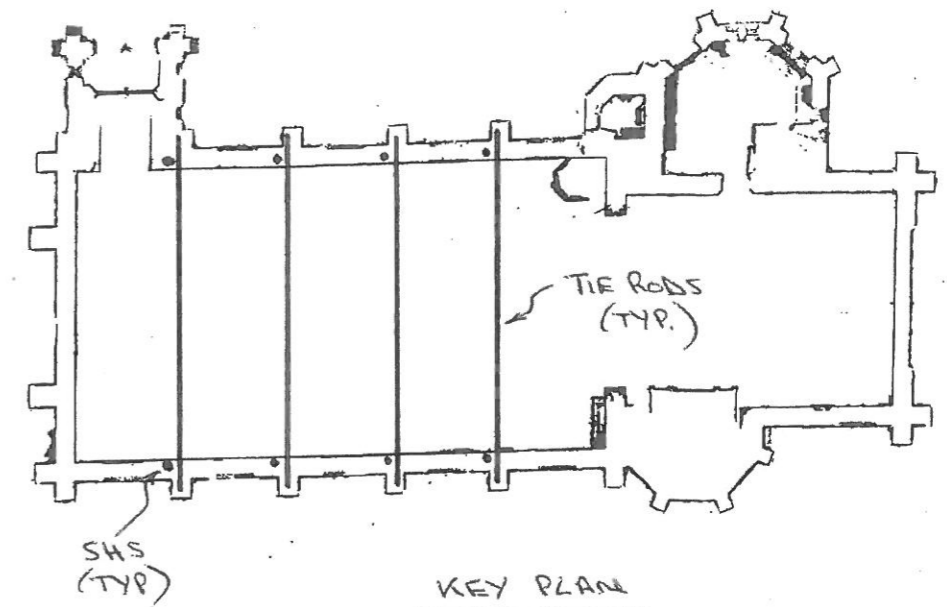
OPTIONAL DOWELLED
CONCRETE FOOTING
SEE SK-06.

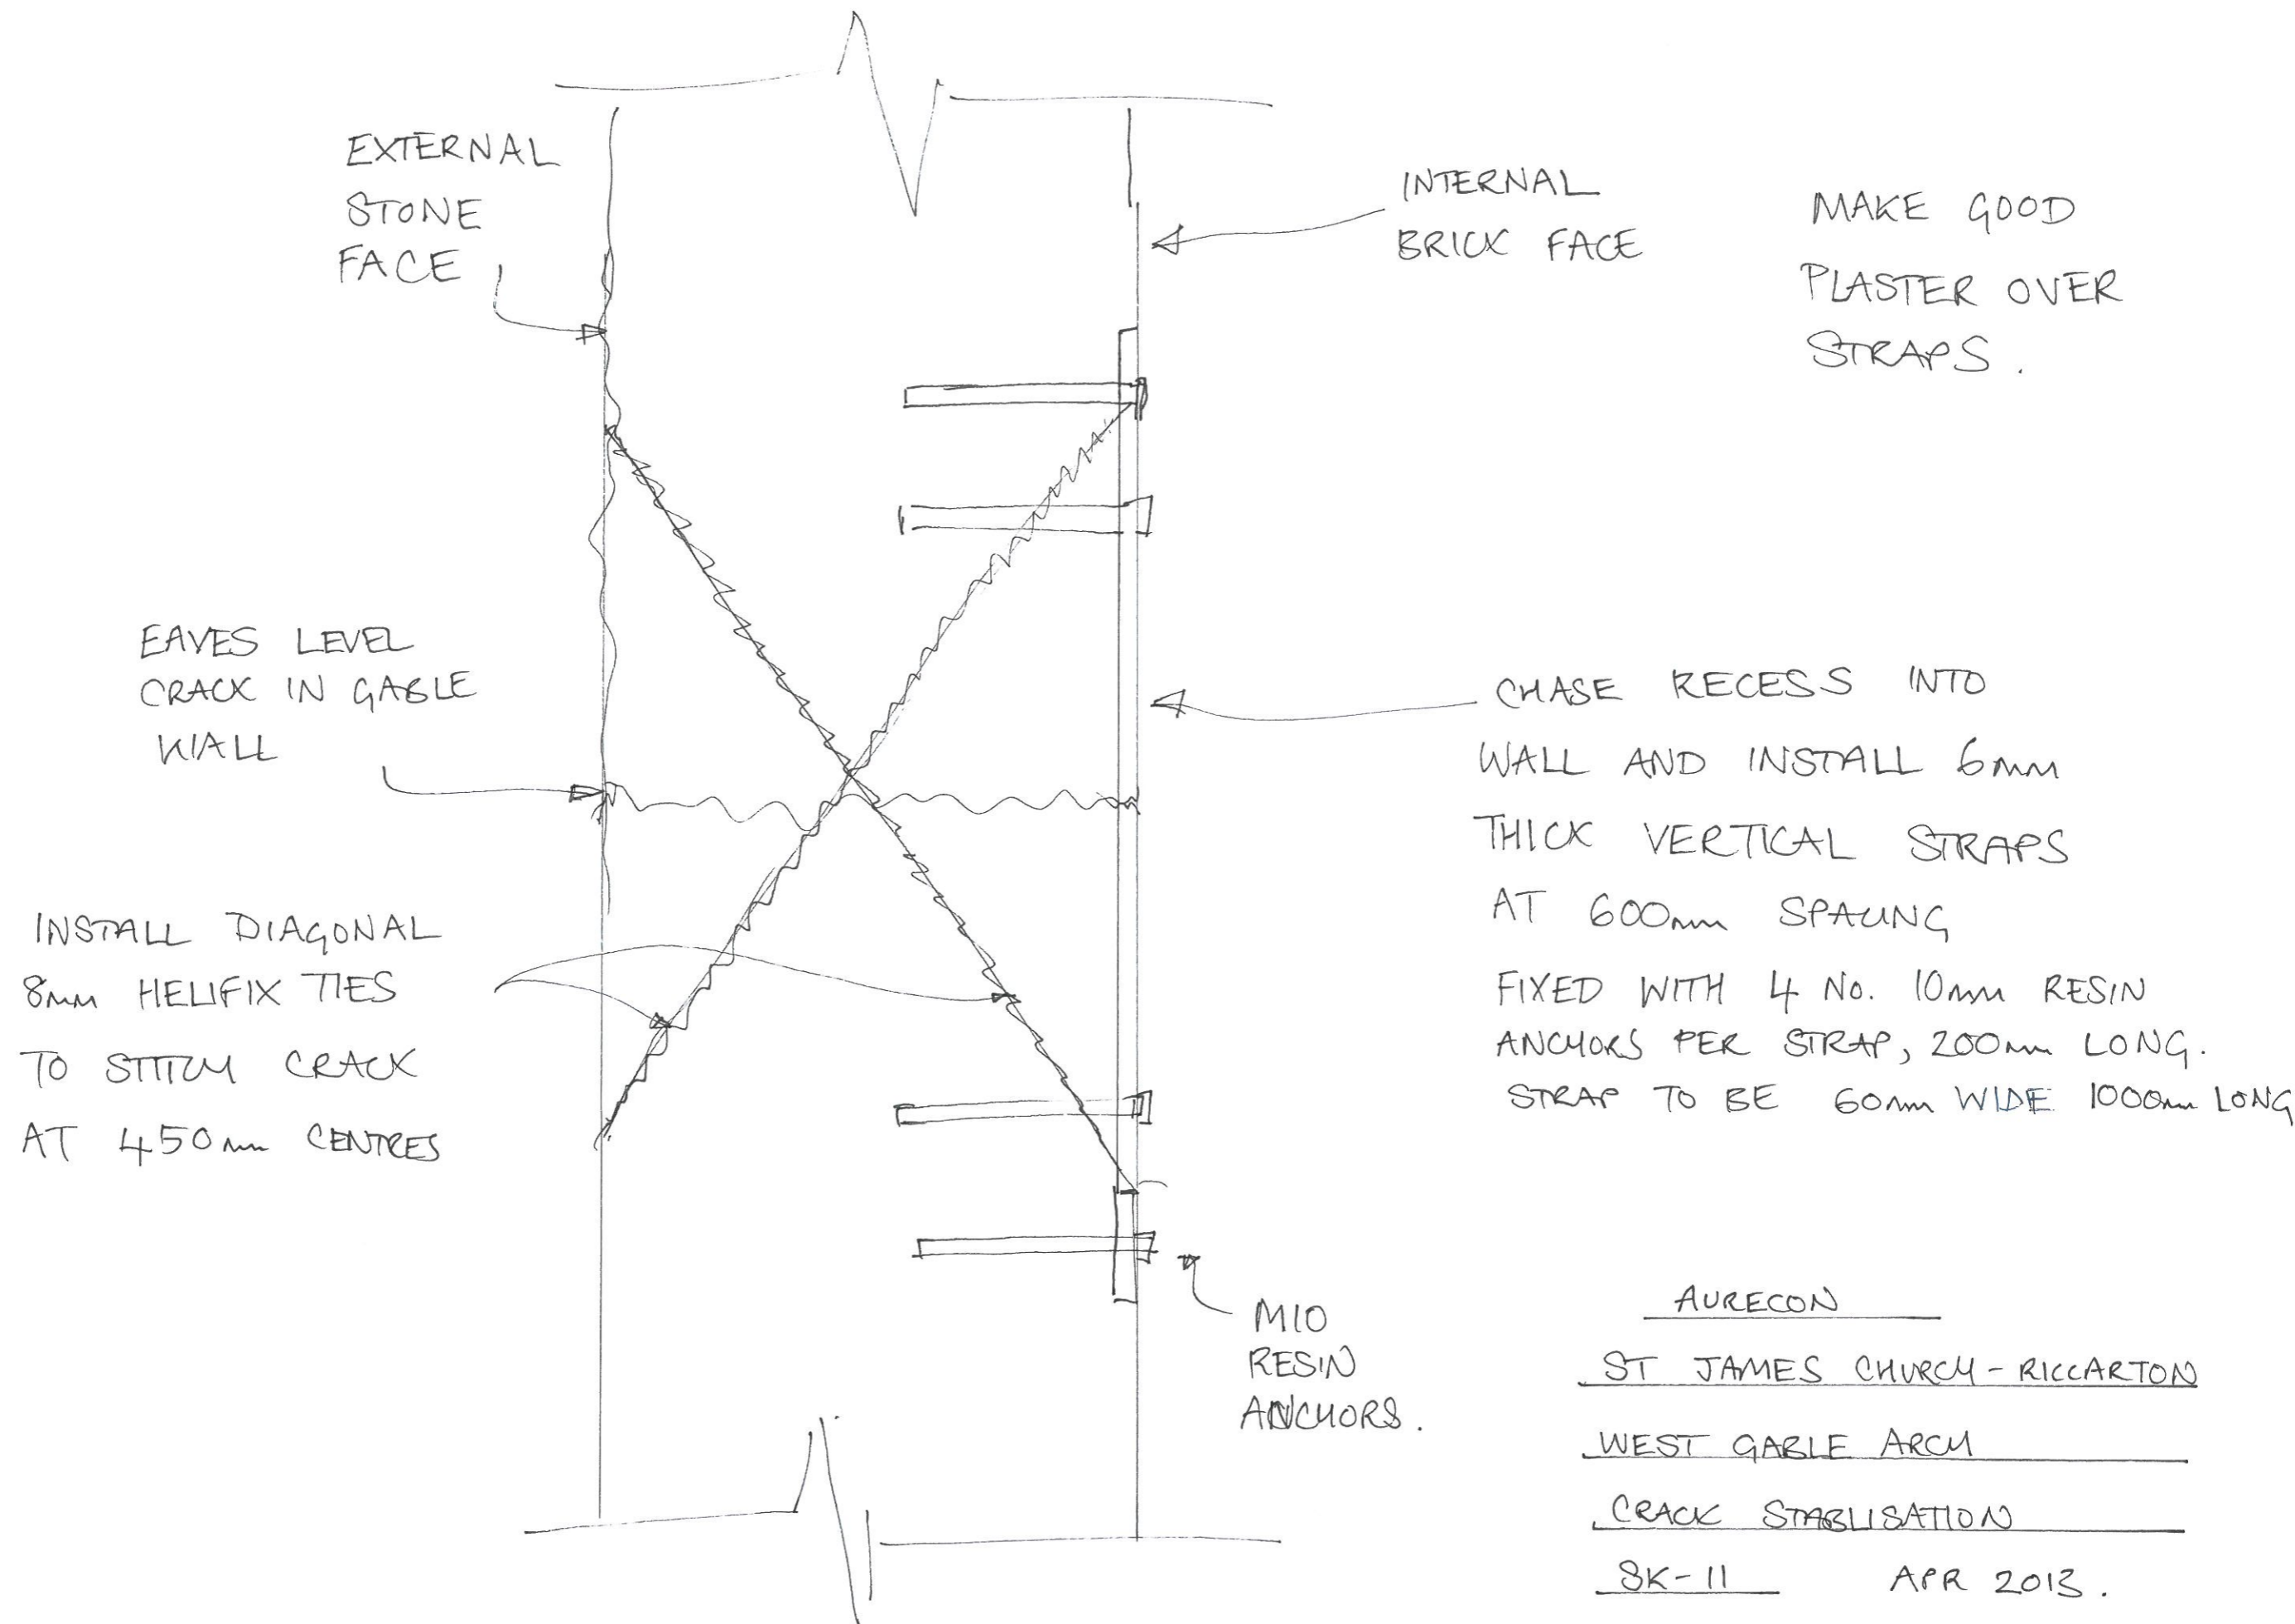
MAKE GOOD
PLASTER OVER
STRAPS.

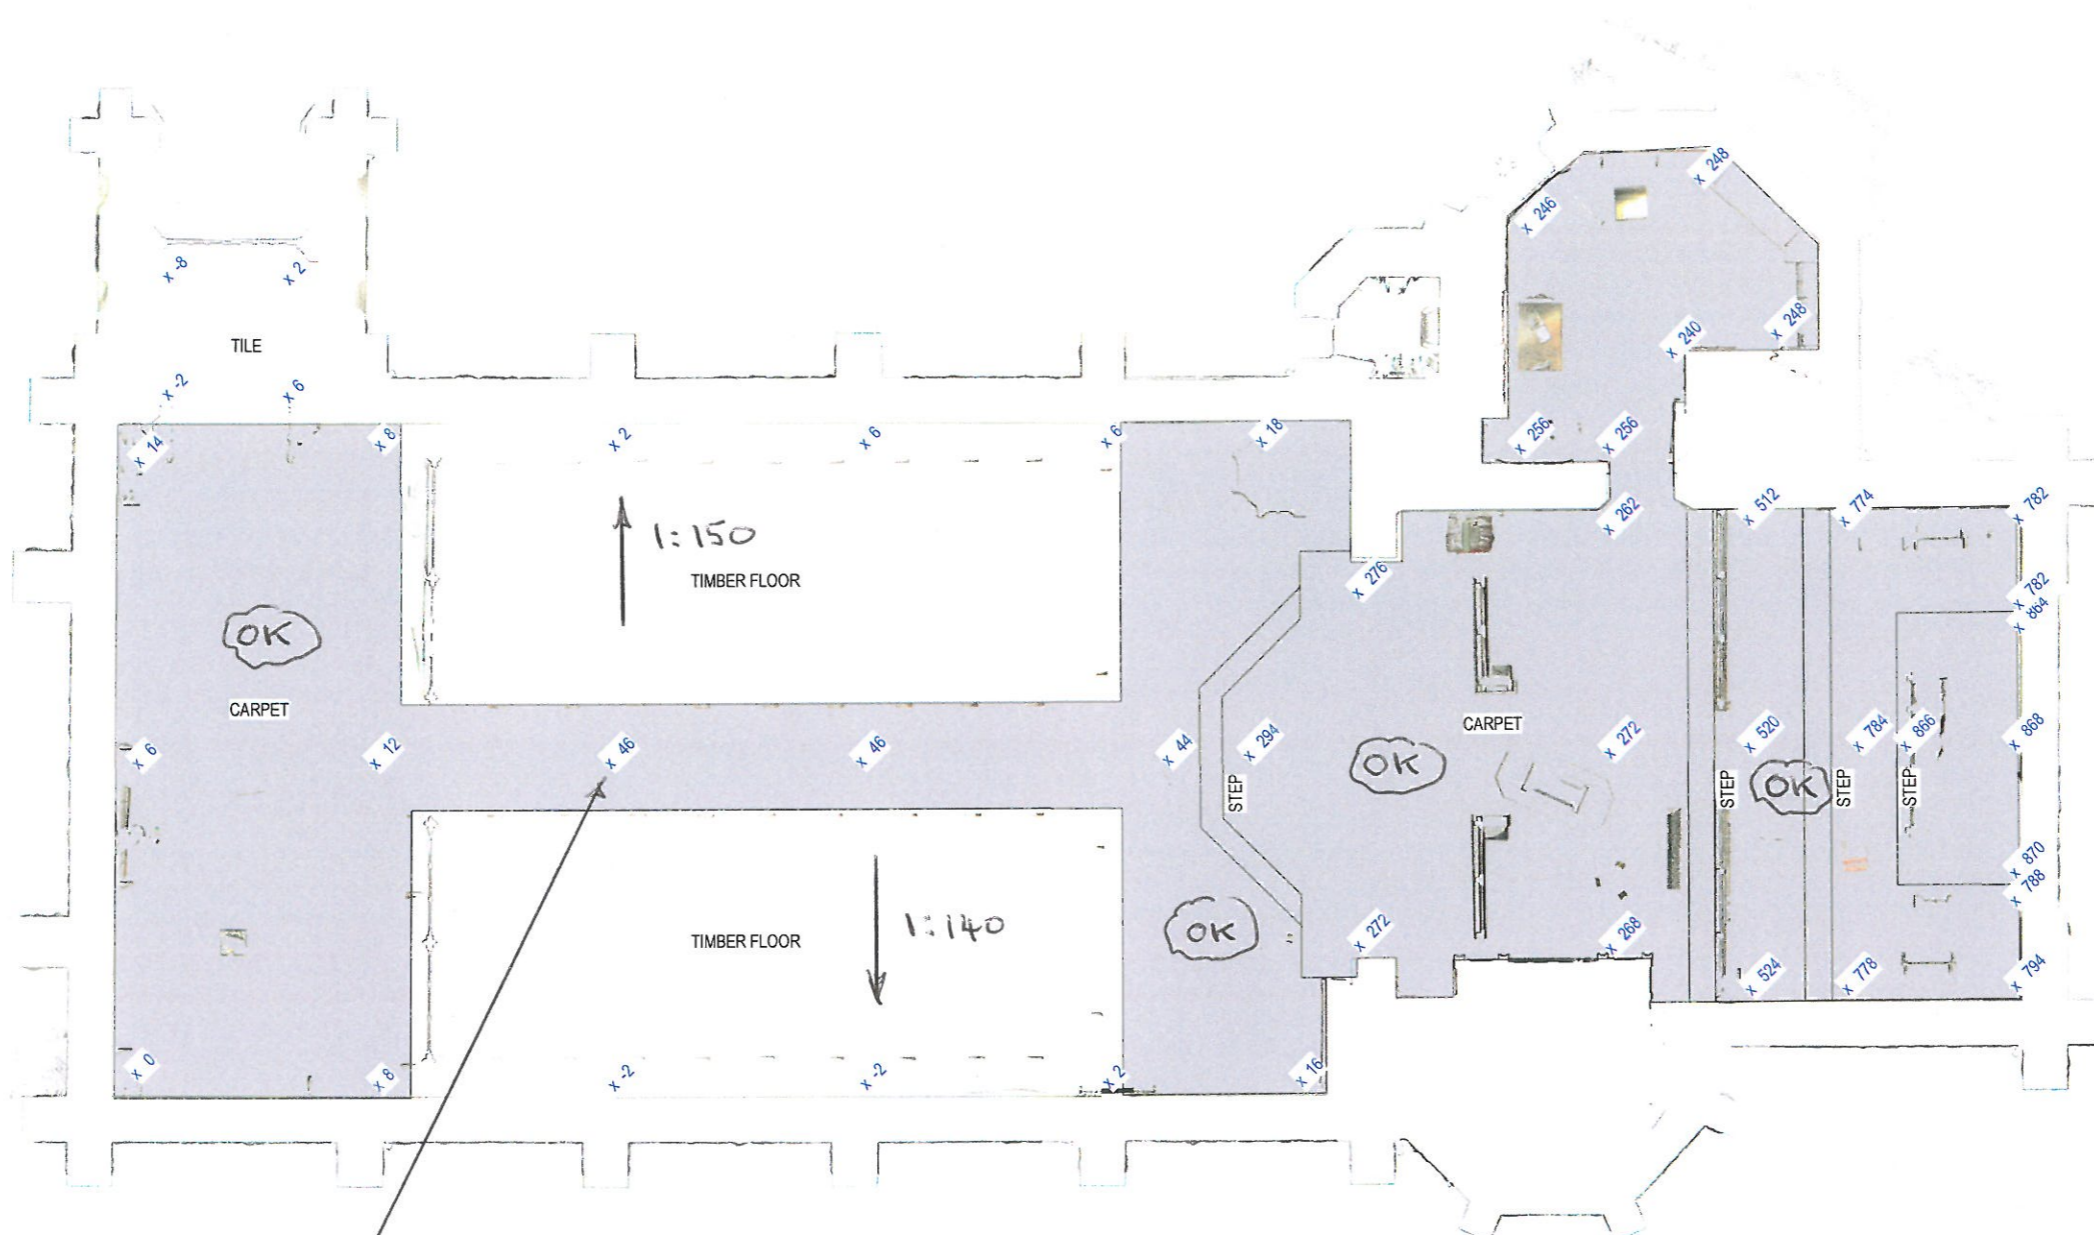
REDUCE LEVELS ON
CARPET BY 15mm
