**STATEMENT OF PRIMARY EVIDENCE OF GARETH WRIGHT ON BEHALF OF
CHRISTCHURCH CITY COUNCIL**

QUALIFYING MATTER: HERITAGE (LISTED HERITAGE ITEMS)

3. My evidence relates to those District Plan provisions applicable to the removal of the former Dwelling and Setting, 471 Ferry Road (the **Building**) from the Schedule of Significant Historic Heritage Items in Appendix 9.3.7.2 (the **Schedule**) in the District Plan.

**APPENDIX A: L2 STRUCTURAL REPORT, DON THOMSON CONSULTING
ENGINEERS, JULY 2011**

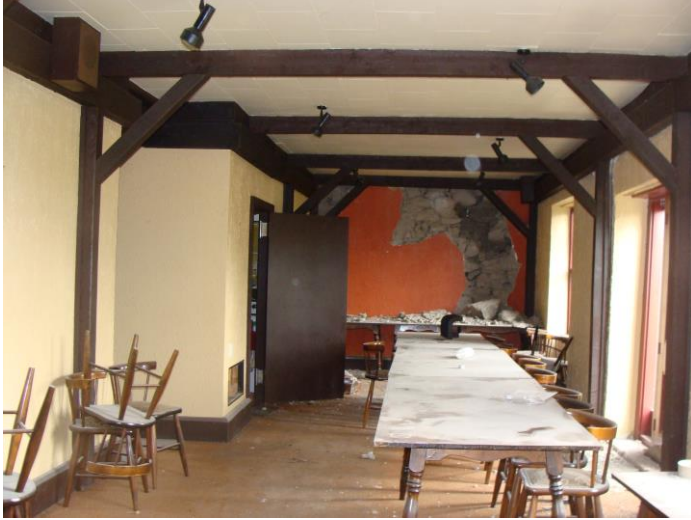
The building has suffered from shaking damage from the earthquake swarm beginning on 4th September 2010. This is evidenced by movement cracking to the external walls principally at the corners and adjacent to openings. Inside the building the plaster and some of the stone rubble has loosened and in some places fallen as shown in the photo below.

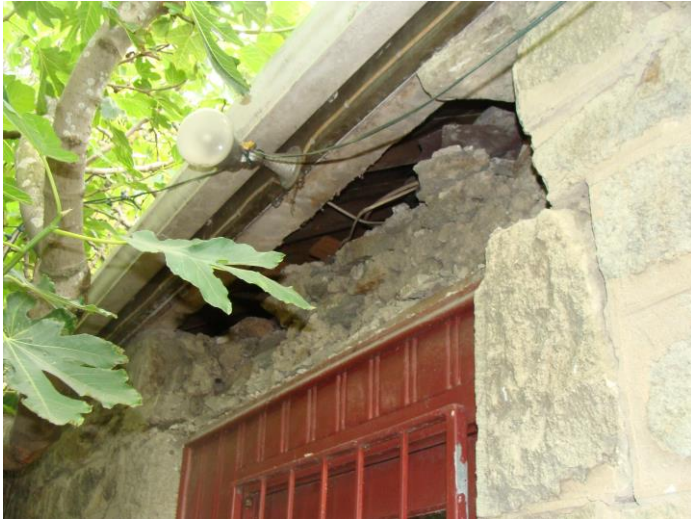
Externally the most severe damage has occurred above the entry door on the western side of the building, where the stone lintel has dislodged and fallen. The photo below shows the area where the stone lintel was and the variable nature of the stone used in the wall with the inner and outer faces being large and worked and the rubble infill being small and un-worked with some mortar bonding the rubble.

“The stone lintel over the door on the western side of the house shows signs of incipient collapse as it has moved away from the adjacent wall. It appears that this lintel is a facing stone approximately 100mm to 150mm thick, as this is the thickness of the stone veneer. There is a greater chance of the lintel toppling in this case as there is less bearing area providing support. There are a number of 1 – 2mm cracks around the other stone lintels on the southern external wall but these are not at risk of collapsing.” At the time of our inspection the stone lintel had collapsed along with some of the rubble infill, as the photo on page 2 above shows. The lintel appeared to be intact

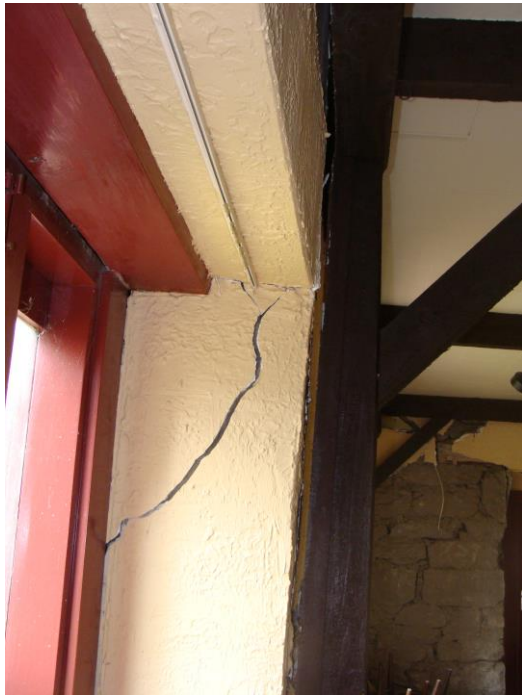
The external stone face on the South wall has tilted towards the exterior resulting in a 50mm gap between the stone and the door frame on this elevation. It would appear that the stone face has separated from the rubble infill and the whole wall is leaning as well as shown in the photo below.

“The external wall on the southern side of the building has tilted and the veneer is showing some signs of separating from the original wall. There is a 25mm gap between the stone veneer and timber doorway. This doorway was measured using a digital level and found to be 1.3° out of plumb. According to Jon Donovan there is a 50mm gap between the main stone wall and the ceiling, which he saw when inspecting the interior before the June seismic event. Windows and doorways around the rest of the house are still plumb.” It is likely that the wall can be plumbed, if necessary, using horizontal walers connected to turfs tied through the width of the building and carefully tensioned to move the wall back into position. The wall should then be permanently tied to the roof structure to prevent it moving out again. The inner and outer stone whytes should then be tied together with Helifix Dryfix ties at 400mm horizontally and vertically. The ties should be installed from the inside once the plaster has been removed from the face of the wall.
