SUMMARY STATEMENT

1. My name is Clara Caponi. I am a Chartered Professional Engineer specialised in Heritage Structures. I am employed at Egis NZ Limited where I hold the position of Associate Engineer.

2. I have prepared evidence on behalf of the **Christchurch City Council** in respect of matters arising from submissions on Plan Change 14 to the Christchurch District Plan (the **District Plan; PC14**).
3. My evidence relates to site specific heritage engineering matters raised in the submissions seeking changes to the Schedule of Significant Historic Heritage Places (**Schedule**). Specifically, the submissions considered in this evidence are:
 - (a) Submission #824 – The Blue Cottage (325 Montreal Street);
 - (b) Submission #825 – St James' Church (65-69 Riccarton Road);
 - (c) Submission #1043 – Portstone Cottage (471 Ferry Road, Woolston);
and
 - (d) Submission #1056 – Mitre Hotel (40 Norwich Quay, Lyttelton).

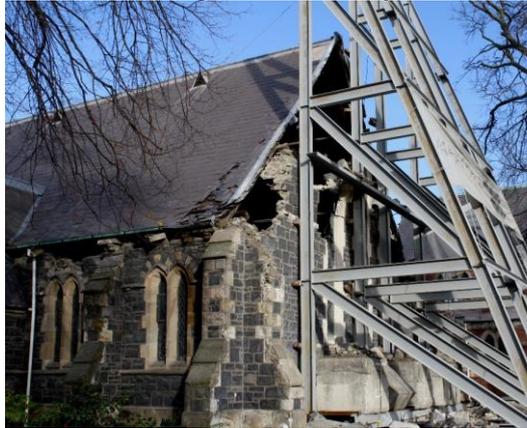
**Fig 1. West gable end
- External View - .**

Out-of-Plane (partial) local failure of the gable end masonry wall. In this case, the installation of the external temporary securing works (steel frame strutting) was not sufficient to prevent further damage to the structure during the 22 February 2011.

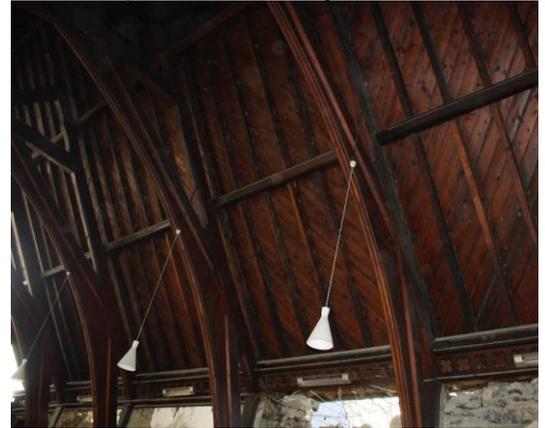
**Fig 2. Church Roof Structure
- Internal View-.**

Minor to negligible damage to the roof timber structure following the 4th of September 2010 and the 22nd of February 2011 earthquakes.

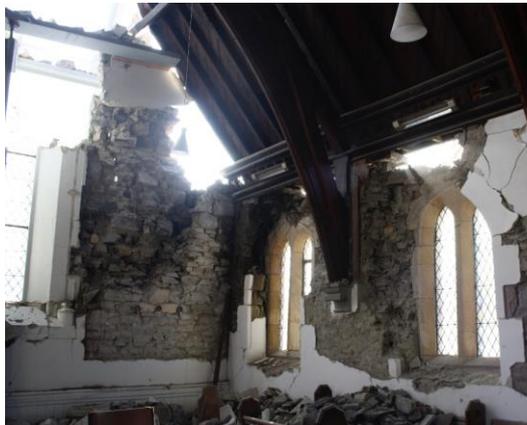
**Fig 3. Church North- West Corner
- Internal View -.**

Out-of-Plane (partial) local failure of the West gable end masonry wall. In the picture it is also possible to observe, the material failure of the stone masonry installed at the building south-west corner.

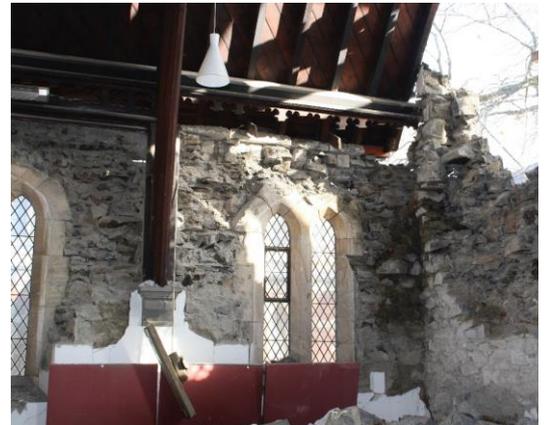
**Fig 4. Church South-West Corner
- Internal View-.**

Out-of-Plane (partial) local failure of the West gable end masonry wall. In the picture it is also possible to observe, the material failure of the stone masonry installed at the building south-west corner.

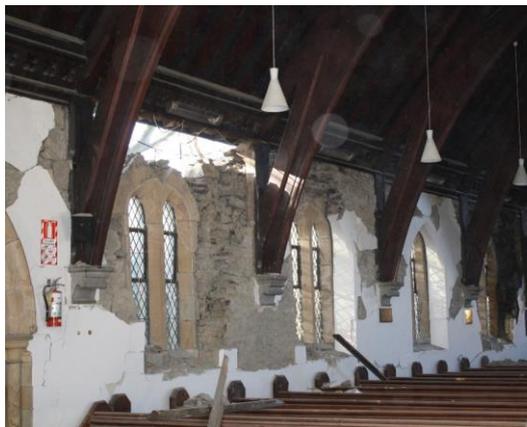
**Fig 5. Church Nave (South side)
- Internal View -.**

Out-of-Plane local failure of the masonry spandrel above nave window. Material failure of the pier internal layer.

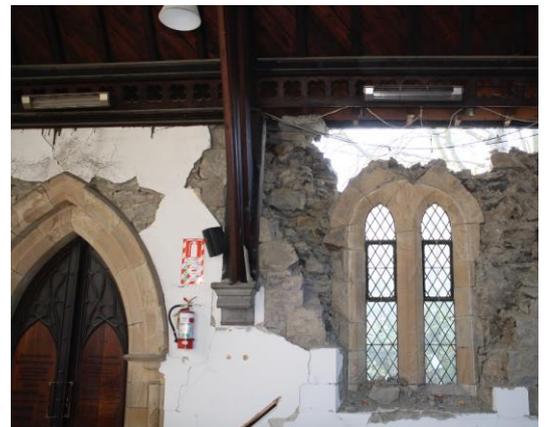
**Fig 6. Church Nave (South side)
- Internal View -.**

Out-of-Plane local failure of the masonry spandrel above nave window. Material failure of the pier internal layer.

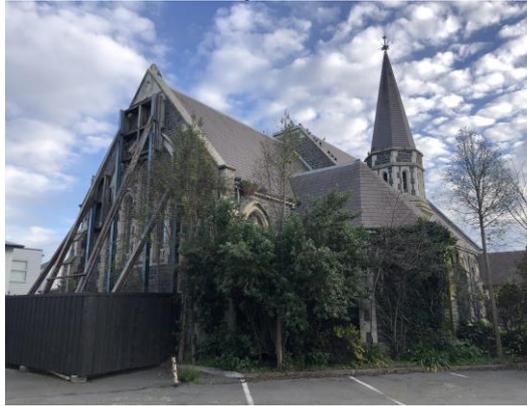
**Fig 1. East gable end
- External View -**

No local or partial collapse of the East gable end wall occurred following the Canterbury Earthquake Sequence or successive high-magnitude earthquakes.

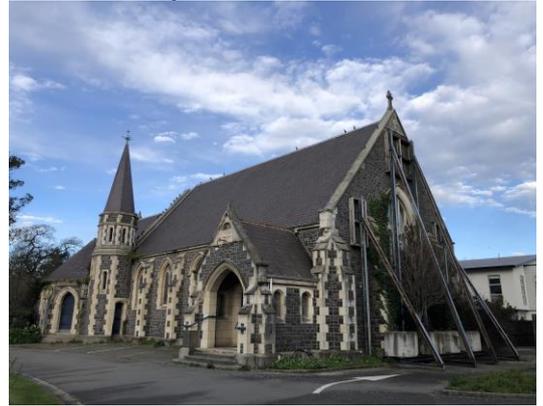
**Fig 2. West gable end
- External View -**

No local or partial collapse of the West gable end wall occurred following the Canterbury Earthquake Sequence or successive high-magnitude earthquakes.

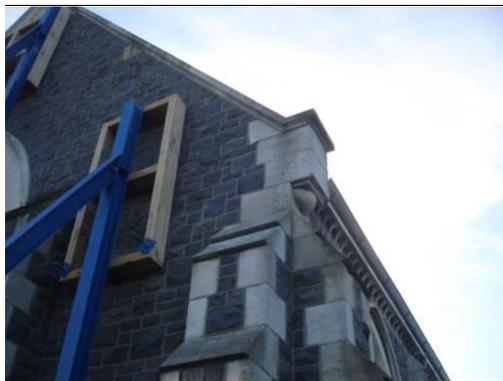
**Fig 3. West Gable End
- External View -.**

Damage consists of minor cracking of the mortar joints at eave level only.

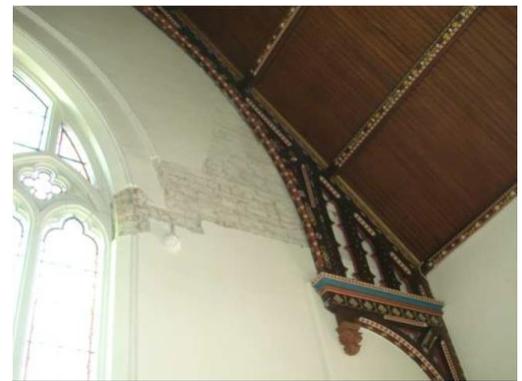
**Fig 4. West Gable End
- Internal View-.**

Damage consists of minor cracking of the mortar joints at eave level and localised damage of the internal plaster.

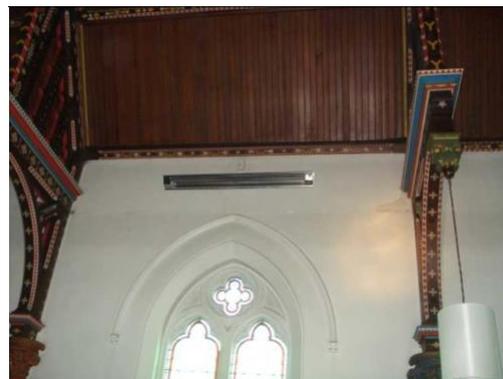
**Fig 5. Church Nave (South side)
- Internal View -.**

No local or partial collapse of the wall spandrels occurred following the Canterbury Earthquake Sequence or successive high-magnitude earthquakes..

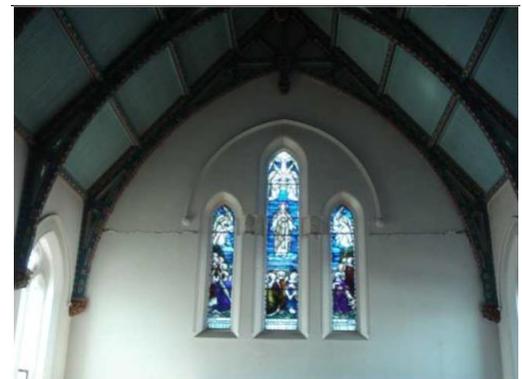
**Fig 6. East Gable End
- Internal View-.**

Damage consists of minor cracking of the mortar joints at eave level only.
