UNDER the Resource Management Act 1991
IN THE MATTER of proposed Plan Change 14: Housing and Business
Choice to the Christchurch District Plan
AND
IN THE MATTER of Cambridge 137 Limited (Submitter 1092)

**JOINT STATEMENT OF EVIDENCE OF JONATHAN LYTTLE AND MICHAEL
DOIG ON BEHALF OF CAMBRIDGE 137 LIMITED**

QUALIFYING MATTER: HERITAGE (HERITAGE SITES)

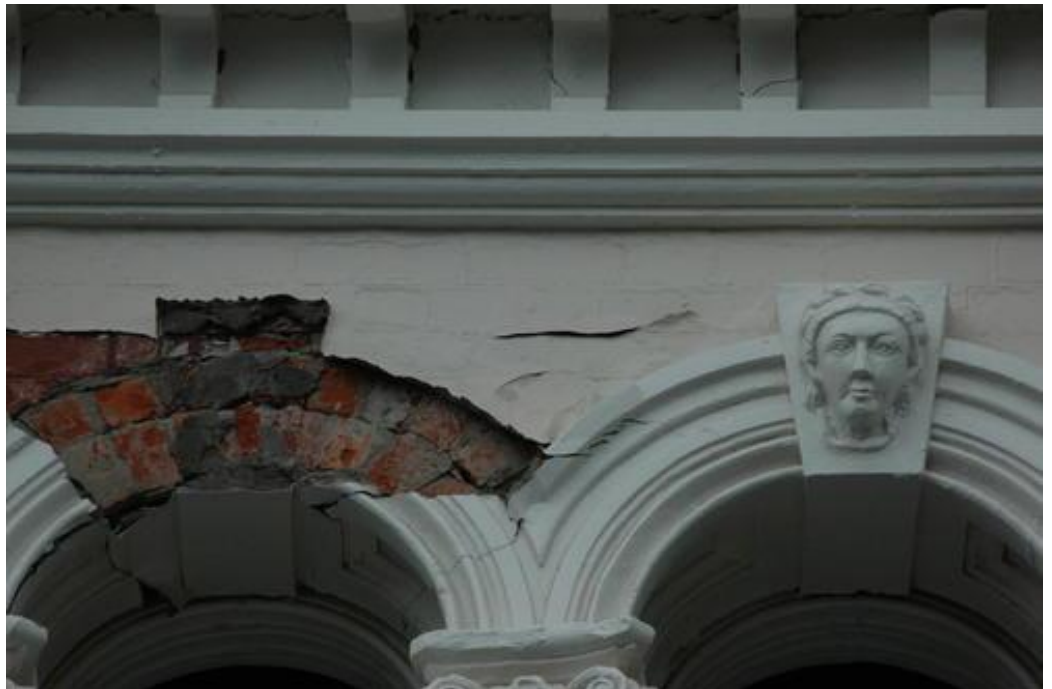
Photograph 2: 158 Gloucester Street, Christchurch – post February earthquake

- 86 The second and third photographs were taken immediately after the February earthquake.
- 87 The February earthquake caused diagonal cracking and the shear failure of all the brick piers and masonry walls. We also lost some of the decorative reliefs/keystones.

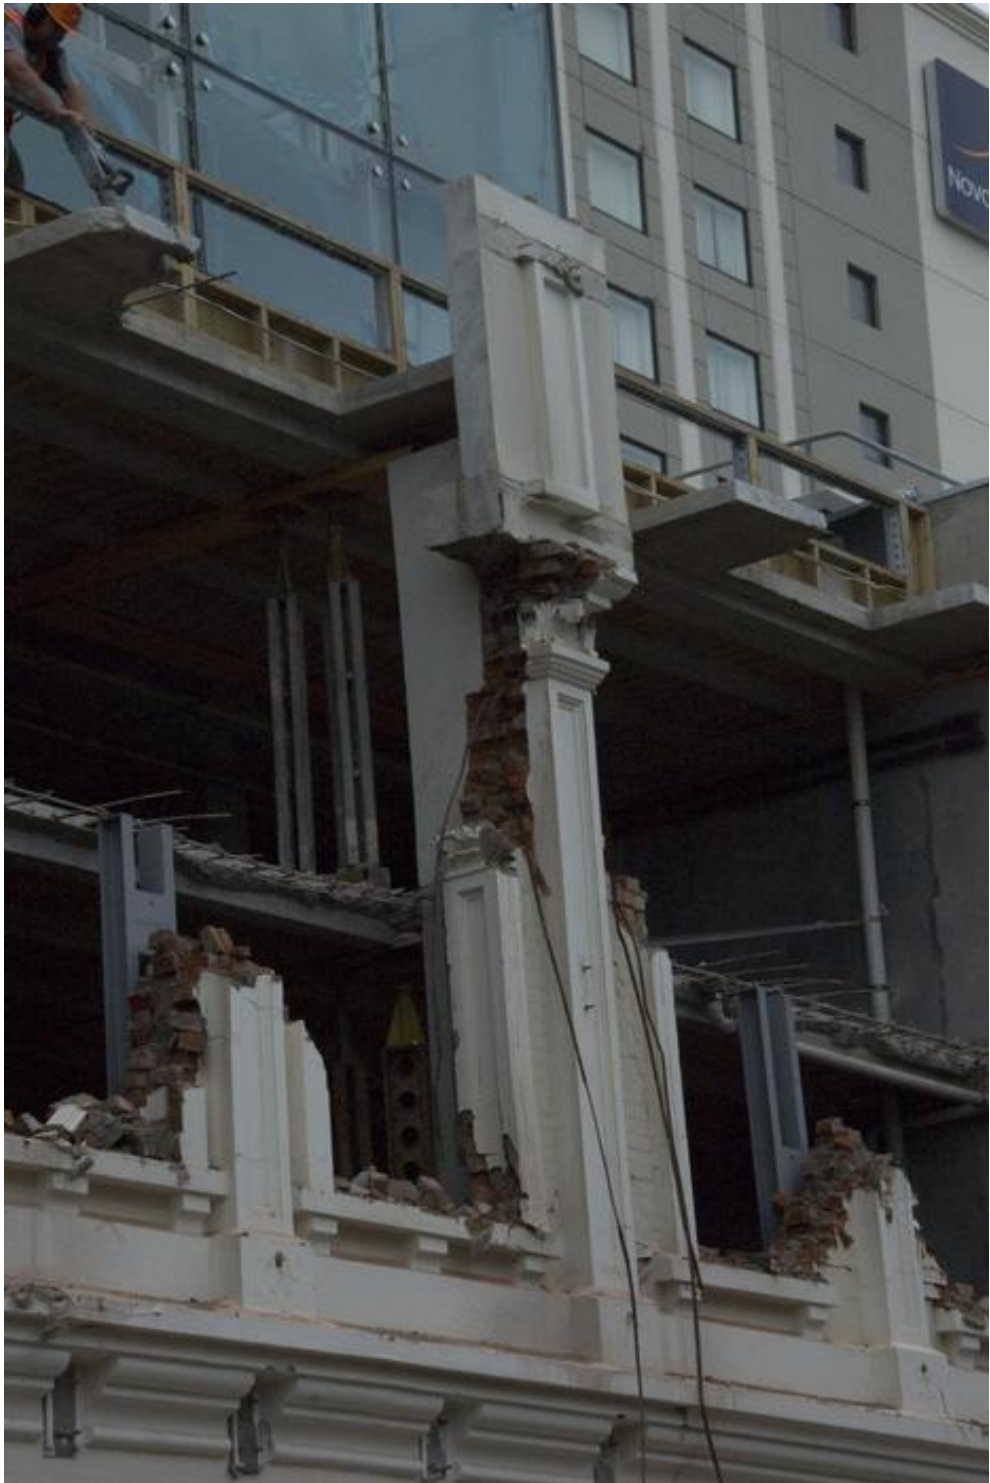
Photograph 4: 158 Gloucester Street, Christchurch – during demolition

88 Photograph 4 was taken during the demolition of the heritage façade.

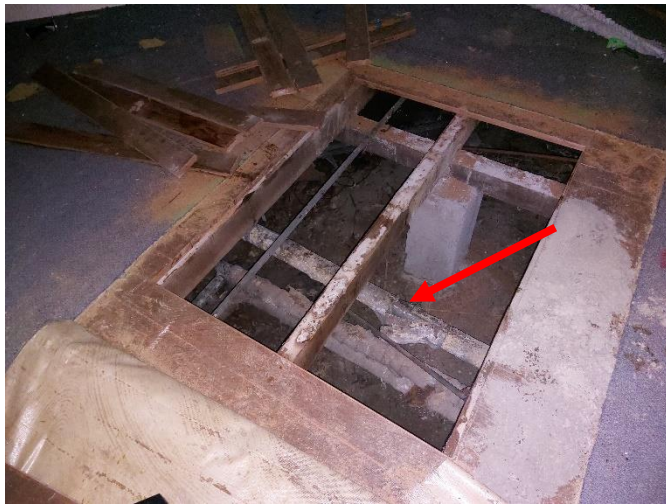
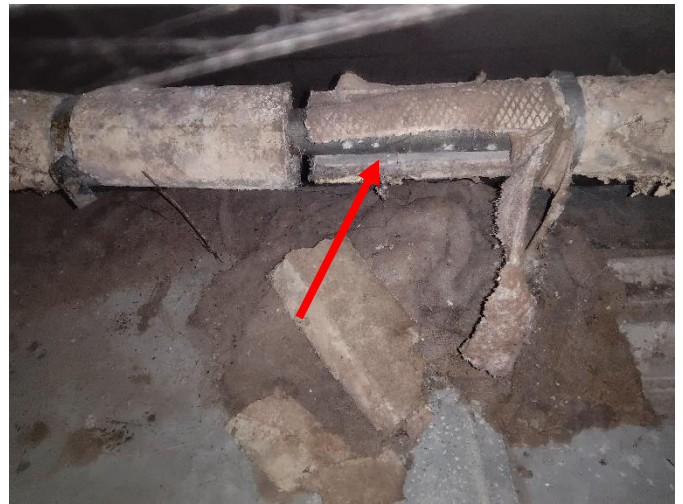
Product Type	Thermal insulation, sprayed asbestos, loose asbestos etc	3	Material Score
Extent of Damage	High Damage	3	9
Surface Treatment	Unsealed	2	Risk
Asbestos Type	Chrysotile	1	Medium

Remove prior to refurbishment / demolition works.
 (Class A material)
 Soil also likely to be impacted and will require testing and remediating.

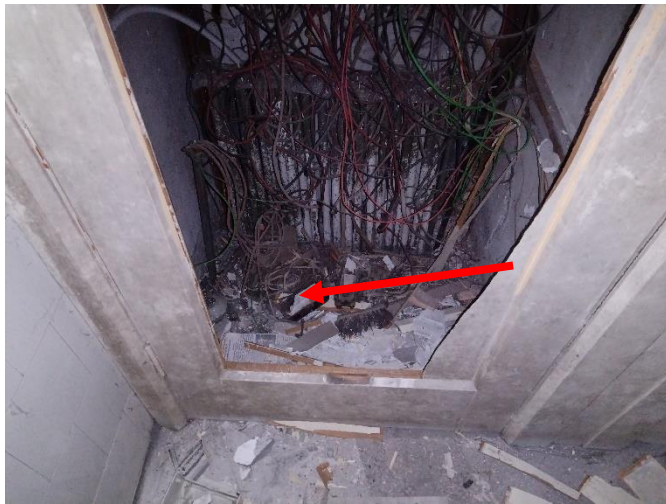
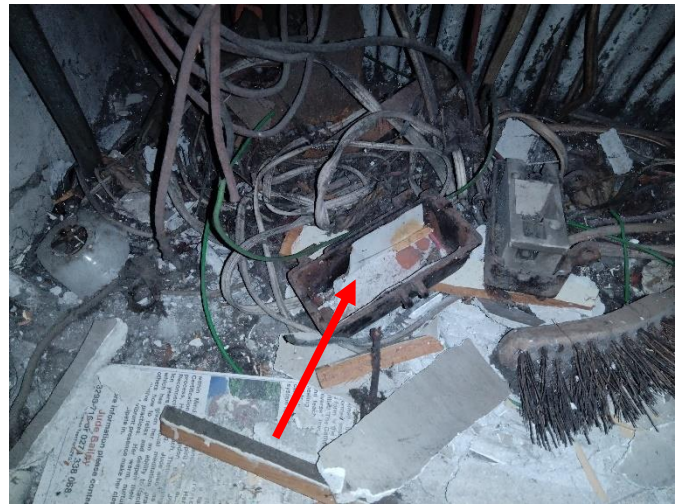
Product Type	AIB, millboards, textiles, gaskets, ropes	2	Material Score
Extent of Damage	High Damage	3	8
Surface Treatment	Unsealed	2	Risk
Asbestos Type	Chrysotile	1	Medium

Comments: Restrict access.
A limited number of other units checked and did not contain the material

Recommendation: Remove prior to refurbishment / demolition works.
(Class A material)

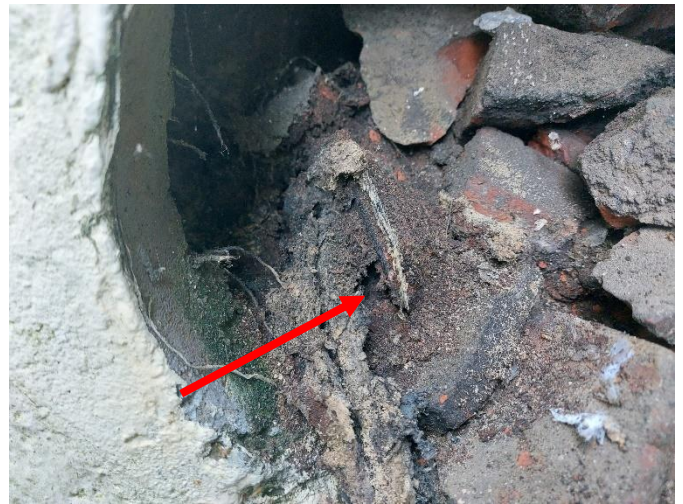
Product Type	AIB, millboards, textiles, gaskets, ropes	2	Material Score
Extent of Damage	High Damage	3	8
Surface Treatment	Unsealed	2	Risk
Asbestos Type	Chrysotile	1	Medium

Comments: Restrict access.
Quantity unknown due to limited visual access to the chimney, but could be located up the entire height of the chimney.

Recommendation: Remove prior to refurbishment / demolition works.
(Class A material)

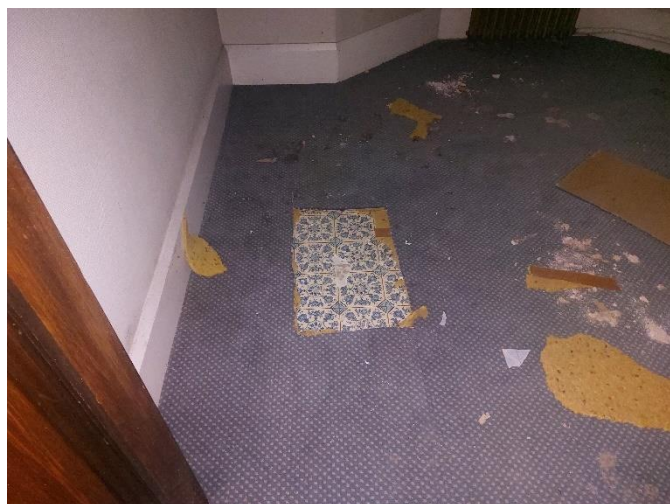
Comments: Blue and white vinyl

Recommendation: Remove prior to refurbishment / demolition works. (Class A material)

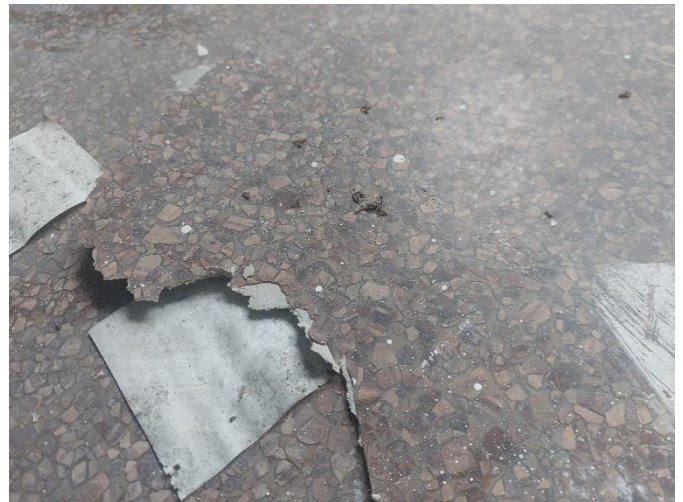
Comments: Brown vinyl

Recommendation: Remove prior to refurbishment / demolition works. (Class A material)

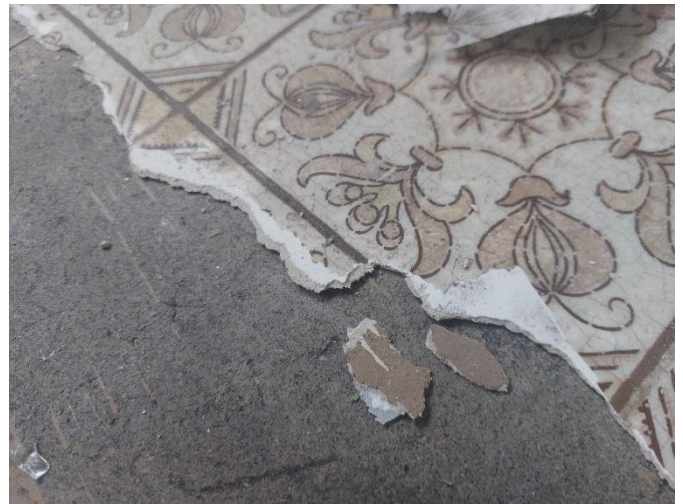
Comments: Small area next to S20 paper backed vinyl floor lining

Recommendation: Remove prior to refurbishment / demolition works. (Class A material)

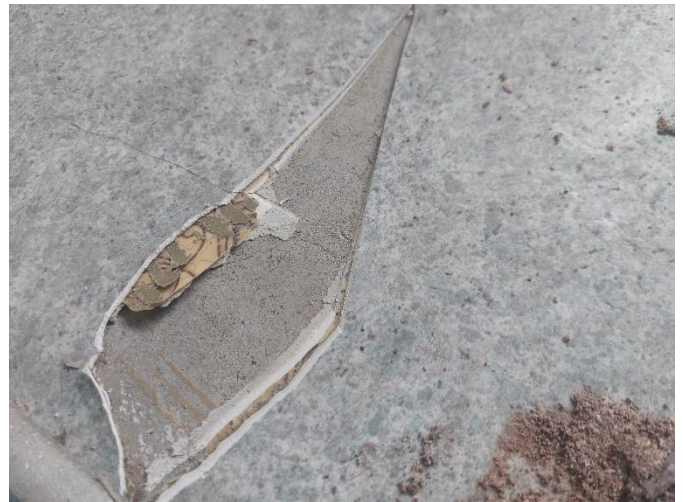
Comments: Brown patterned vinyl underneath newer grey vinyl

Recommendation: Remove prior to refurbishment / demolition works. (Class A material)

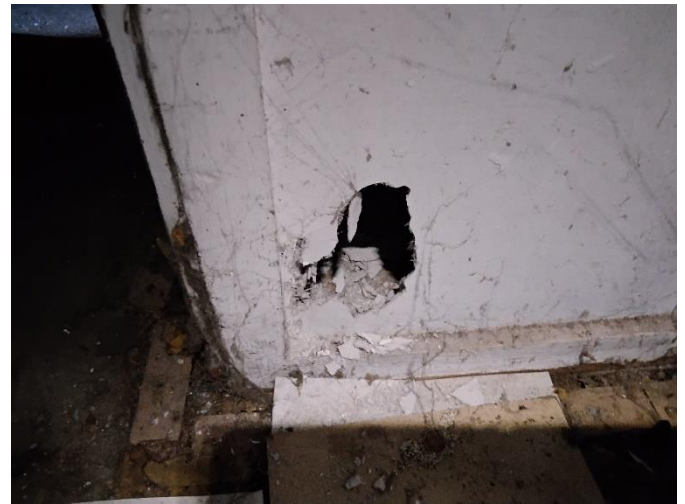
Product Type	Asbestos reinforced composites	1	Material Score
Extent of Damage	Low Damage	1	5
Surface Treatment	Enclosed	1	Risk
Asbestos Type	Amosite	2	Low

Remove prior to refurbishment / demolition works.
(Class B material)

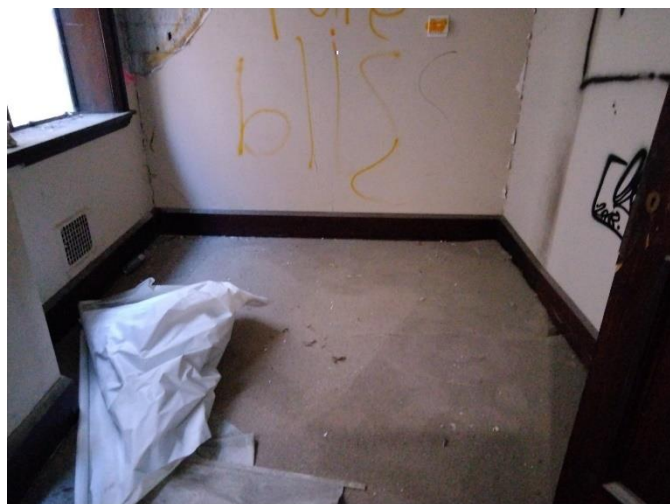
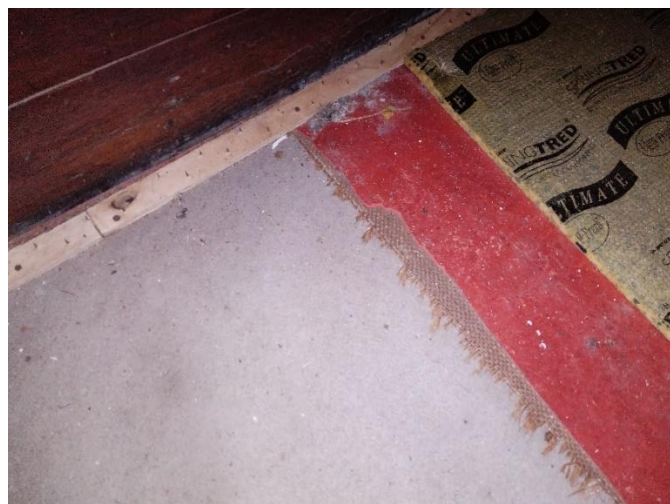
Product Type	AIB, millboards, textiles, gaskets, ropes	2	Material Score
Extent of Damage	Low Damage	1	5
Surface Treatment	Enclosed	1	Risk
Asbestos Type	Presumed Chrysotile	1	Low

Comments: Grey paper/felt beneath carpet, underlay and lino layers

Recommendation: Remove prior to refurbishment / demolition works.
(Class A material)

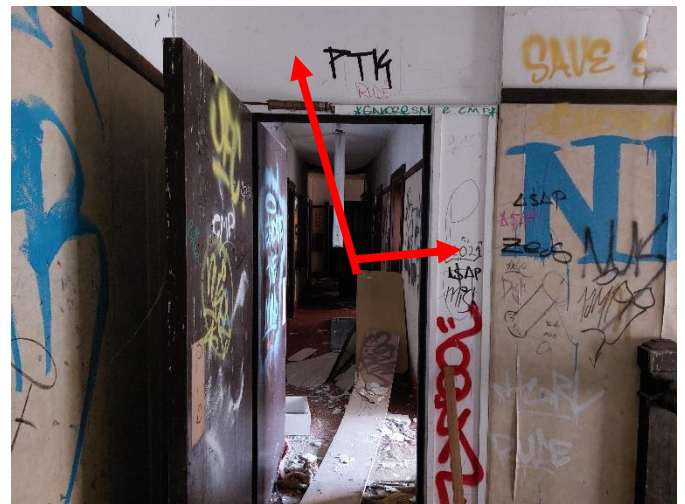
Comments: As per S03
Located around 2 x doorways leading to lobby area

Recommendation: Remove prior to refurbishment / demolition works. (Class B material)

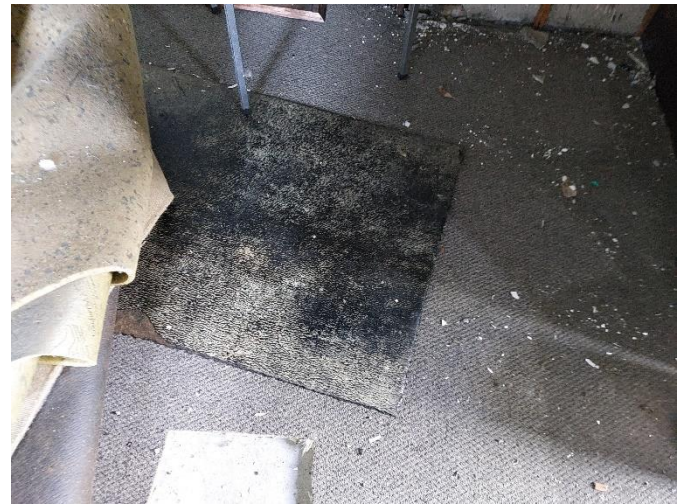
Product Type	AIB, millboards, textiles, gaskets, ropes	2	Material Score
Extent of Damage	Low Damage	1	5
Surface Treatment	Enclosed	1	Risk
Asbestos Type	Chrysotile	1	Low

Comments: Loose rolls and under carpet

Recommendation: Remove prior to refurbishment / demolition works.
(Class B material)

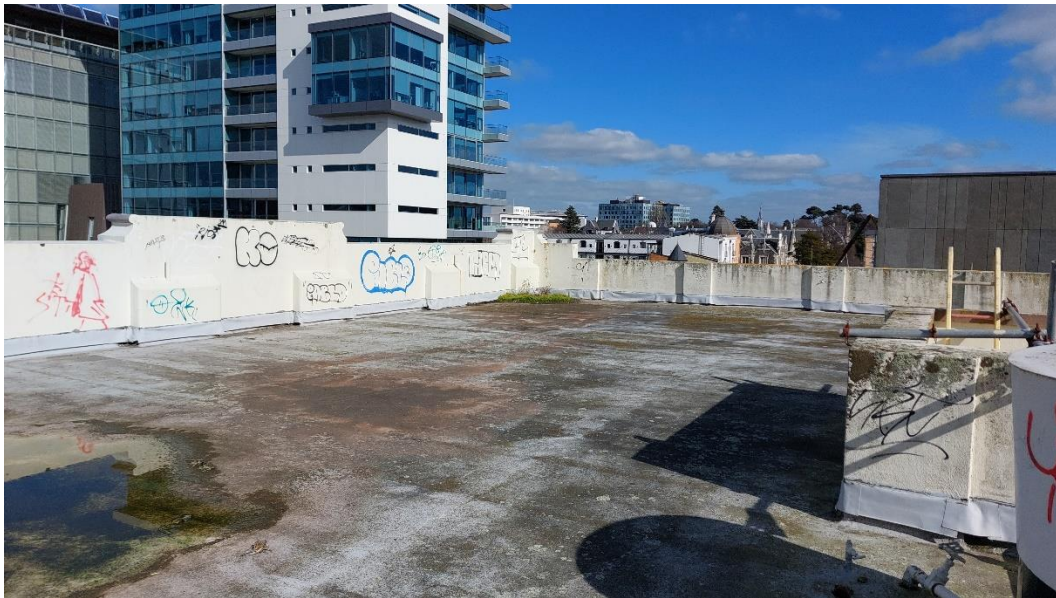
Product Type	Asbestos reinforced composites	1	Material Score
Extent of Damage	Low Damage	1	3
Surface Treatment	Composite	0	Risk
Asbestos Type	Chrysotile	1	Very Low

Comments: To southern section of roof, underneath top layers and applied to concrete

Recommendation: Remove prior to refurbishment / demolition works.
(Class B material)

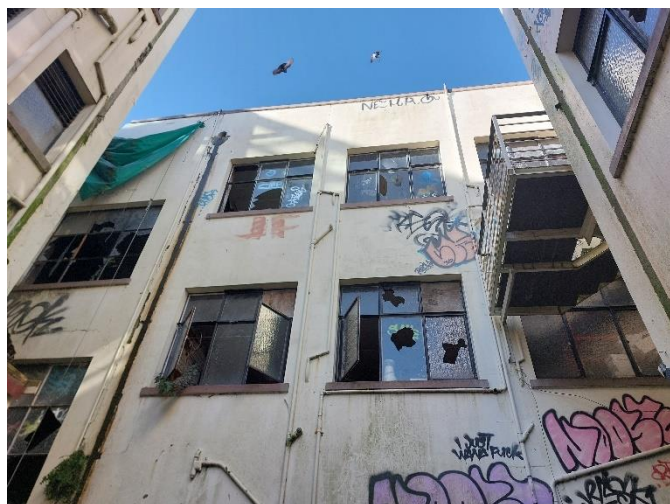
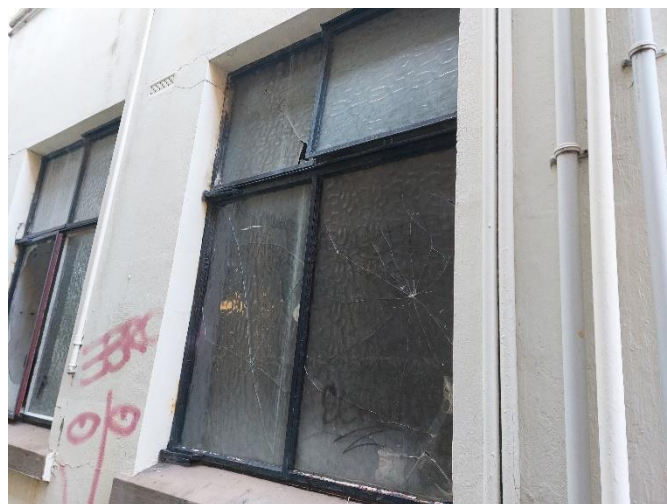
Comments: Material potentially located between metal framed windows and concrete walls

Recommendation: Further investigation required.

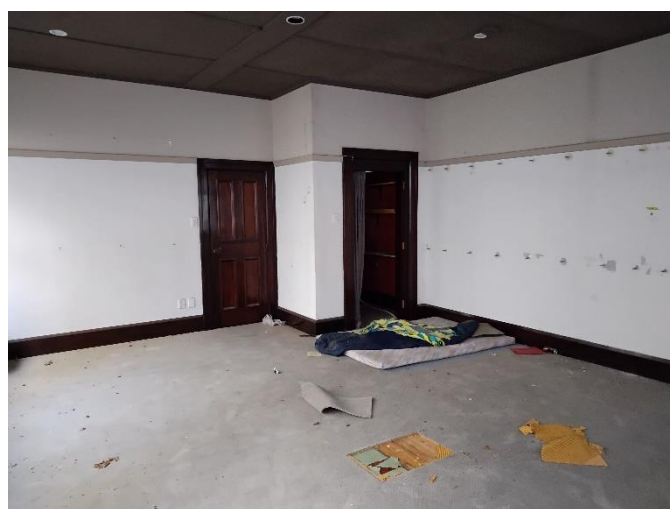
Photo 5: Evidence of condition – Room 7

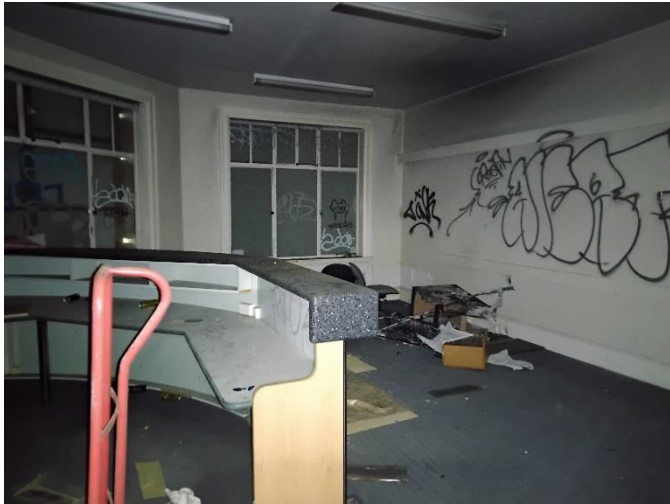
Photo 6: Evidence of condition – Room 8

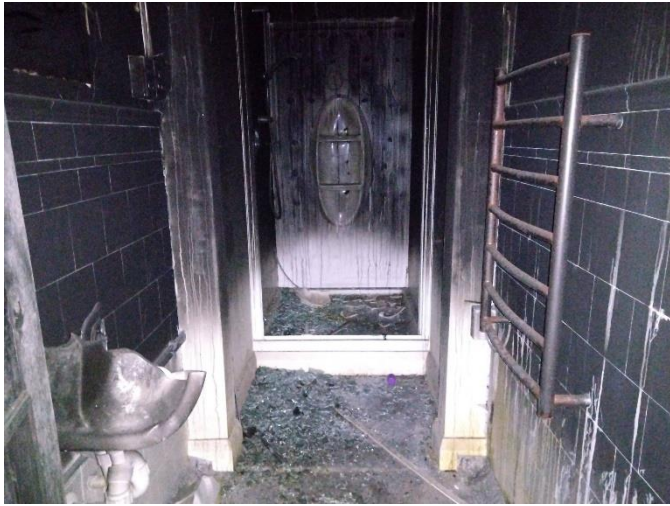
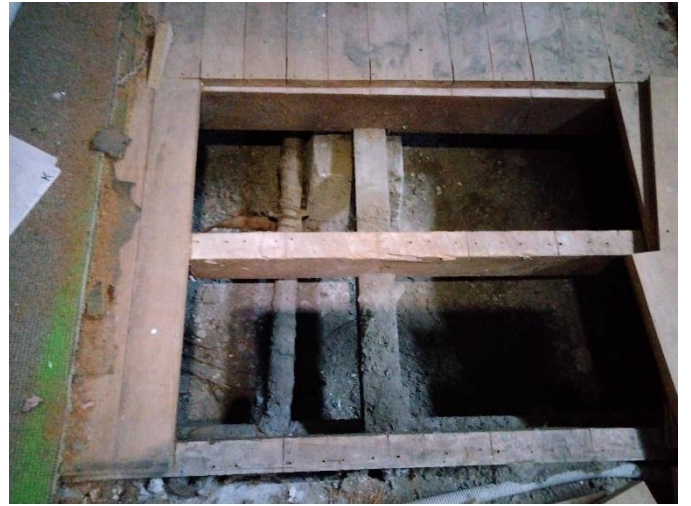
Photo 12: Evidence of condition – Fire damaged parts of Room 1

Photo 13: Evidence of condition – Fire damaged parts of Room 1

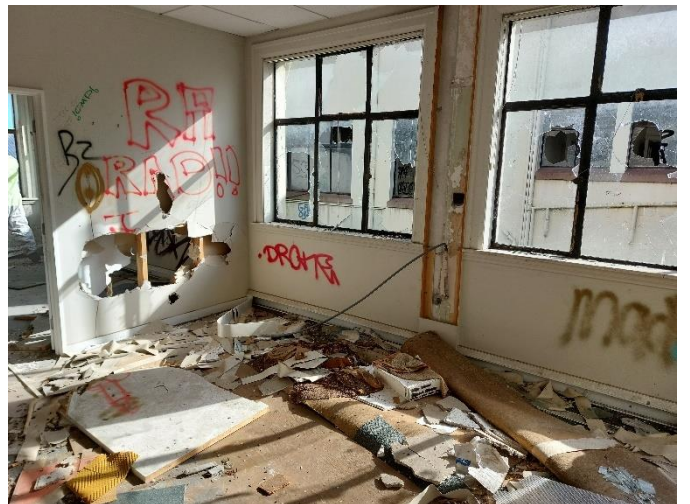
significant water ingress. The elevated result in Room 29 on the second floor is likely due to the water damage observed in the timber floor, carpet and underlay area around the radiator.

Photo 21: Evidence of condition – Floor space in Room 29
