**STATEMENT OF REBUTTAL EVIDENCE OF CLARA CAPONI ON BEHALF OF
CHRISTCHURCH CITY COUNCIL**

HERITAGE ENGINEERING

CITY-WIDE QUALIFYING MATTERS: HISTORIC HERITAGE

Dated: 9 October 2023

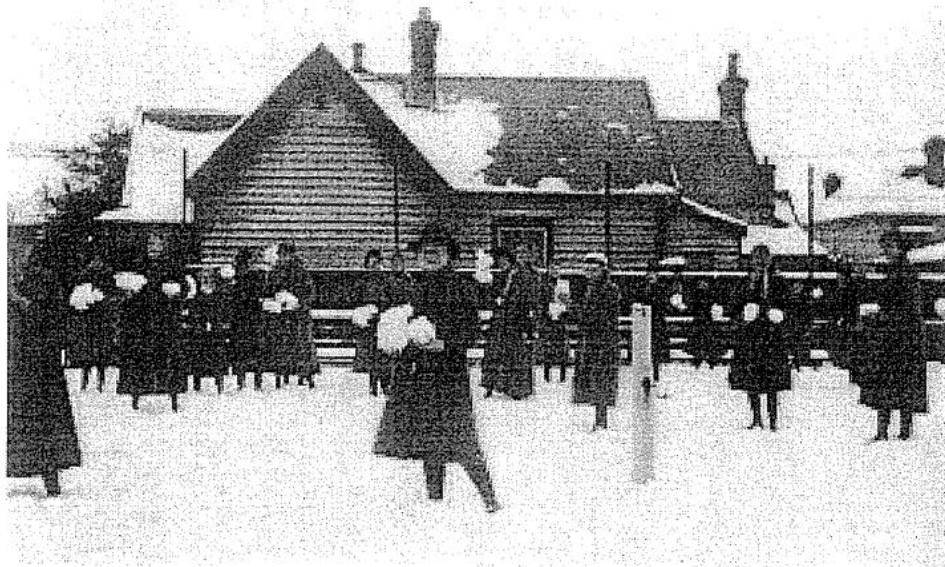
Fig 1. Early photo of the Blue cottage (325 Montreal Street, Christchurch)³

12. The external alterations mentioned by Mr Hill (and reported in my primary evidence as well) do not alter the substantial character of the building. An early photo of the building (probably circa 1900's), identifies the dwelling portrayed in the picture as the same structure on site today. This is despite

the removal of slate roofs, chimneys, bullnose veranda and replacement of some sash windows.

13. It is worth noting that in this picture the lean-to structures added to the South-West Elevation are also portrayed. As Dave Pearson commented in his Conservation Plan ⁴, “*Although the date of these additions is not known, it is likely to have been within a few years of the original construction date as they maintain the detailing and character of the original building.*”
14. Since the cottage is believed to have been constructed around 1885, it is likely that these ancillary structures were built around or even before 1900. In my opinion, the lean-to structures added to the South-West Elevation should be then considered as an integral part of the original heritage structure and not simply later additions. Based on the above observations, I disagree with Mr Hill and I consider that the cottage still continues to retain much of its original character, fabric and finishes.

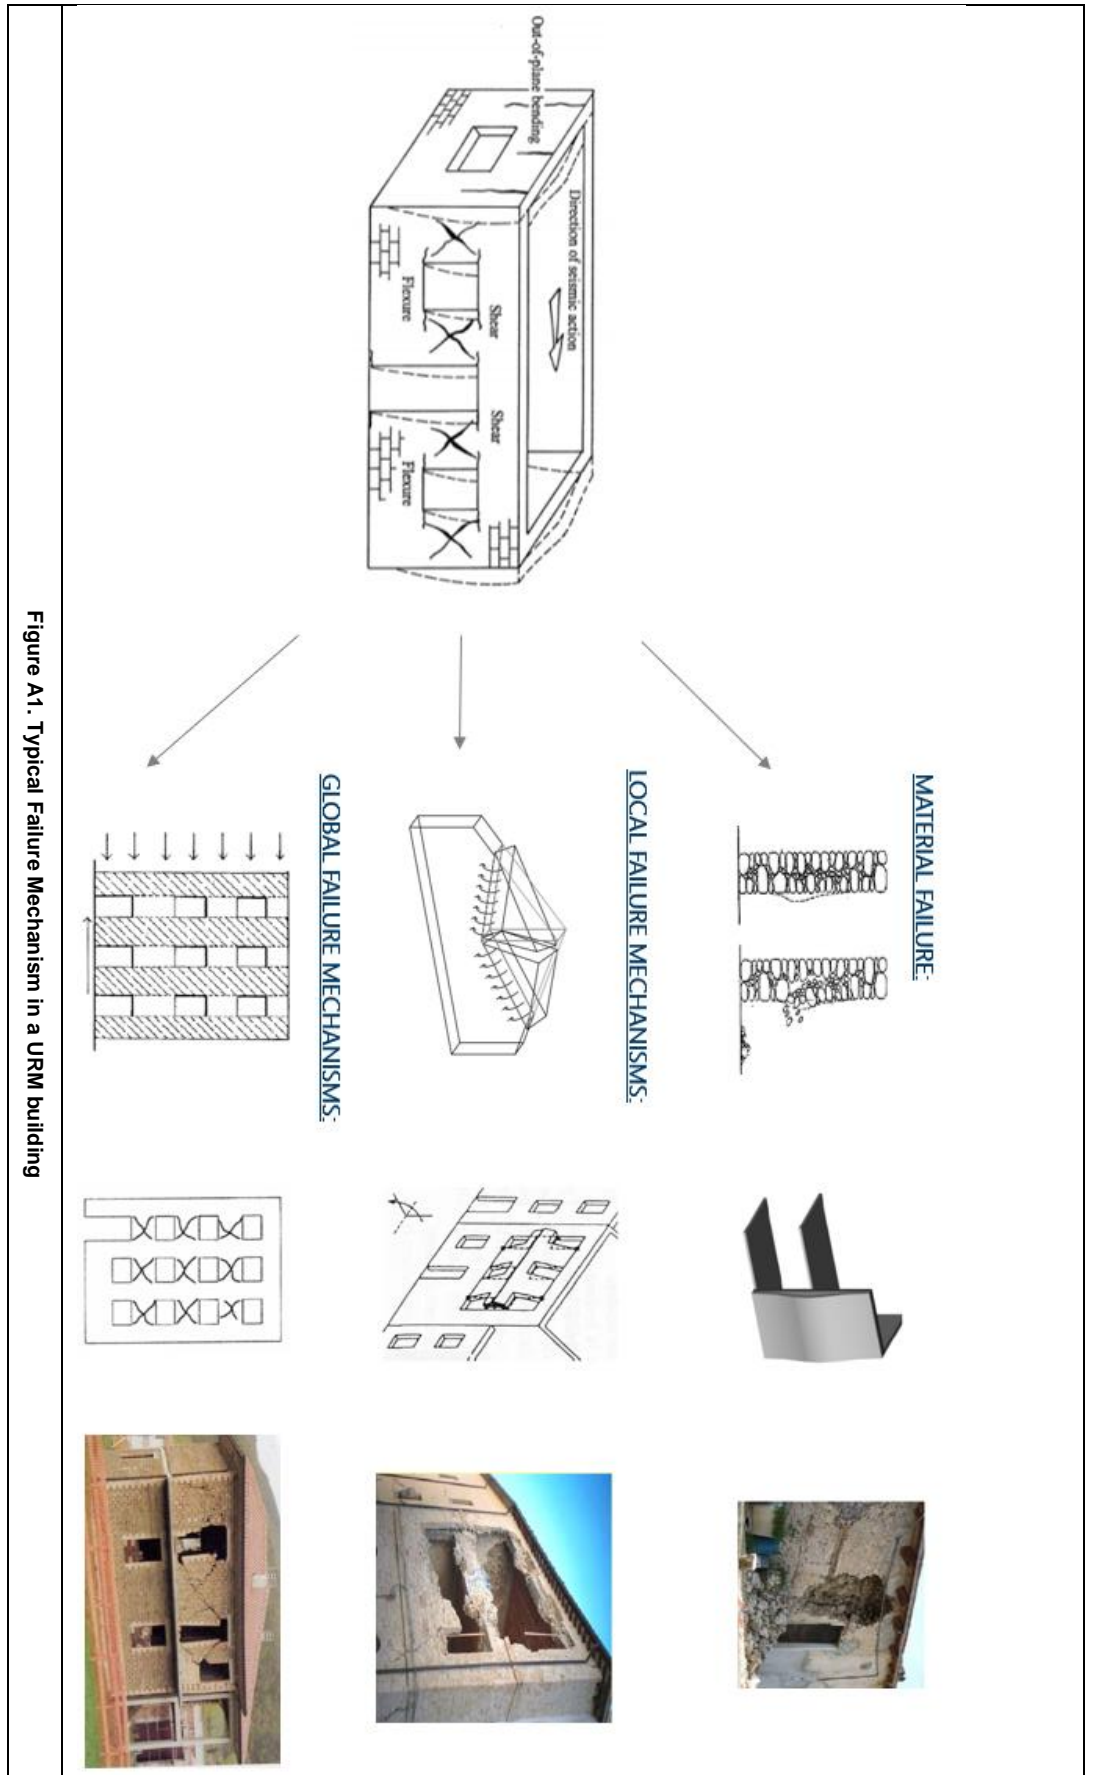
Figure A1. Typical Failure Mechanism in a URM building

When subjected to earthquake loading, Un-Reinforced Masonry (URM) structures (such as the St. James Church) are generally susceptible to three different failure mechanisms:

- **Material Failure Mechanisms**: When the walls consist of different layers not properly tight together, the vibration and shaking induced by earthquake motions is likely to cause bulging and consequently spalling of the external layer (or internal layer, depending by the specific construction details adopted), severely affecting the stability and capacity of the wall structures.

- **Local Failure Mechanisms**: When subjected to seismic loads, certain portions of the building (usually called “*macro-elements*”) tend to detach from the surrounding fabric and start to develop an independent dynamic response to the earthquake motions. If the earthquake magnitude is sufficiently high, these mechanisms can activate local instabilities and, consequently, lead to partial collapse of the building fabric. The local failure mechanisms are, therefore, mainly related to the out-of-plane capacity of the building portions.

- **Global Failure Mechanisms**: When the in-plane shear or flexural capacity of the building lateral resistant system is exceeded, significant cracking and damage to piers and spandrels occur severely compromising the capacity of the building to withstand earthquake loading.

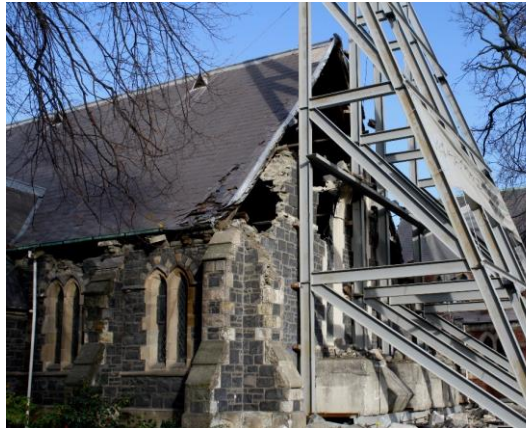
**Fig 1. West gable end
- External View - .**

Out-of-Plane (partial) local failure of the gable end masonry wall. In this case, the installation of the external temporary securing works (steel frame strutting) was not sufficient to prevent further damage to the structure during the 22 February 2011.

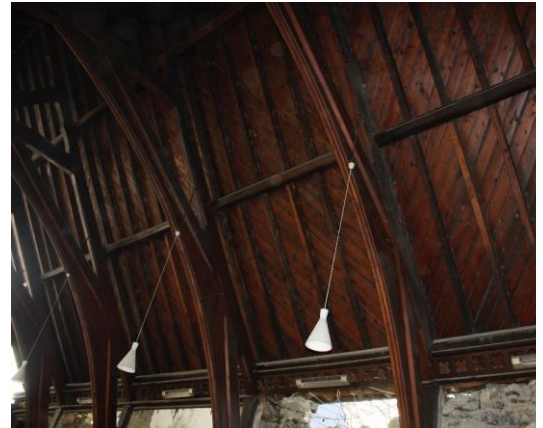
**Fig 2. Church Roof Structure
- Internal View-.**

Minor to negligible damage to the roof timber structure following the 4th of September 2010 and the 22nd of February 2011 earthquakes.

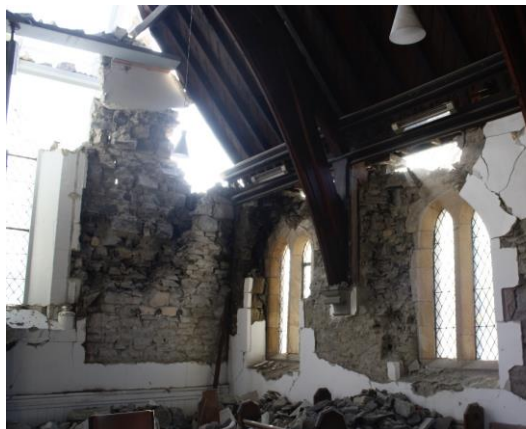
**Fig 3. Church North- West Corner
- Internal View - .**

Out-of-Plane (partial) local failure of the West gable end masonry wall. In the picture it is also possible to observe, the material failure of the stone masonry installed at the building south-west corner.

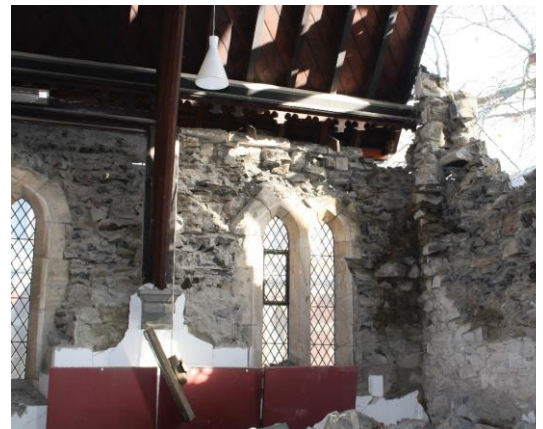
**Fig 4. Church South-West Corner
- Internal View-.**

Out-of-Plane (partial) local failure of the West gable end masonry wall. In the picture it is also possible to observe, the material failure of the stone masonry installed at the building south-west corner.

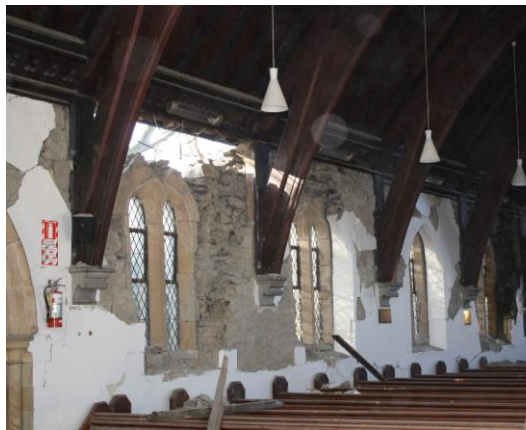
**Fig 5. Church Nave (South side)
- Internal View - .**

Out-of-Plane local failure of the masonry spandrel above nave window. Material failure of the pier internal layer.

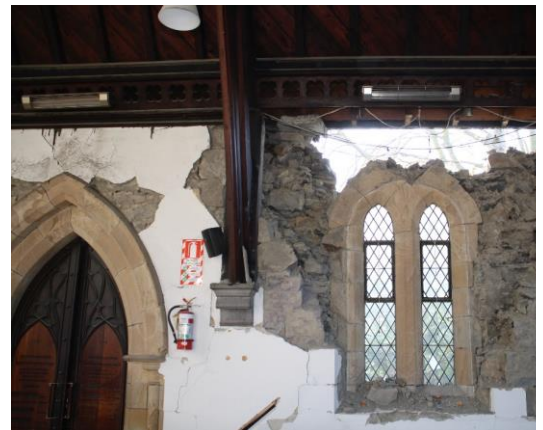
**Fig 6. Church Nave (South side)
- Internal View - .**

Out-of-Plane local failure of the masonry spandrel above nave window. Material failure of the pier internal layer.
