**STATEMENT OF REBUTTAL EVIDENCE OF JOHN DAVID THORNTON ON
BEHALF OF CHRISTCHURCH CITY COUNCIL**

**Significant Horizontal Elm (*Ulmus glabra* 'Horizontalis') District Plan Tree ID
Number T1118 (300 Stanmore Street)**

Dated: 9 October 2023

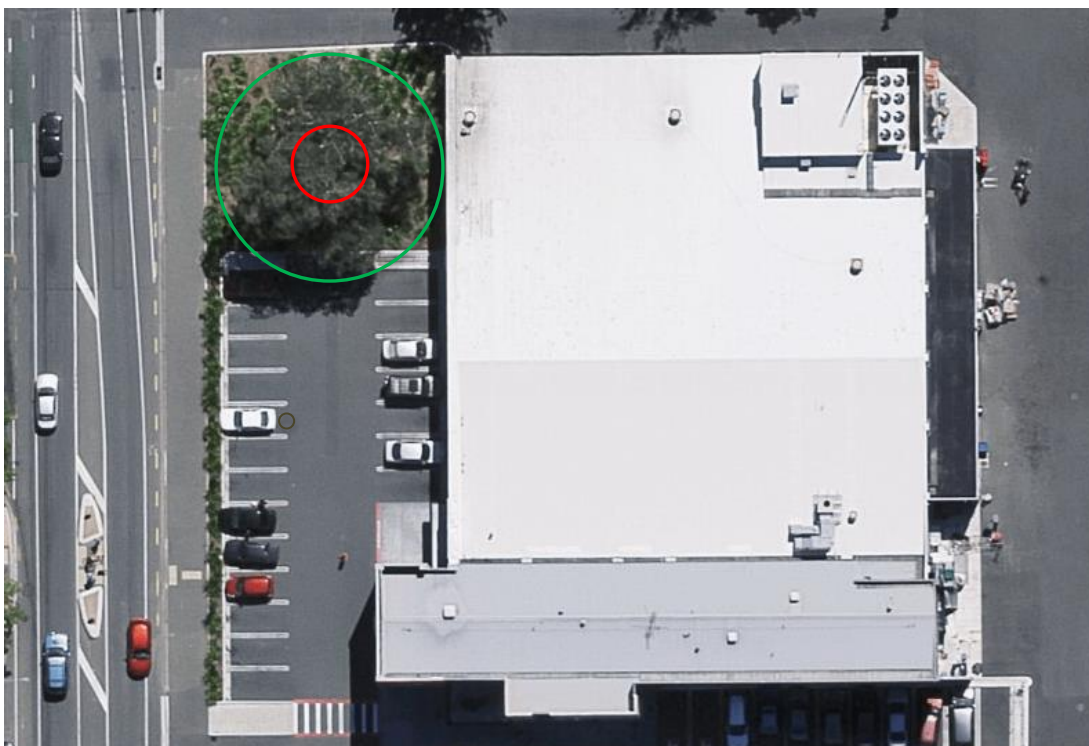
Photo Image 1: Stanmore Road New World: Ulmus glabra 'Horizontalis'. (Green: TPZ) (Red: SRZ).

- i. The subject tree *Ulmus glabra* 'Horizontalis' is located in a formed garden bed at the Stanmore Road, New World Supermarket. The tree's rooting environment is adjudged 'good', with adequate soil porosity or void fraction and organic material availed. The trees growth footprint is relatively unfettered and no obvious lean and/or stability issues are visible (Mattheck and Breloer, 1994).

- ii. The subject trees form, shape and structure is atypical of its species due to archaic pruning techniques ('pollarding'), with its natural decurrent form being altered due to this incorrect pruning.
- iii. The subject trees crown and main scaffolds show signs of limited vigour through a combination of biotic factors and senescence. The tree is slightly asymmetrically to the south-west with the canopy spread being marginally phototropic. This is accentuated due to the lineal pruning over the roofline.

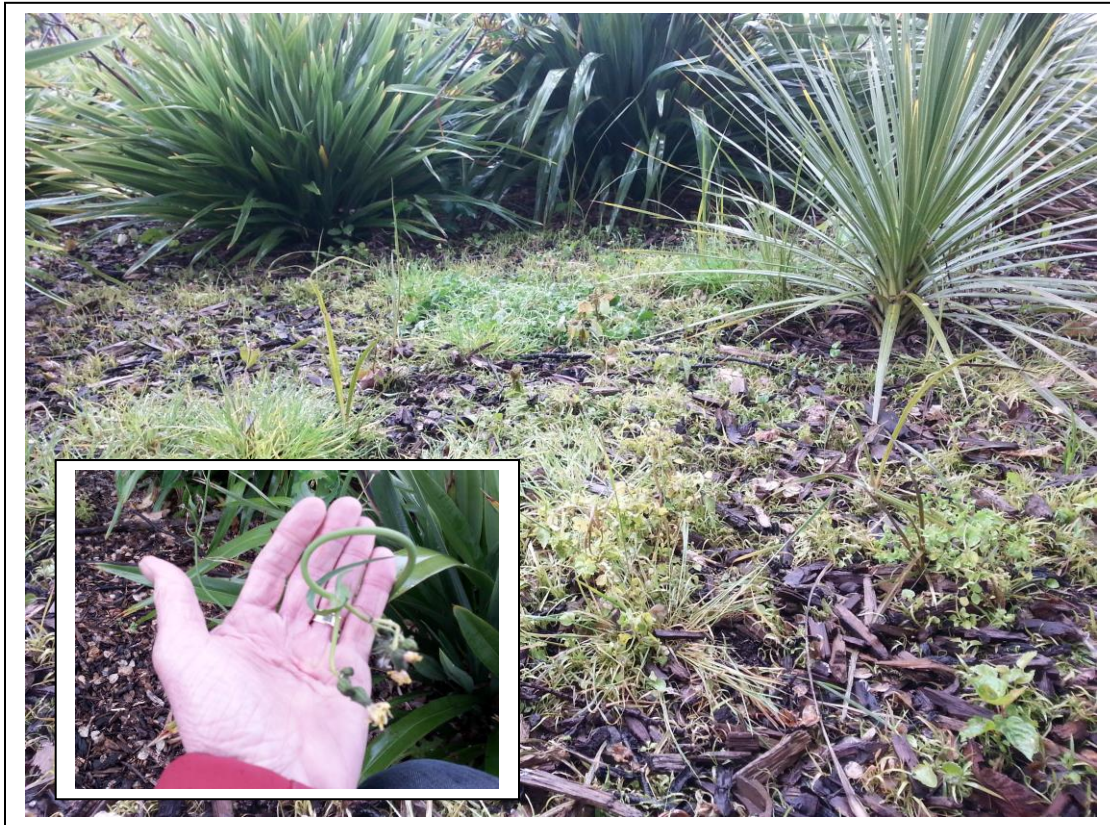
Not recorded in previous reporting on the tree has been the use of herbicide around the base of the elm that I personally observed in 2017 (see following images). It may not have been obvious to other arborist that have inspected the tree but the use of herbicides to manage weeds in landscaped areas such as this is now common practice. Their infrequent use makes them hard to detect and the symptoms of their use can mimic other tree conditions. Some herbicides such as glyphosate have little effect on established trees, but broadleaf herbicides can cause serious damage.

It is possible that what has been observed as 'decline' over the past 25 years has in fact been the intermittent use of broadleaf herbicides rather than solely the disturbance to the rooting environment. In my opinion the symptoms of periodic dieback in the tops of the elm are entirely consistent with effects of an acid-based herbicide.

Image shows 2017 herbicide application to weeds beneath elm. Inset shows distortion of growth consistent with an acid-based broadleaf herbicide commonly used for weed control.

If the use of broadleaf herbicides to control weeds is discontinued then the elm can be expected to recover, however full recovery can take many years.
