Statement of evidence of Kyle Brookland (building condition
assessment) on behalf of Carter Group Limited

- 7 I was asked by Mr Philip Carter to undertake an inspection of the Blue Cottage at 325 Montreal Street (on the corner of Gloucester and Montreal Street, noting the address is sometimes described as 32 Armagh Street, which is the rear entrance to the wider site).
- 8 I undertook an inspection on 25 August 2023. I carried out the inspection in accordance with NZS 4306:2005 Residential property inspection. I undertook a subsequent inspection for lead paint on 16 September 2023.
- 9 I produced a Building Inspection Report which is attached as **Appendix 1** to my evidence.

Name: Kyle Brookland
Phone: 021 298 7395
Email: kyletheinspector@gmail.com
Date: 25 August 2023.
16 September 2023. Lead Paint Testing.
Time: 9:00 am.
Weather Conditions: Fine.
Site Address: 325 Montreal Street - (Corner of Gloucester & Montreal).
Client: Shane Olivia Limited.

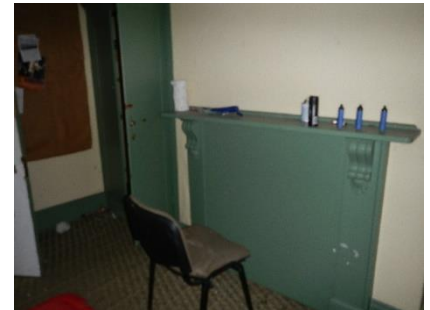
G1

Flooring:	Human excrement is present on the flooring and as a result all timbers will require removal – this may include sections of the subfloor as well.
Walls:	Lath and plaster, painted. Relining of the surfaces will be required due to the timber framing condition – sections of the exterior and interior framing will require replacement due to moisture damage.
Ceiling:	Lath and plaster, painted. Re-lining of the surfaces will be required due to mold present throughout the ceiling cavity.
Doors:	Due for replacement.
Windows:	Timber, single glazed. Due for replacement due to moisture damage.
Heating:	Old fireplace – bricks appear to be from the 1950's.

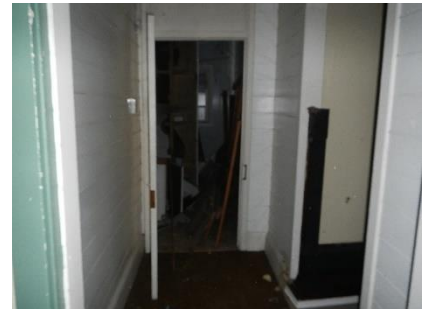
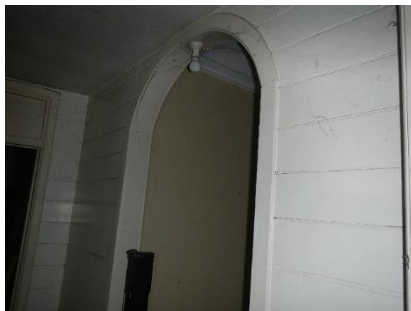
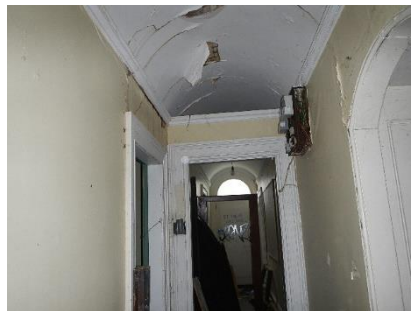
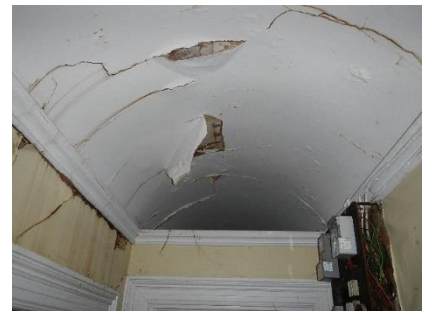
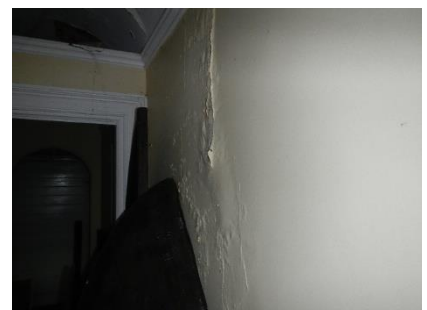
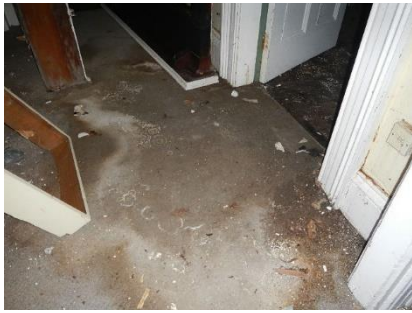
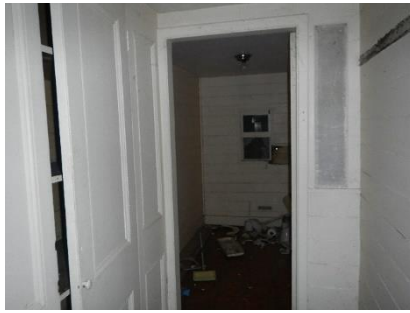
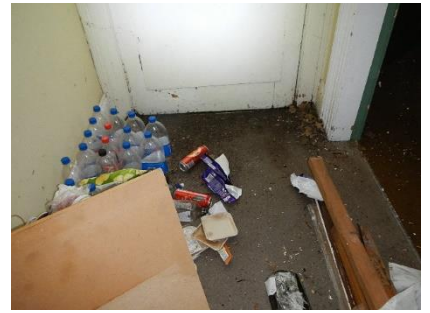
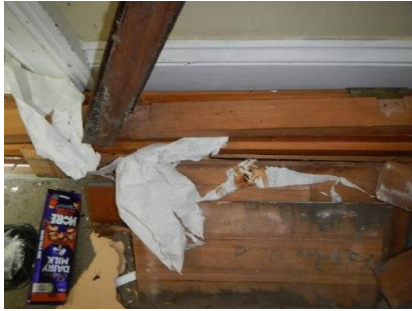
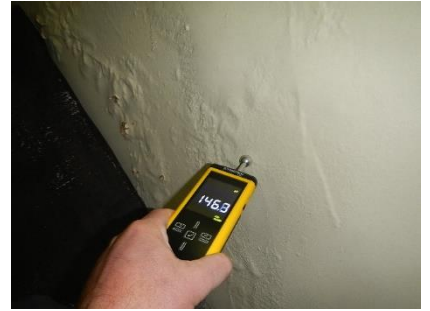
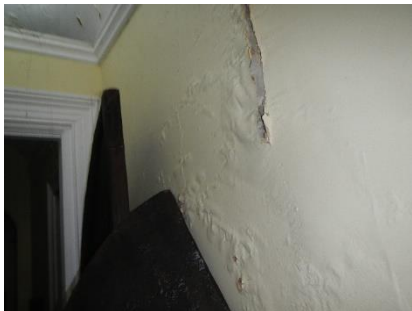
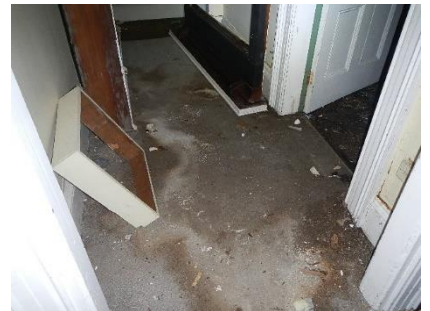
G3 – G8

Human excrement is present on the flooring and as a result all timbers will require removal – this may include sections of the subfloor as well. Section of moisture damage are present to the flooring and the subfloor timbers in this area – directly related to the condition of the roofing – the roof system is not draining correctly and is currently overflowing.

Very high moisture readings were recorded in the walls due to the water ingress from the roofing structure.

Re-lining of the surfaces will be required due to the timber framing condition – large sections of moisture damage are present with structural walls requiring replacement.

Relining of the surfaces will be required due to extensive moisture damage.

The main door leading to the exterior is due for replacement due to moisture damage.

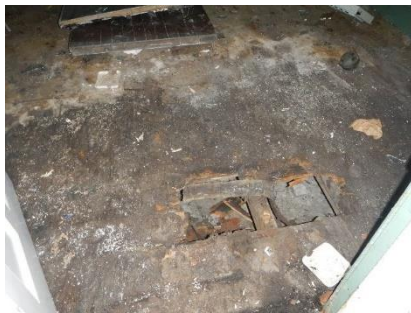
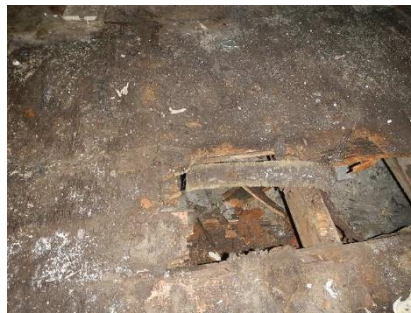
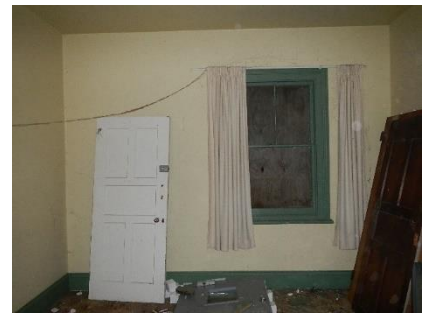
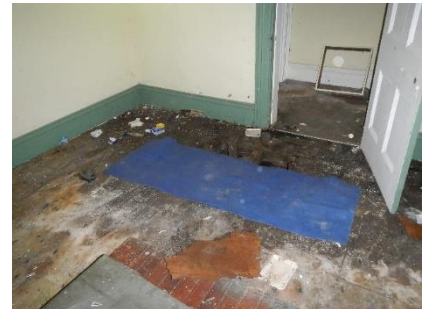
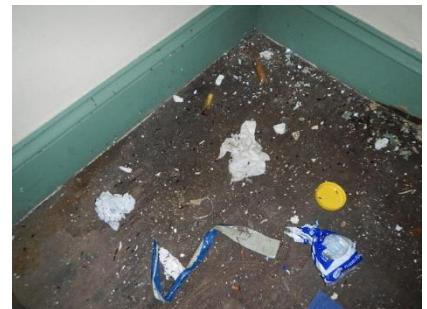
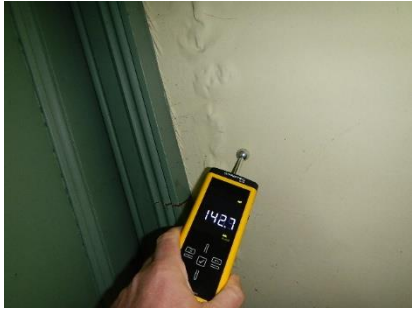
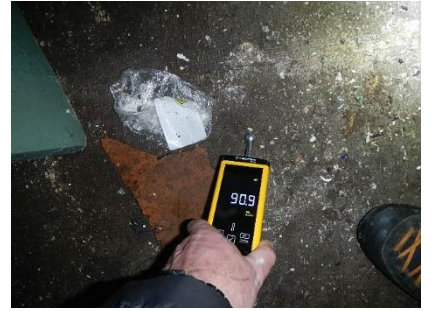
G4

Flooring:	Human excrement is present on the flooring and as a result all timbers will require removal – this may include sections of the subfloor as well. Sections of moisture damage are present to the flooring and the subfloor timbers in this area – directly related to the condition of the roofing – the roof system is not draining correctly and is currently overflowing. Very high moisture readings were recorded in the flooring due to the water ingress from the roofing structure.
Walls:	Lath and plaster, painted. Re-lining of the surfaces will be required due to the timber framing condition – large sections of moisture damage are present with structural walls requiring replacement. Very high moisture readings were recorded in the walls due to the water ingress from the roofing structure.
Ceiling:	Lath and plaster, painted. Relining of the surfaces will be required due to extensive moisture damage.

Doors:	Due for replacement due to moisture damage.

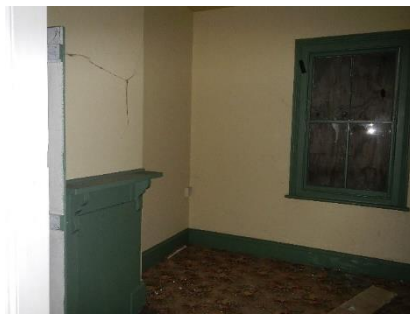
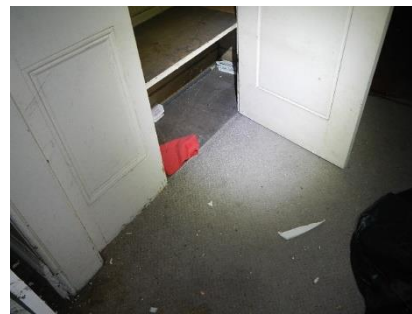
G5

Flooring:	Human excrement is present on the flooring and as a result all timbers will require removal – this may include sections of the subfloor as well. Sections of moisture damage are present to the flooring and the subfloor timbers in this area – directly related to the condition of the roofing.
Walls:	Lath and plaster, painted. Re-lining of the surfaces will be required due to the timber framing condition – large sections of moisture damage are present with structural walls requiring replacement.
Ceiling:	Lath and plaster, painted. Relining of the surfaces will be required due to extensive moisture damage.
Heating:	Old fireplace – bricks appear to be from the 1950's.

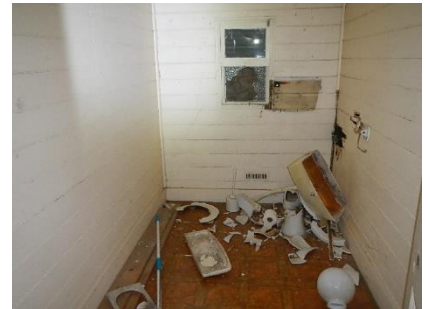
G6

Flooring:	Tiles over an assumed concrete substrate – this floor appears to have been installed in the 1950's.
Walls:	Painted timbers. Re-lining of the surfaces will be required due to the timber framing condition – large sections of moisture damage are present with structural walls requiring replacement.
Ceiling:	Painted timbers. Relining of the surfaces will be required due to extensive moisture damage.
Doors:	Due for replacement due to moisture damage.
Sewer:	The toilet is broken, and the line is currently open.

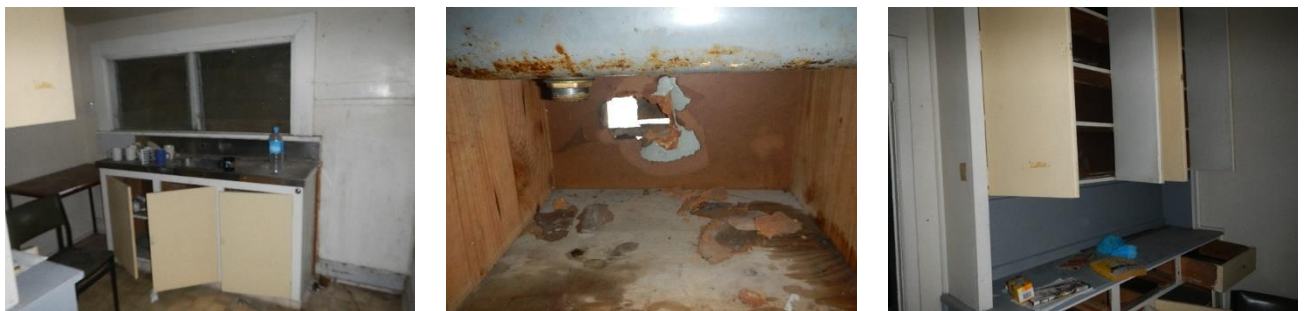
G9

This room requires a full re-fit and appears to have been installed in the 1950's and does not appear to be original to the property.

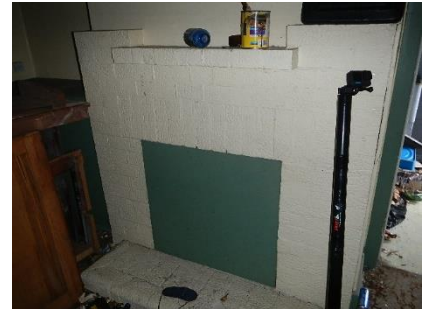
G10

Flooring:	Human excrement is present on the flooring and as a result all timbers will require removal – this may include sections of the subfloor as well.
Walls:	Lath and plaster, painted. Re-lining of the surfaces will be required due to the timber framing condition.
Ceiling:	Lath and plaster, painted. Relining of the surfaces will be required due to extensive moisture damage.
Heating:	Old fireplace – bricks appear to be from the 1950's.

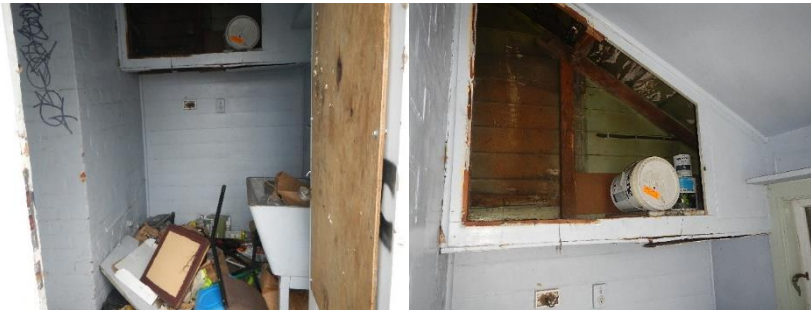
G11

Flooring:	Sections of moisture damage are present on the surface.
Walls:	Lath and plaster, painted. Re-lining of the surfaces will be required due to the timber framing condition – large sections of moisture damage are present with structural walls requiring replacement.
Ceiling:	basic linings and lounge and grooved timbers, painted. Relining of the surfaces will be required due to extensive moisture damage.
Doors:	Due for replacement due to moisture damage.
Heating:	Old fireplace – bricks appear to be from the 1950's.

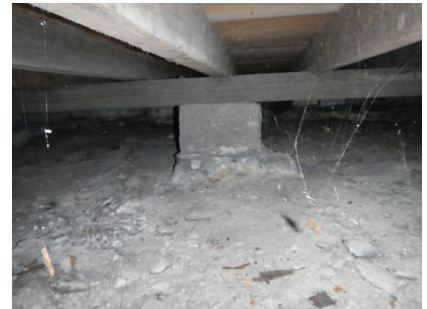
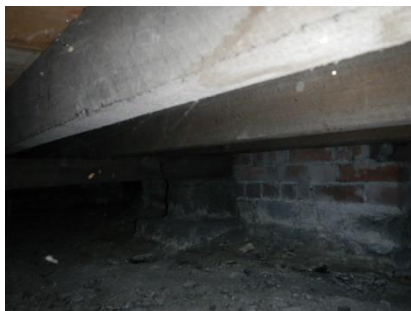
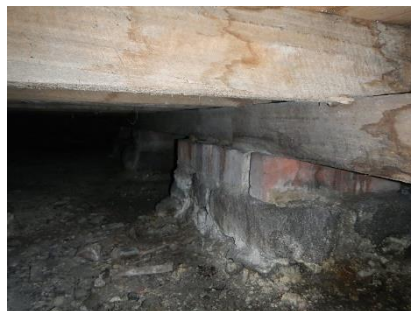
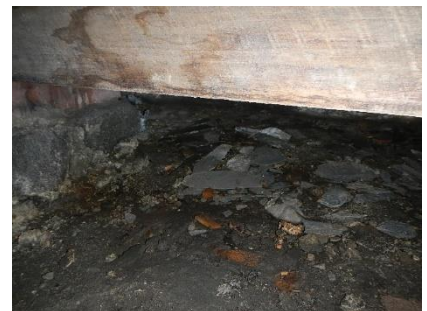
Foundation System

Construction Type:	Stone perimeter ring beam.
Condition:	There are sections of movement to the foundation with sections of re-levelling required.
Timber Flooring:	Numerous sections of the flooring will require removal and replacement due to moisture damage and contamination of the flooring.
Subfloor Timbers:	There are sections of borer damage present with sections of moisture damage also present around the center of the property due to water ingress.

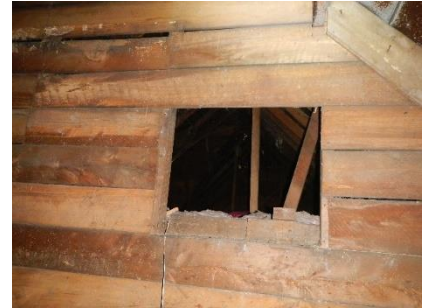
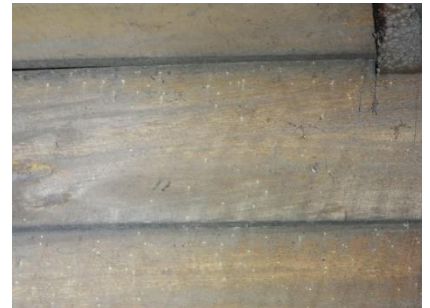
Ceiling Cavity

Pitched timber framing supporting the corrugated iron roofing.

The timber framing is covered in mold and testing is required prior to any
Due to the mold and border present it is likely to require complete
replacement of all timbers above the top plate of the timber framing.

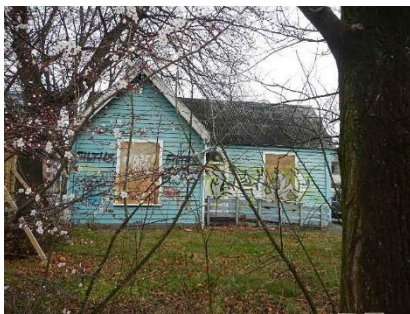
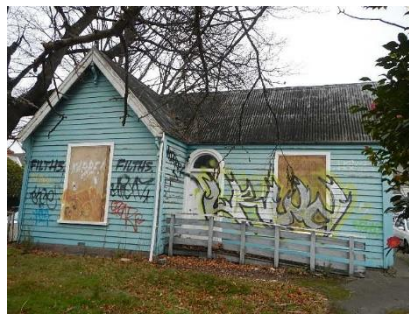
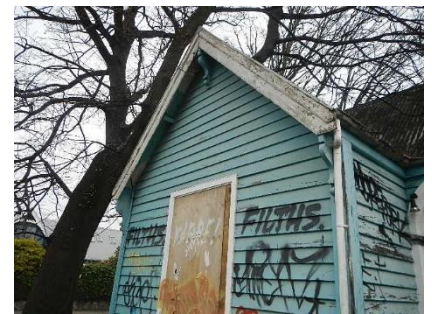
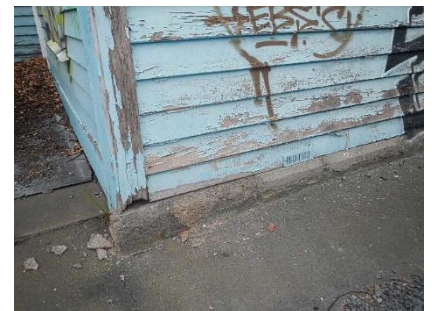
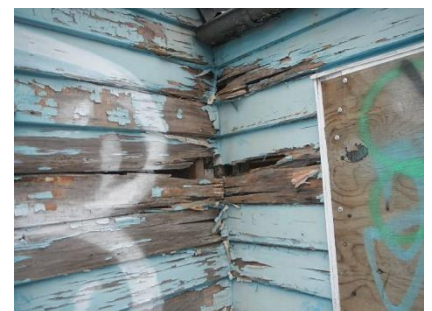
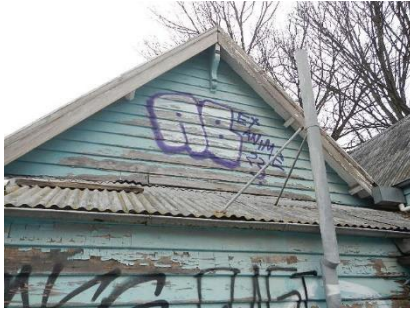
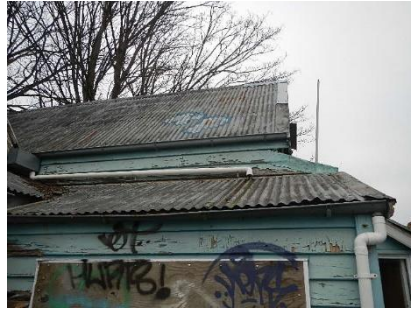
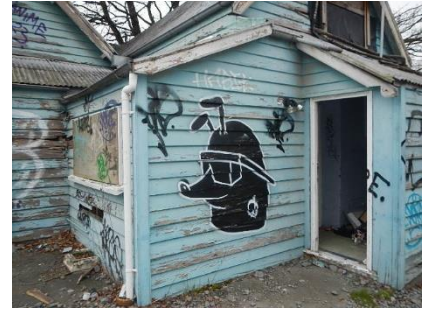
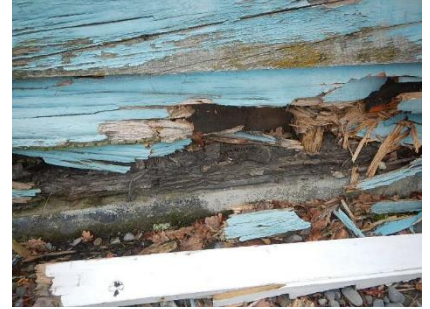
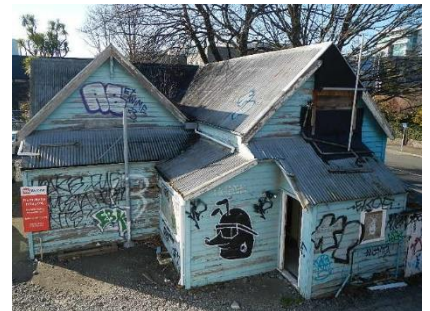
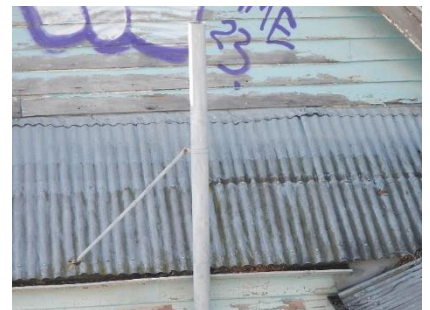
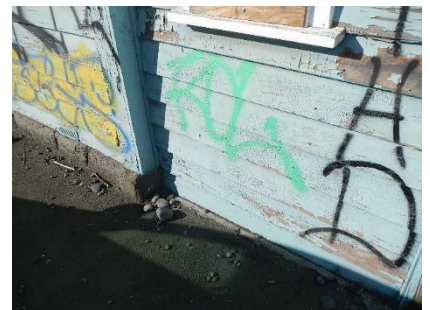
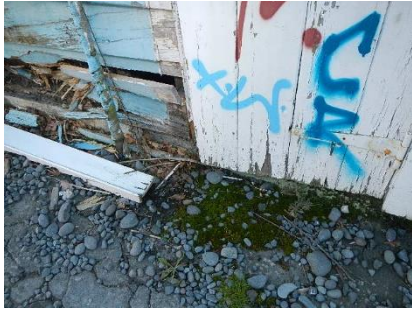
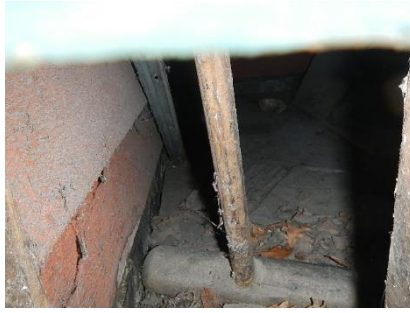
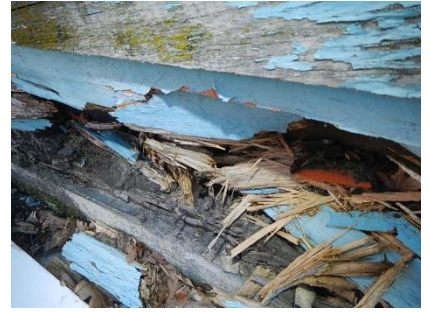
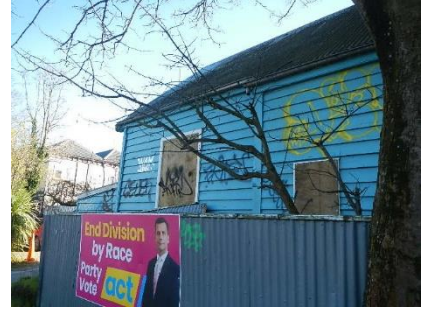
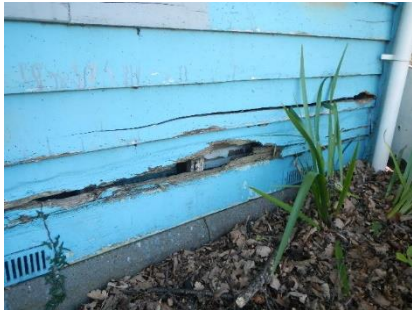
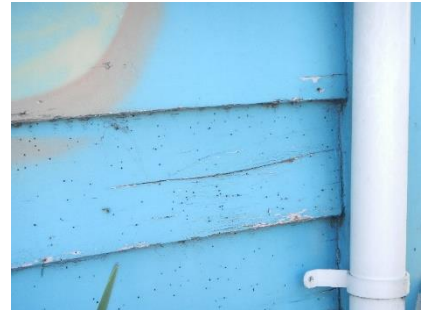
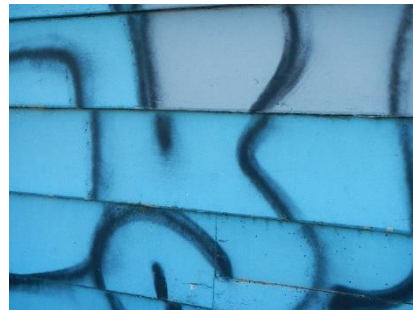
Wall Cladding

The cladding is in very poor overall condition with full replacement of the cladding required to ensure that the property can be returned to a fully weathertight condition.

All of the doors to the exterior will require replacement due to extensive moisture and impact damage.

The windows are due for full replacement – moisture damage is present.

There is currently direct contact with the surrounding soils – this is likely to have caused damage to the cladding – framing and the subfloor timbers. ground clearance present.

This would also provide the opportunity for new flashings around the new doors and windows.

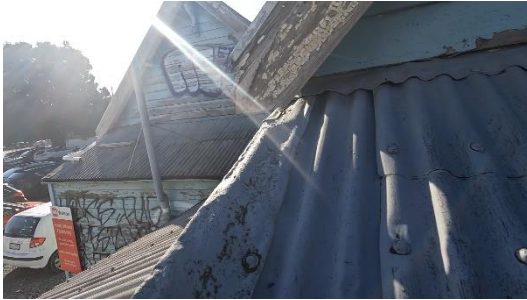
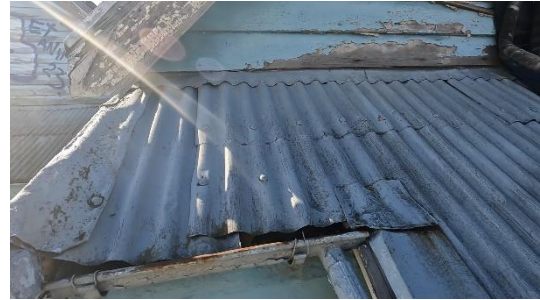
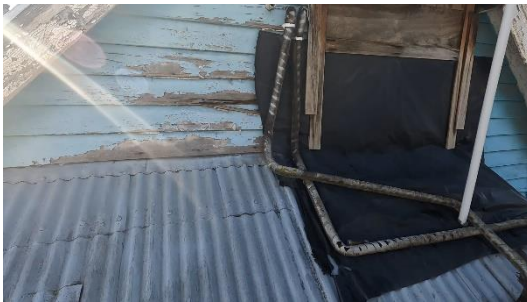
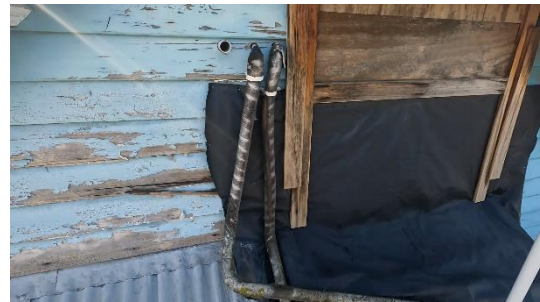
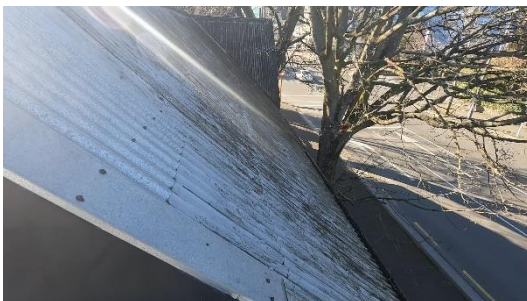
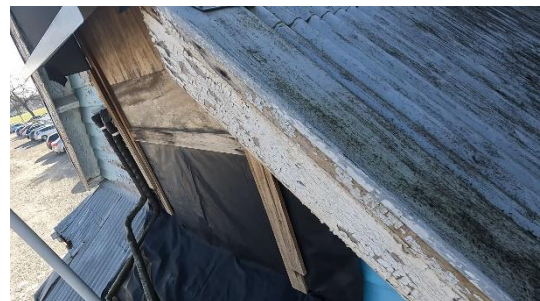
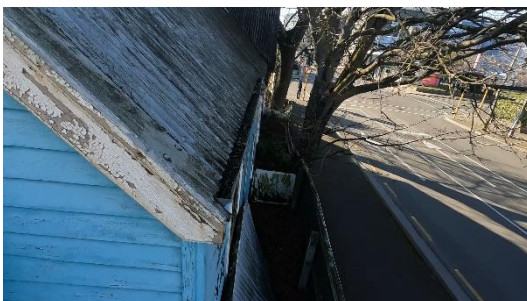
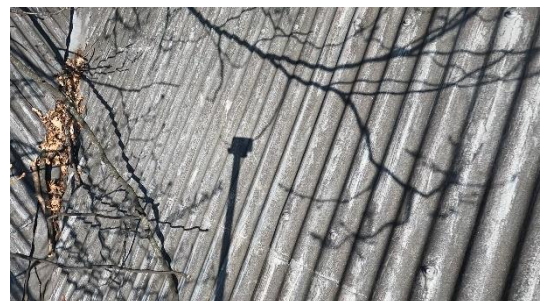
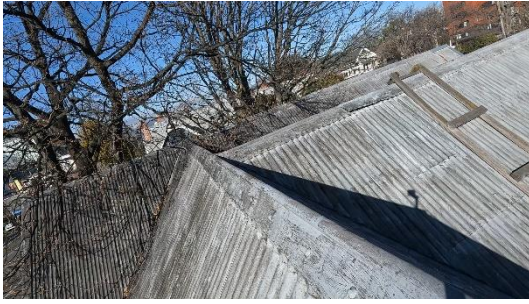
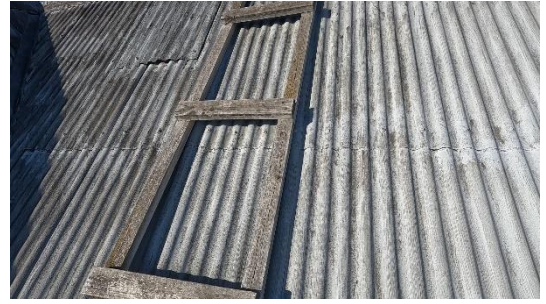
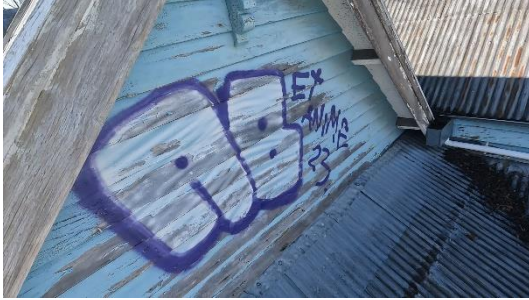
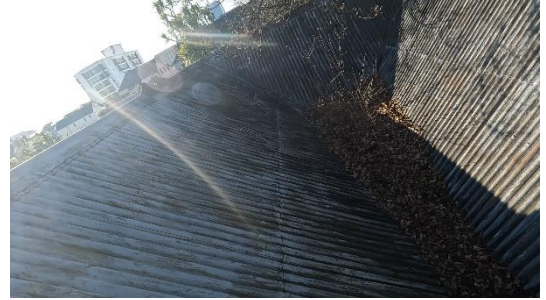
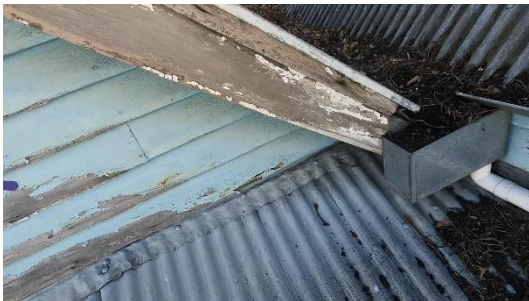
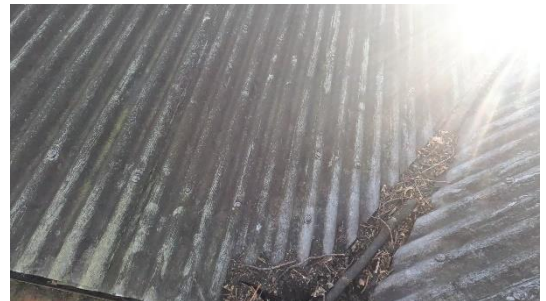
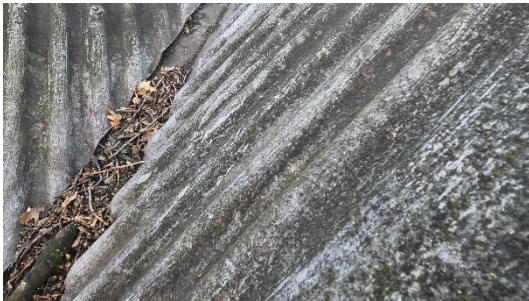
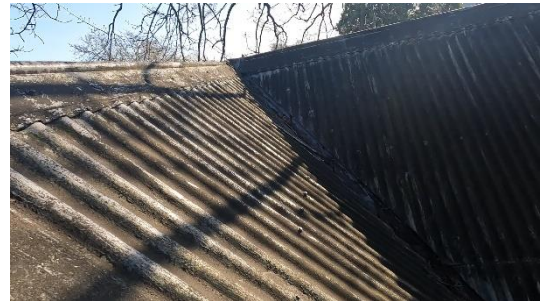
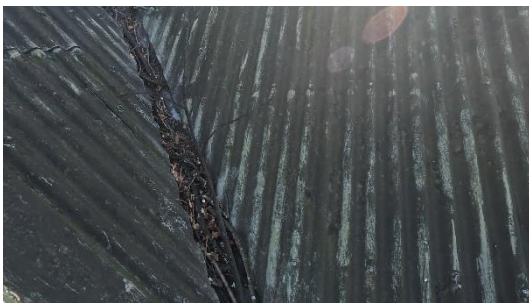
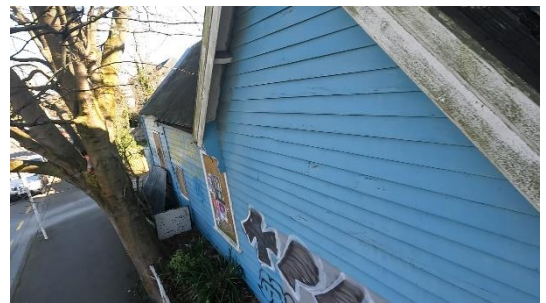
Roof Cladding

Construction Type:	Painted corrugated iron roofing located over pre-tensioned timber trusses.
Condition:	The roofing is due for complete replacement to all areas.
Ridge Capping:	The Ridge capping is due for replacement.
Gable Flashing:	The gable flashings are due for replacement.
Spouting:	Due for full replacement.
Fascia/Barge Boards:	Timber – due for replacement.
