*in the matter of:* proposed Plan Change 14 to the Christchurch District  
Plan

*and:* **Daresbury Limited**  
(Submitter 874)

Statement of evidence of Brett Andrew Gilmore for Daresbury  
Limited (Structural Engineering)

Dated: 20 September 2023

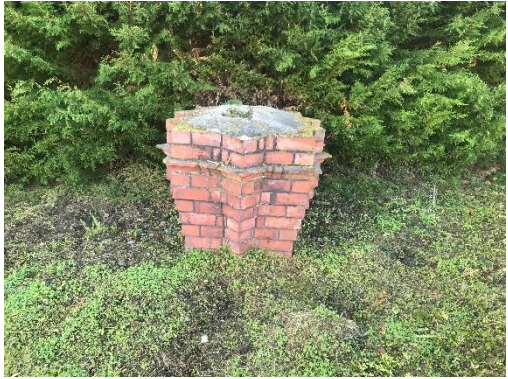
17.	Collapsed chimney stack

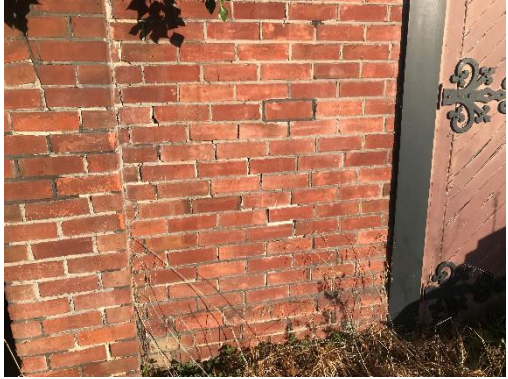
24.	Stepped cracking and slippage gaps in east brick wall to Office 2

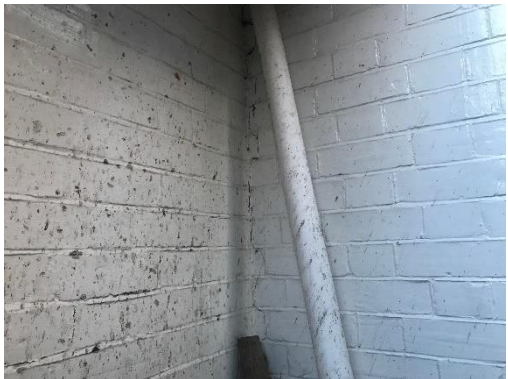
26.	Cracks in brick wall at re-entrant corner between Hall 3 and Dining Hall

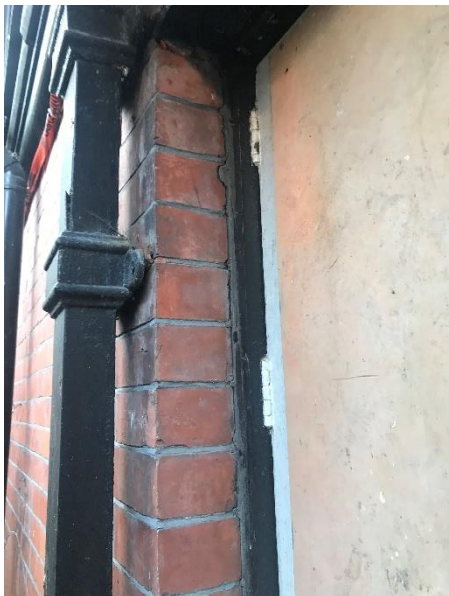
27.	Cracks in mortar and movement gaps between brick wall and door frame at west exterior door between Chiller and WC

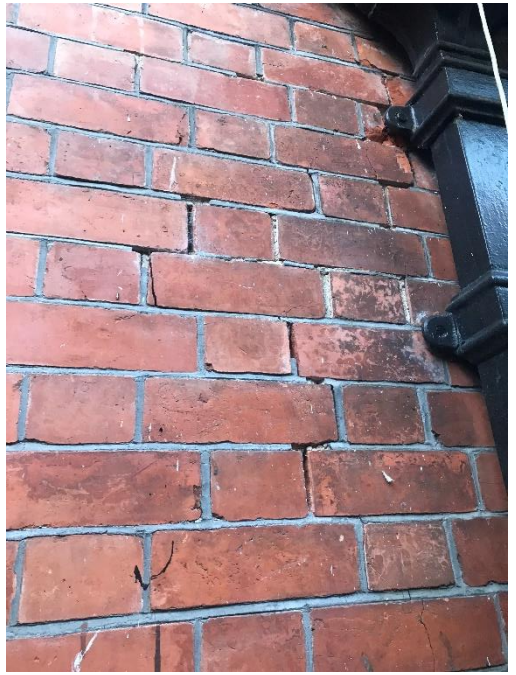
28.	Cracks in west brick wall to Chiller

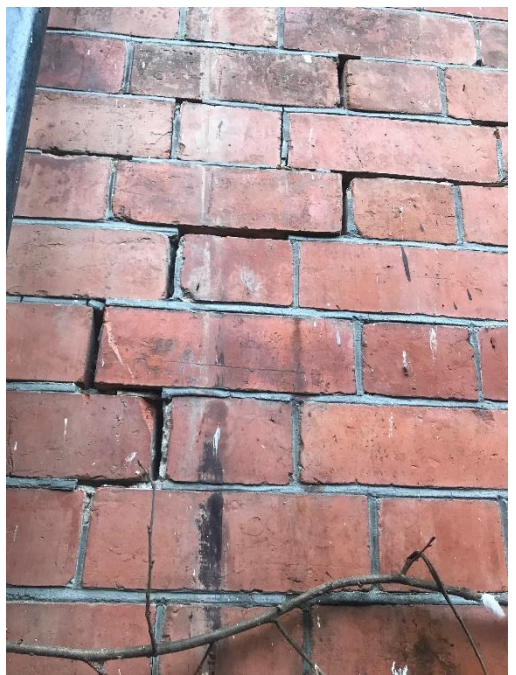
29.	Cracks and slippage gaps in west brick wall to Laundry

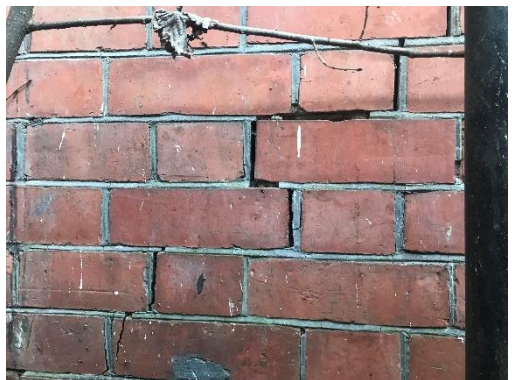
30.	Cracks and significant brick slippage gaps in west brick wall to Laundry

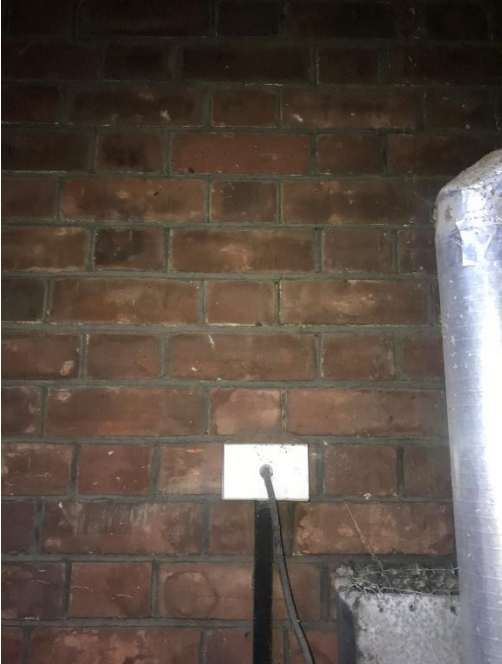
33.	Cracks in mortar joints to east brick wall to Dining Hall

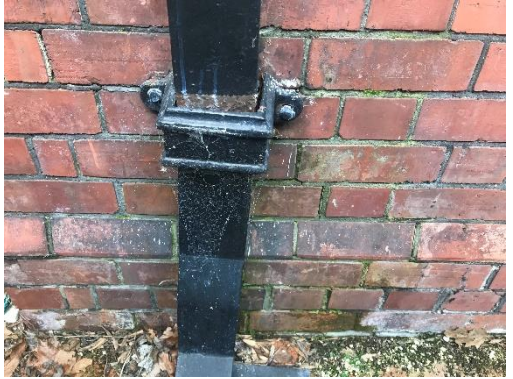
<p>34.</p>	<p>Cracks in mortar joints to east brick wall to Dining Hall</p>

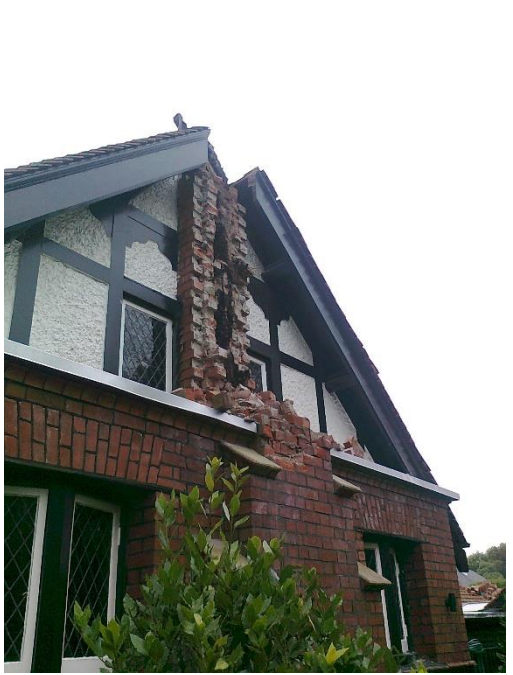
<p>35.</p>	<p>Collapse of chimney to south wall of Dining Hall</p>

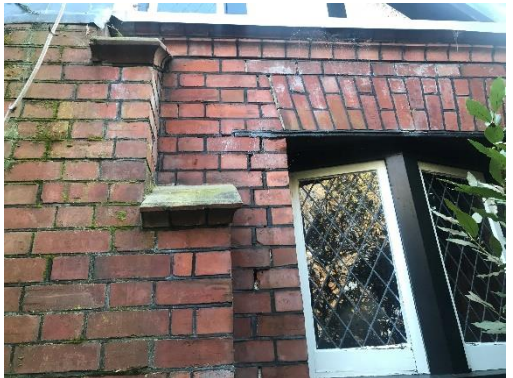
<p>36.</p>	<p>Cracks and slippage gaps in south block wall to Dining Hall</p>

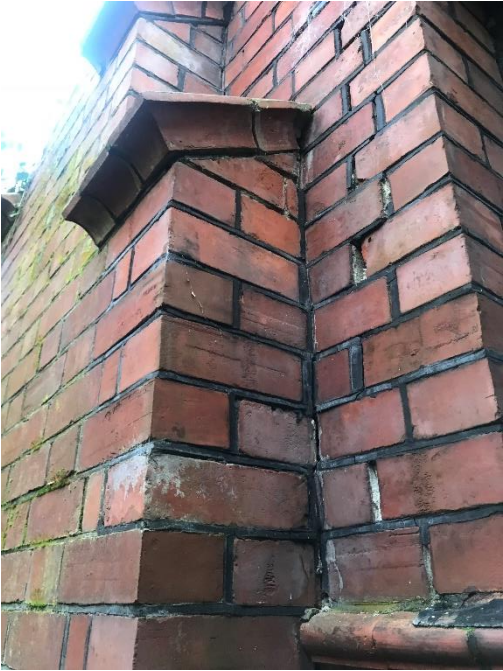
37.	Cracks in south brick wall to Dining Hall at re-entrant corner of chimney and wall

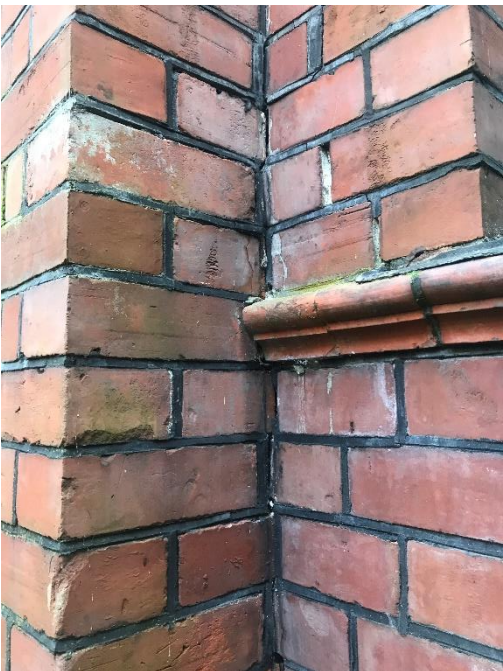
38.	Cracks in south brick wall to Dining Hall at re-entrant corner of chimney and wall

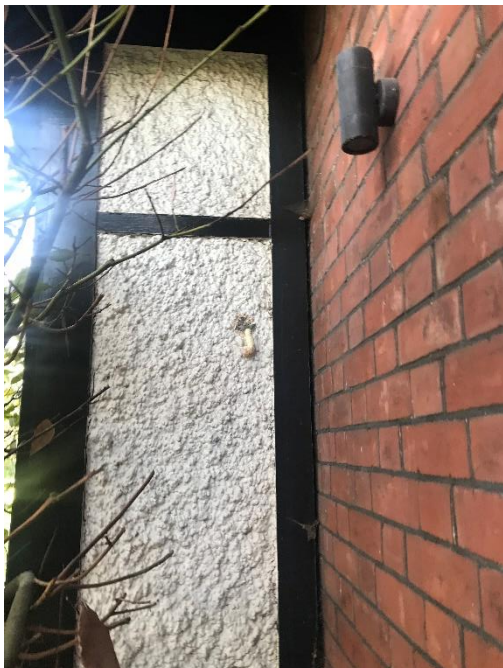
<p>41.</p>	<p>Large 10 – 15mm movement gap between timber framed bay window and west brick wall to Dining Hall</p>

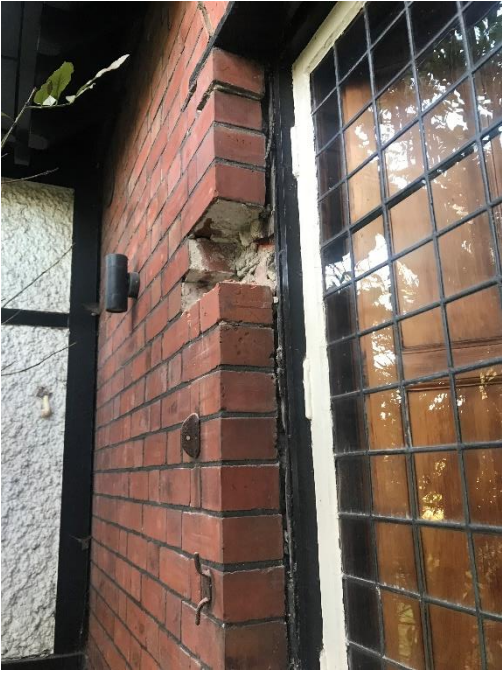
43.	Localised failure and large 10 – 25mm movement of brick wall adjacent to west window to Dining Hall

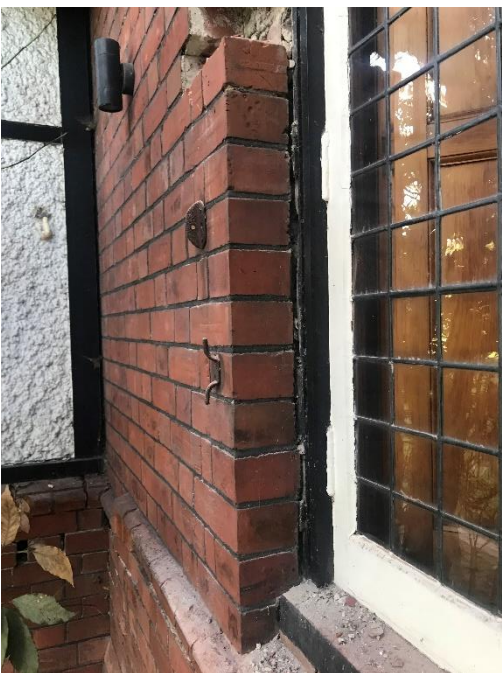
A photograph showing a corner of a red brick wall adjacent to a window. There is a significant localized failure of the brickwork, with several bricks missing and the mortar joints crumbling. The window has a black frame and multiple panes.
44.	Localised failure and large 10 – 25mm move of brick wall adjacent to west window to Dining Hall

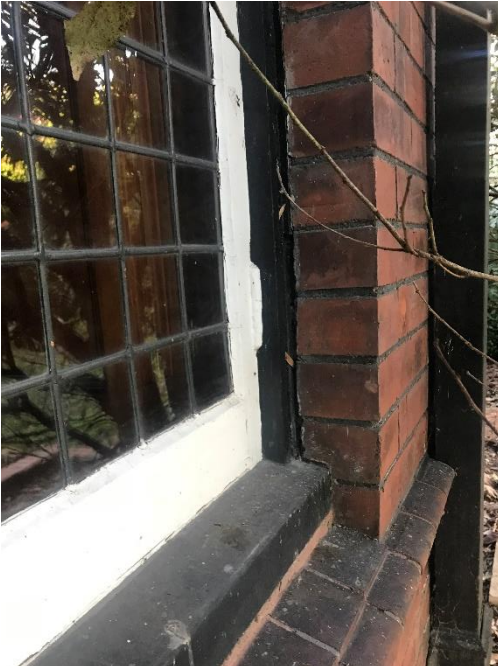
<p>45.</p>	<p>Large 15 – 25mm movement of west brick wall at window to Dining Hall</p>

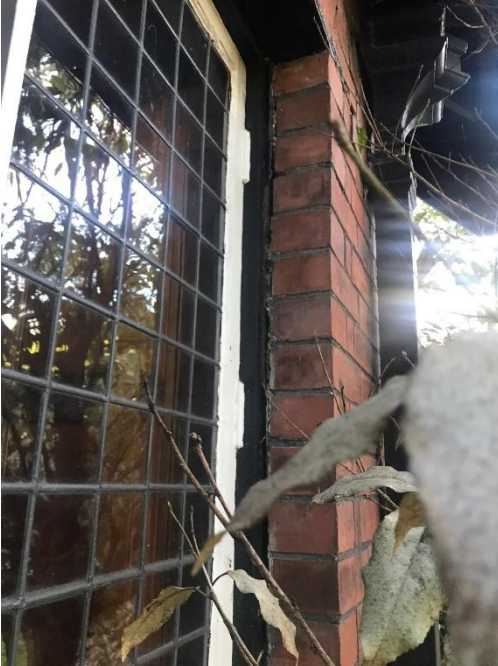
<p>46.</p>	<p>Large 15 – 25mm movement of west brick wall at window to Dining Hall</p>

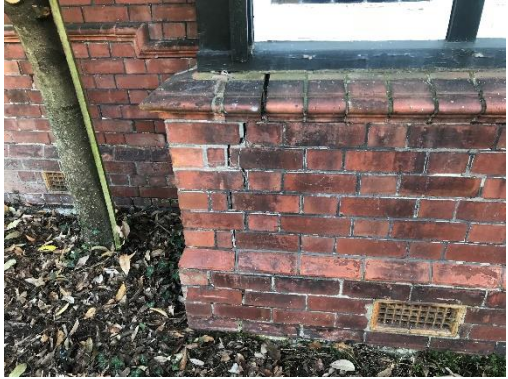
48.	Cracks and large slippage gaps in brick wall beneath west side bay window to Dining Hall

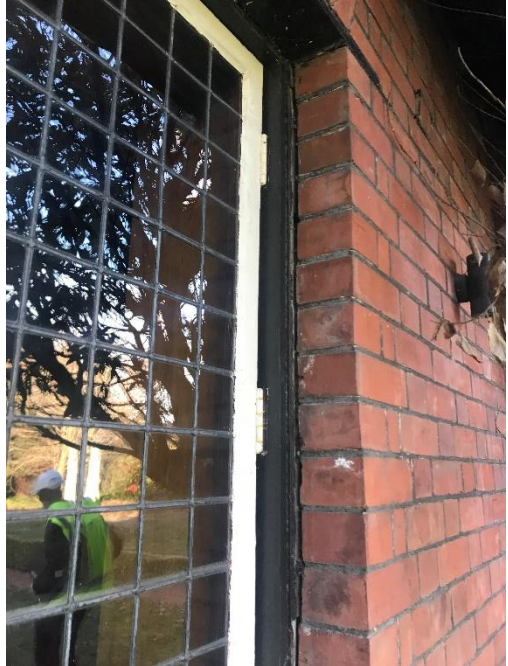
<p>57.</p>	<p>Large 15 – 25mm movement of west brick wall at window to Dining Hall</p>

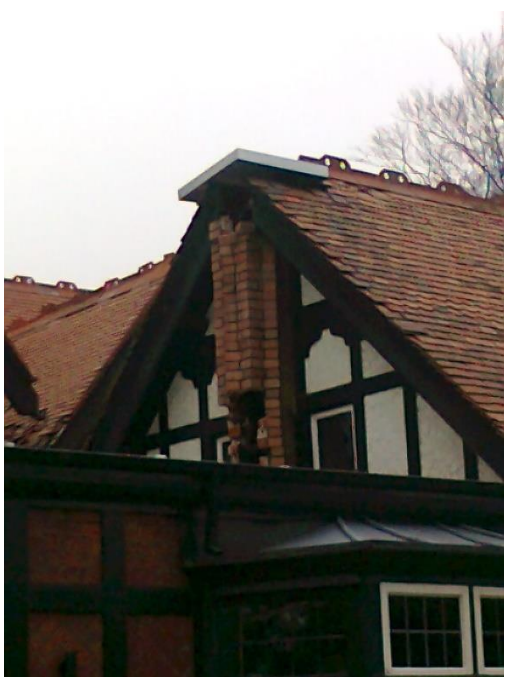
<p>59.</p>	<p>Collapse and failure of brick chimney to north end of Dining Hall, above flat roof to Library, plus movement damage to tile roofing</p>

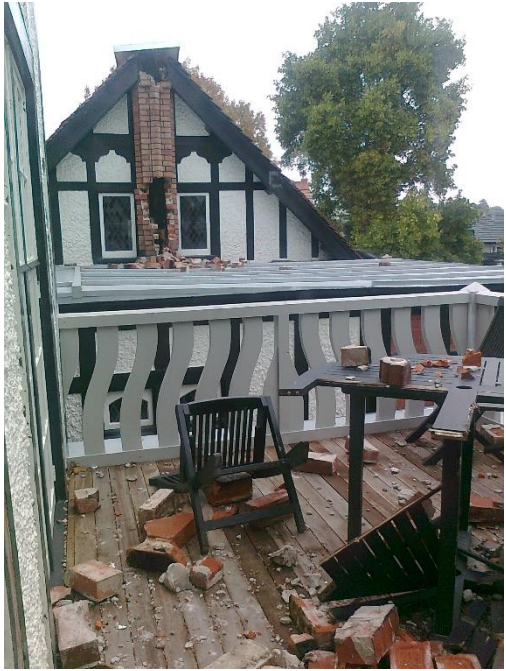
<p>60.</p>	<p>Collapse and failure of brick chimney to north end of Dining Hall, above flat roof to Library, plus movement damage to tile roofing</p>

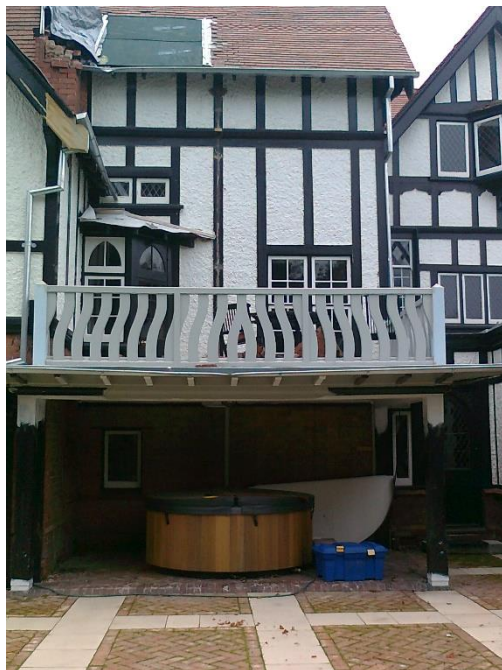
<p>63.</p>	<p>Collapse of brick chimney to south-west corner of Bed 8 plus movement damage to tile roofing</p>

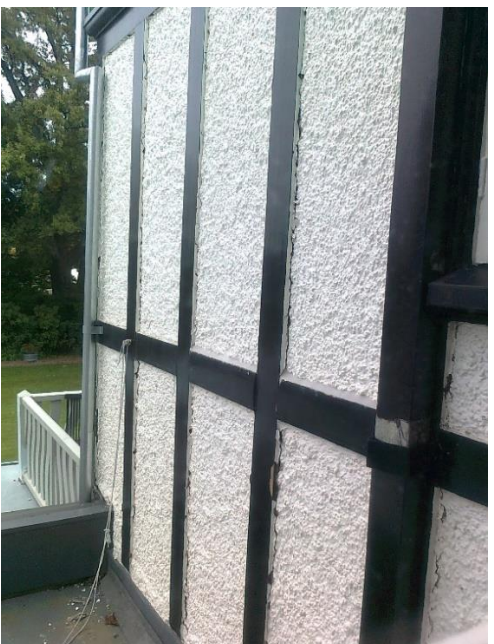
68.	Cracks and tearing in decorative plaster to south wall of main north-west Stairwell

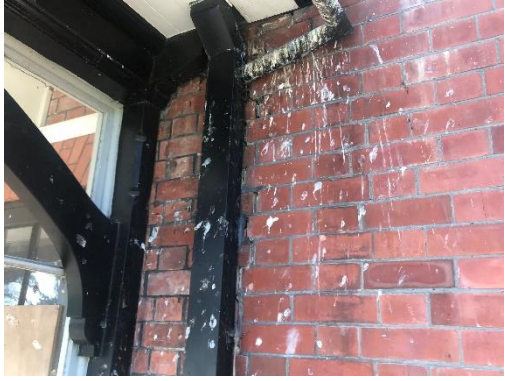
77.	Failure of north brick wall to Lounge, at north-west corner

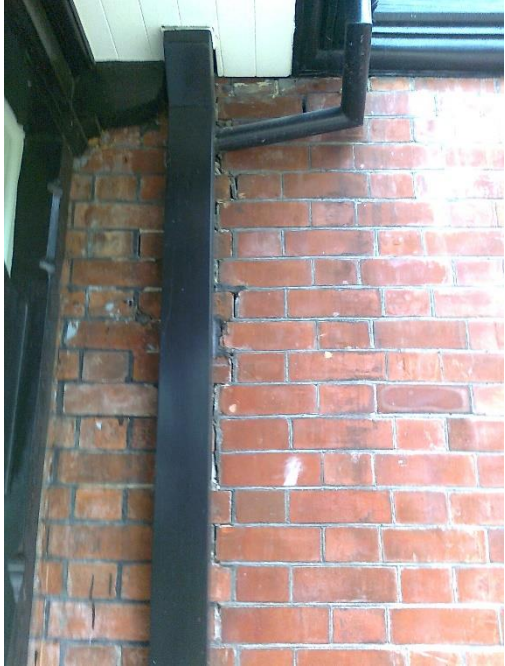
78.	Failure of north brick wall to Lounge, at north-west corner

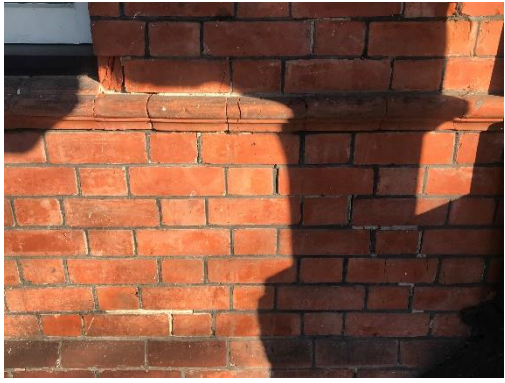
100.	Cracks and slippage gaps in east brick wall to Kitchen

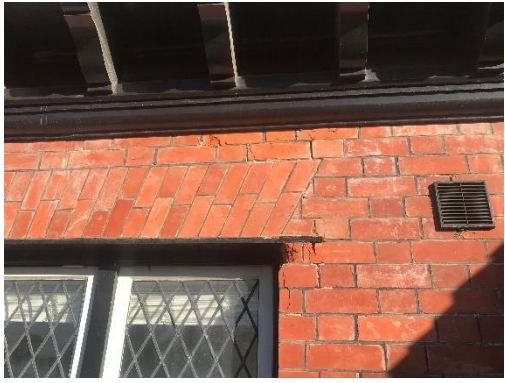
101.	Cracks in east brick wall to Kitchen

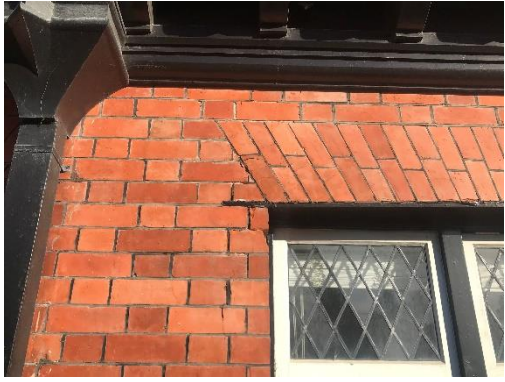
102.	Cracks and slippage gaps in east brick wall to Kitchen

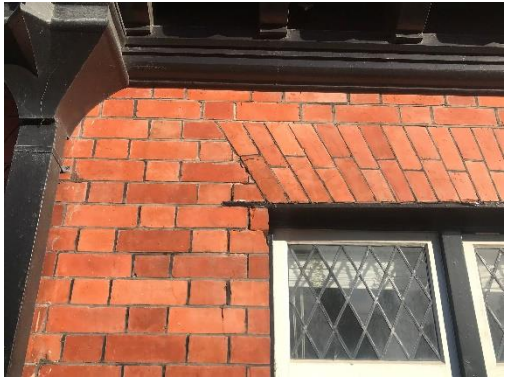
103.	Cracks and slippage gaps in east brick wall to Kitchen

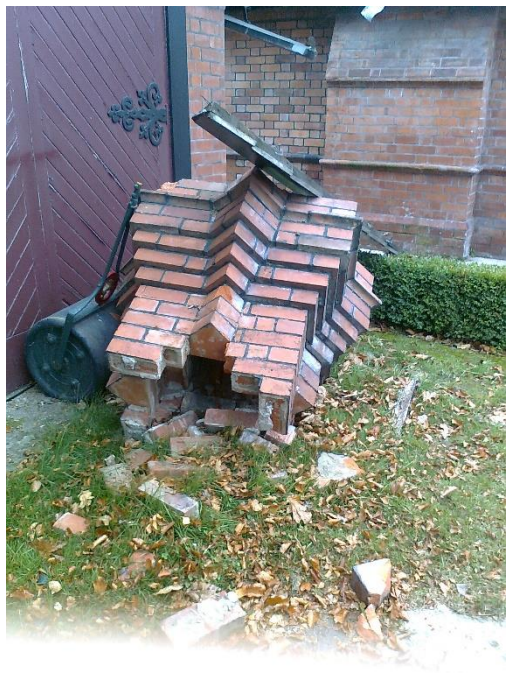
111.	Collapsed chimney to south wall of Office 1

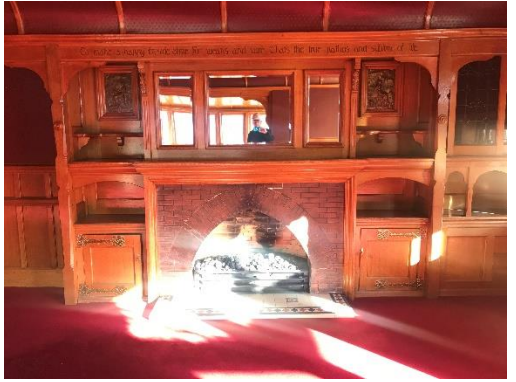
112.	Chimney fireplace in Family (west wall) looking west

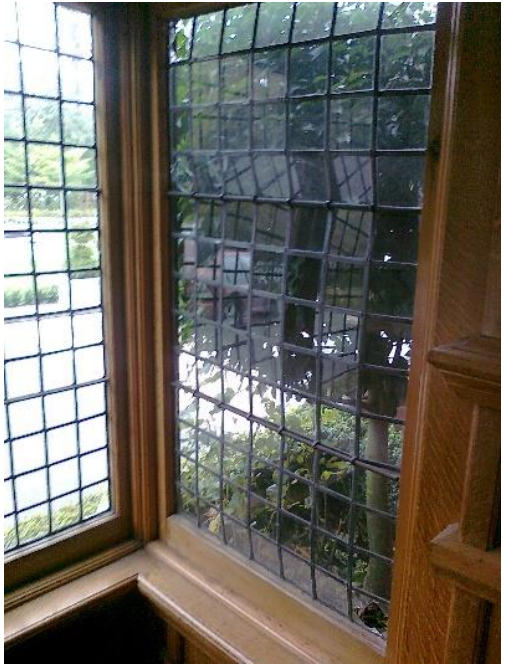
113.	Deformed and broken lead framed window to Family

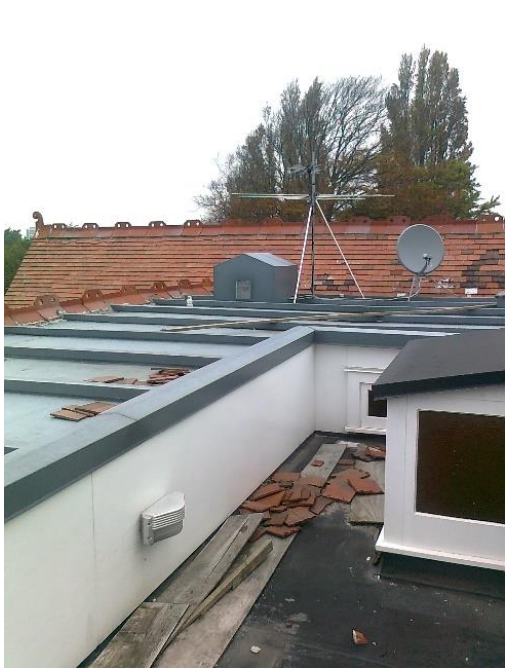
114.	Movement of roof tiles to Dining Hall

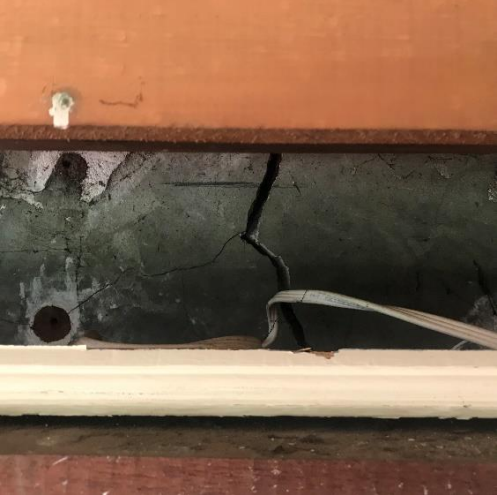
<p>116.</p>	<p>Chimney fireplace in Lounge (east wall) looking east, with cracks/gaps in bricks</p>	 
<p>117.</p>	<p>Crack/gap in concrete lintel above east fireplace in Lounge</p>

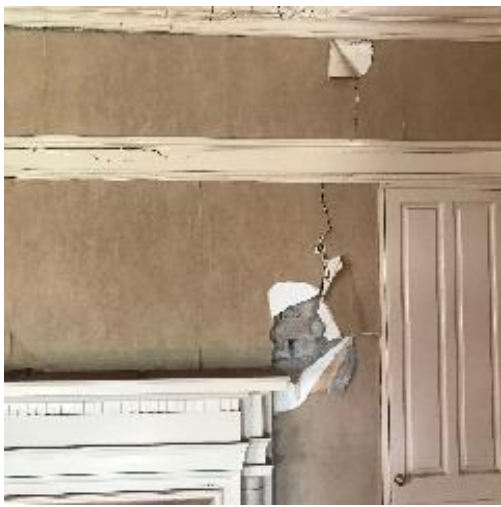
120.	Chimney fireplace in Lounge (south-west) looking south, with extensive damage to wall and ceiling finishes and cracks/gaps in brick walls

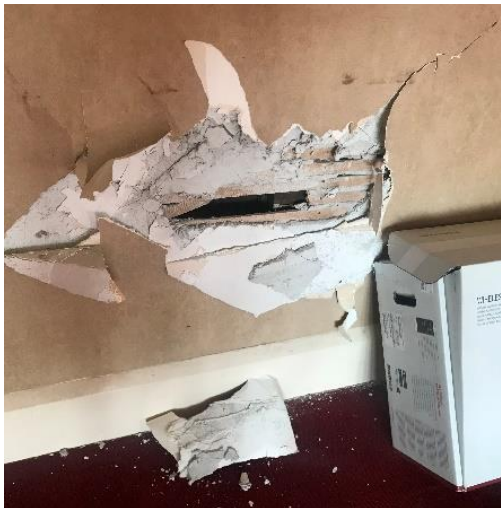
121.	Racking damage to south wall of Lounge

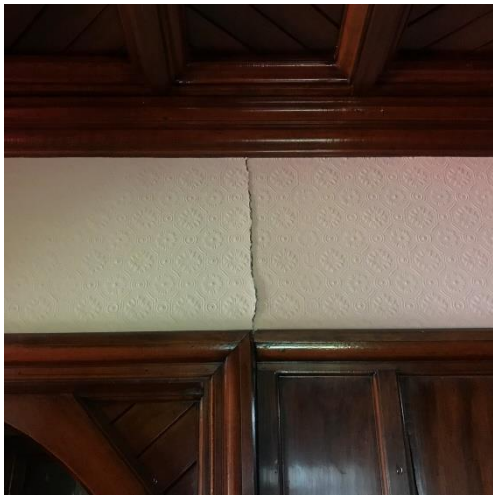
122.	Crack/gap in wall finishes in Entry Hall

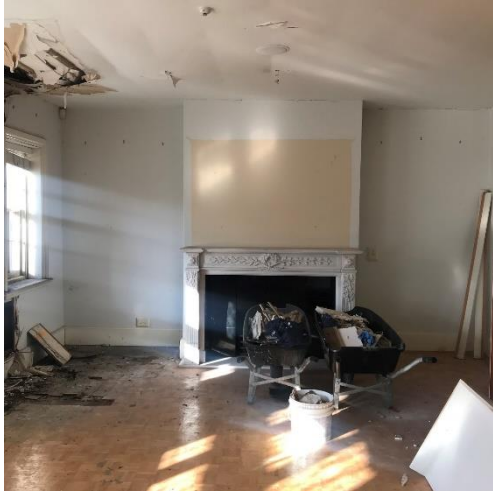
125.	General view of Kitchen, looking south towards fireplace, with significant ceiling damage

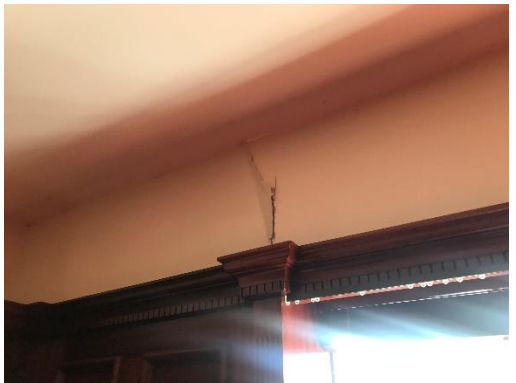
129.	Wall damage in Office 1

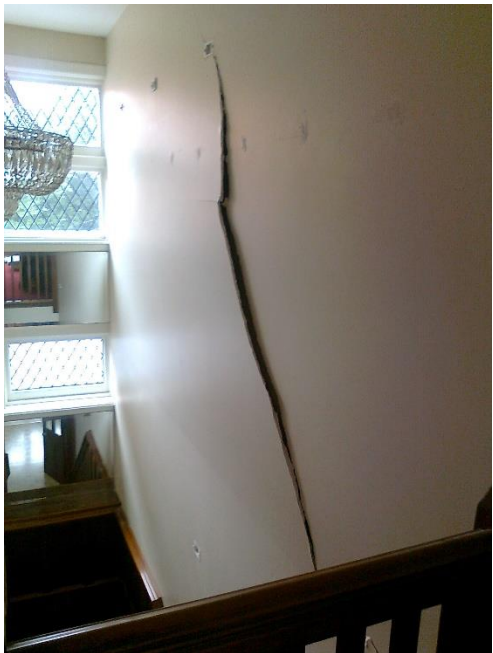
133.	Failure of wall finishes to middle Stairwell

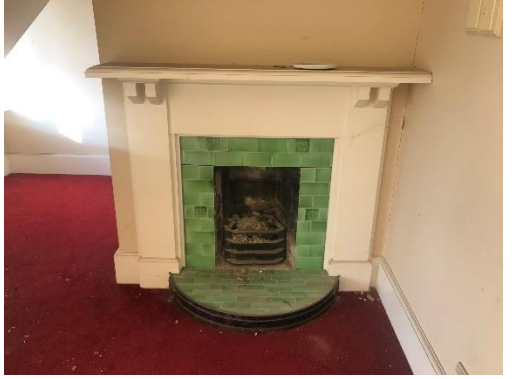
137.	Cracks in fireplace surround and wall finishes to Bed 4

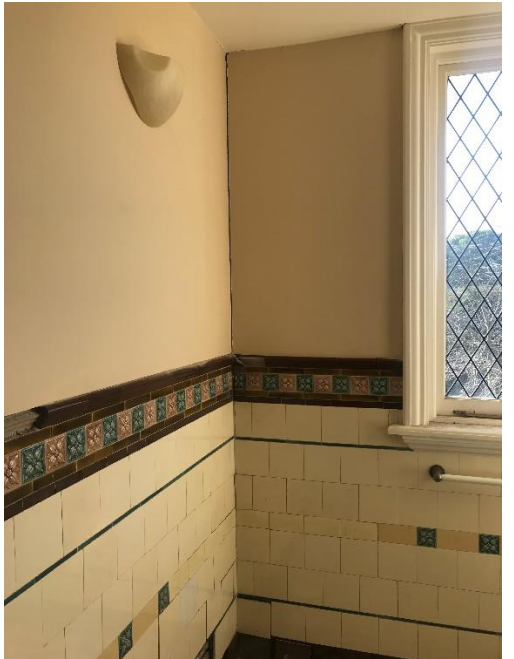
146.	Bath 3 large movement gap in wall finishes at north-east corner

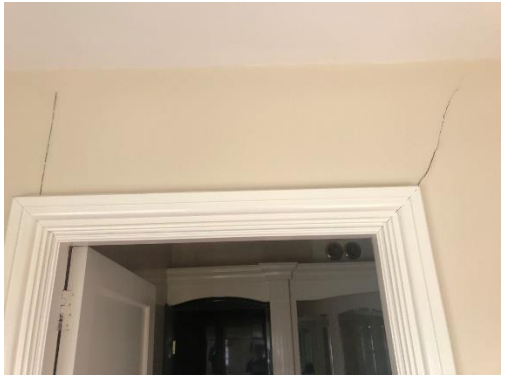
161.	Bed 1 extensive and severe cracking damage to wall and ceiling finishes

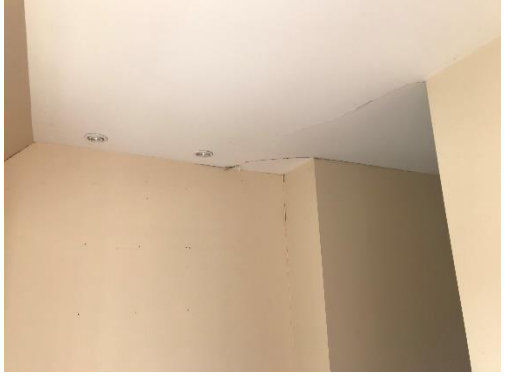
162.	Bed 1 extensive and severe cracking damage to wall and ceiling finishes

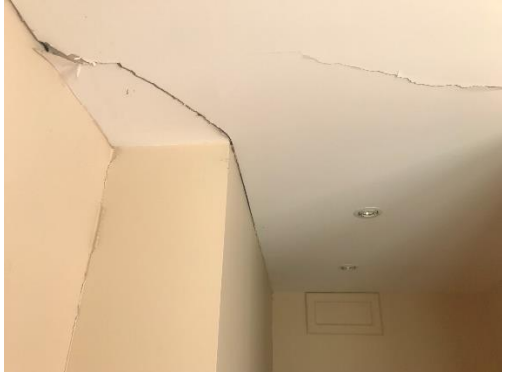
164.	Bed 1 extensive and severe cracking damage to wall and ceiling finishes

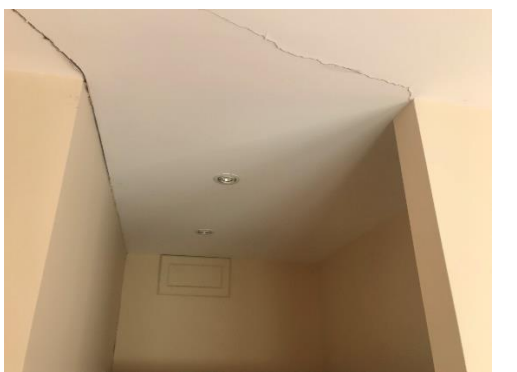
165.	Bed 1 extensive and severe cracking damage to wall and ceiling finishes

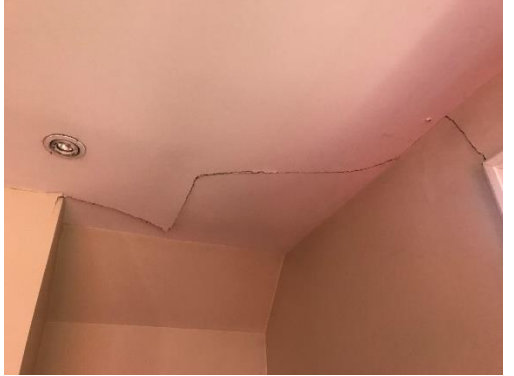
169.	Bed 1 extensive and severe cracking damage to wall and ceiling finishes

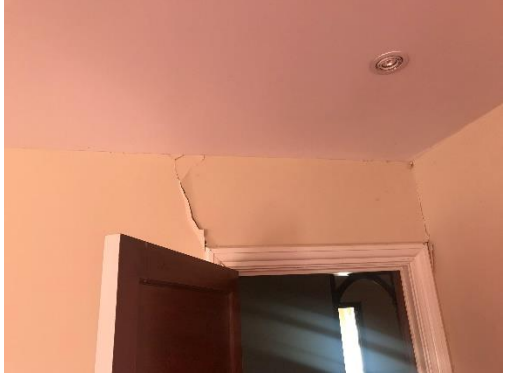
170.	Bed 1 extensive and severe cracking damage to wall and ceiling finishes

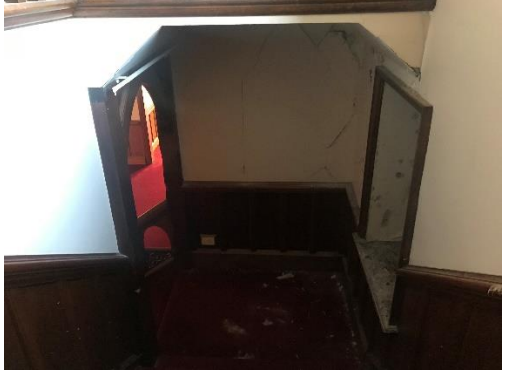
171.	Extensive cracks in wall finishes to main north Stairwell

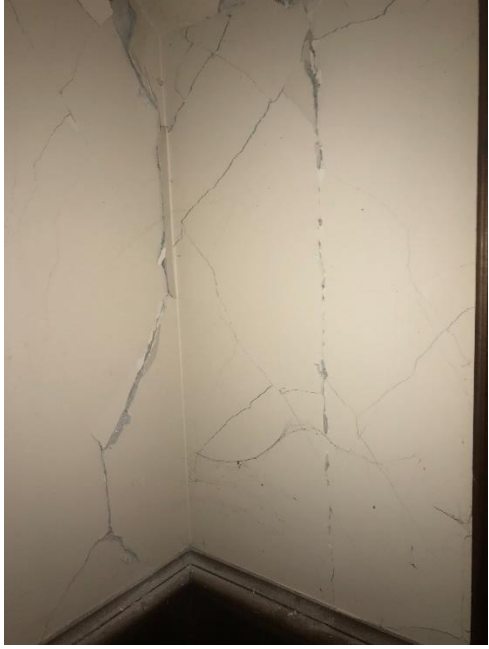
172.	Extensive cracks in wall finishes to main north Stairwell

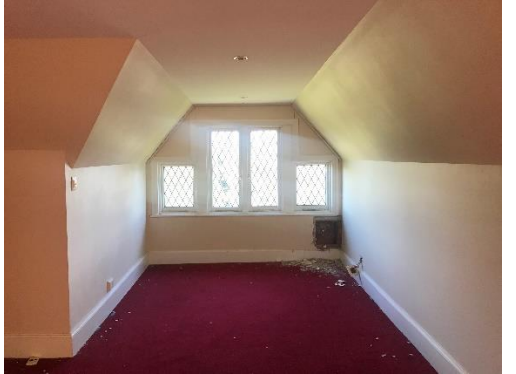
176.	Cracks in wall finishes to Bed 8

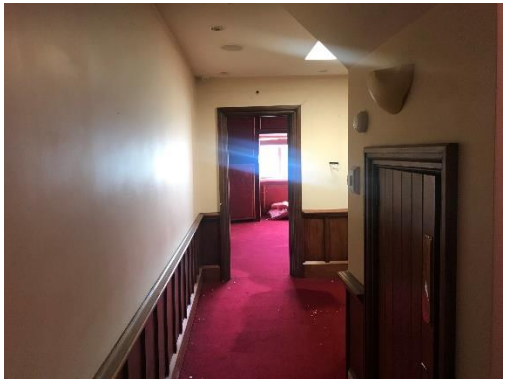
177.	Cracks in wall finishes to Second Level Hall

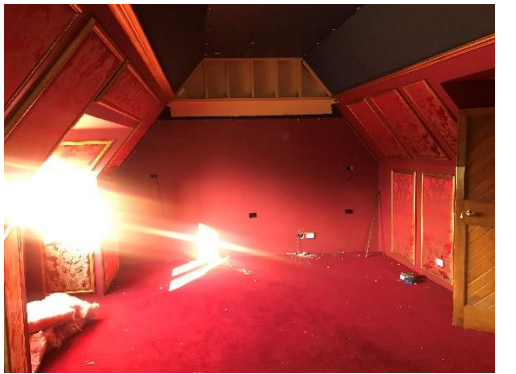
179.	General view of Entertainment Room looking south, including cracks and movement gaps to wall/ceiling finishes
