UNDER the Resource Management Act 1991
IN THE MATTER of proposed Plan Change 14: Housing and Business
Choice to the Christchurch District Plan
AND
IN THE MATTER of Cambridge 137 Limited (Submitter 1092)

**STATEMENT OF EVIDENCE OF JOHN BROWN ON BEHALF OF
CAMBRIDGE 137 LIMITED**

QUALIFYING MATTER: HERITAGE (HERITAGE SITES)

20 September 2023

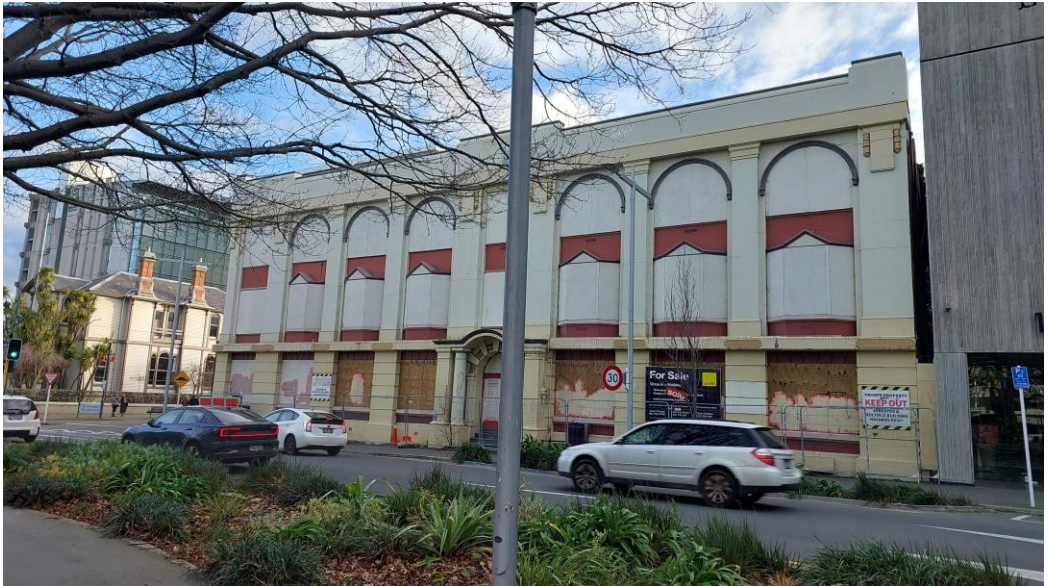
Comparison of pre- and post- earthquake façade (top 1990) bottom 2023-08-09

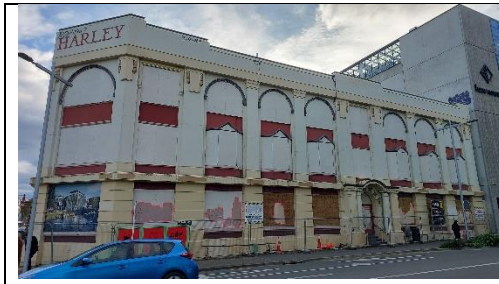
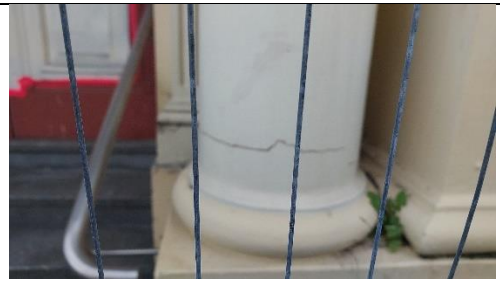
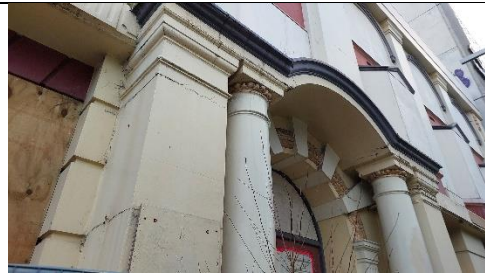
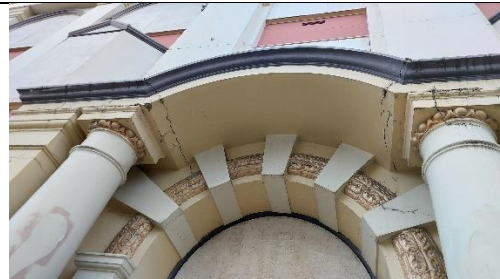
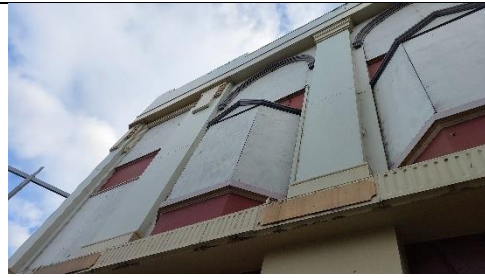
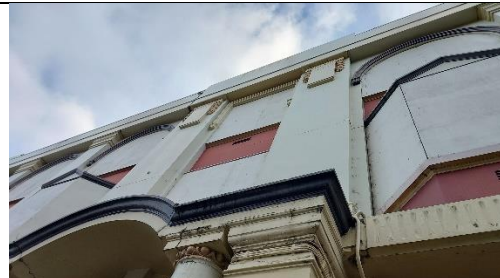
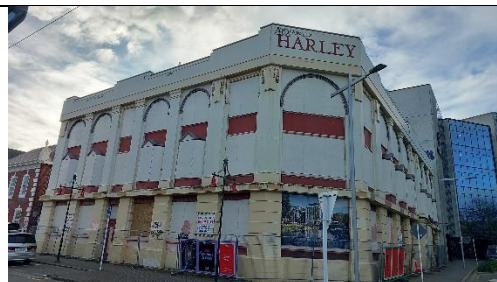
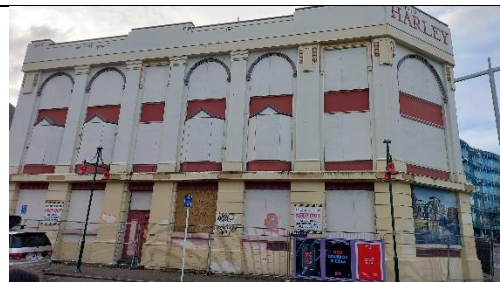
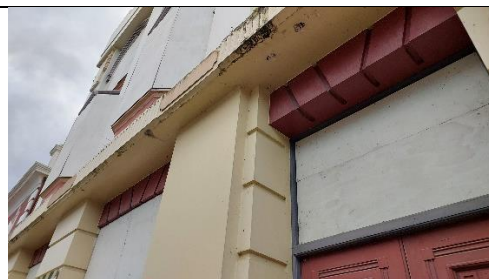
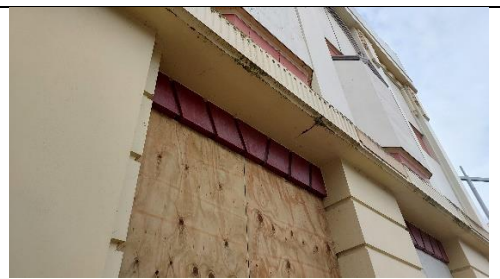
Exterior images 2023-08-09

- (a) Ingress of water through cracks in the walls and ceilings;
- (b) Ingress of water into the basement;
- (c) Possible ongoing settlement suggested by the nature of some cracking (i.e., indicating building movement in particular directions);
- (d) Generally cracks in the plaster and concrete;
- (e) Vandalism from unauthorised parties;
- (f) Fire damage in one location;
