STATEMENT OF PRIMARY EVIDENCE OF ANDREW JAMES HURLEY ON BEHALF OF THE GLENARA FAMILY TRUST (Submitter 91 / Further Submitter 2070)

QUALIFYING MATTER - SPECIFIC PURPOSE OTAKARO AVON RIVER CORRIDOR ZONE

ALTERNATIVE ZONING PROVISIONS FOR PRE-EXISTING RESIDENTIAL ACTIVITIES IN THE ŌTĀKARO AVON RIVER CORRIDOR ZONE

This geotechnical report evaluates the ground conditions, assesses the geotechnical hazards and recommends a suitable foundation system for the proposed development of 254-256 Fitzgerald Avenue, Richmond, Christchurch. It is intended to be used in support of foundation design and for building and resource consent applications.

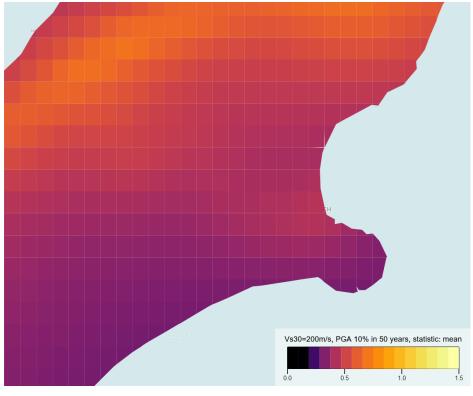
The GNS Science, National Seismic Hazard Model⁵ (NSHM) was updated in 2022 to include the latest available research on frequency and directivity effects from the Alpine Fault (amongst other earthquake sources). Figure 1 shows the estimated PGA, aggregated from all sources, over the central South Island. The region close to the Alpine Fault can be seen to have much higher ground accelerations than Christchurch.

Figure 1 PGA Map from NSHM2022

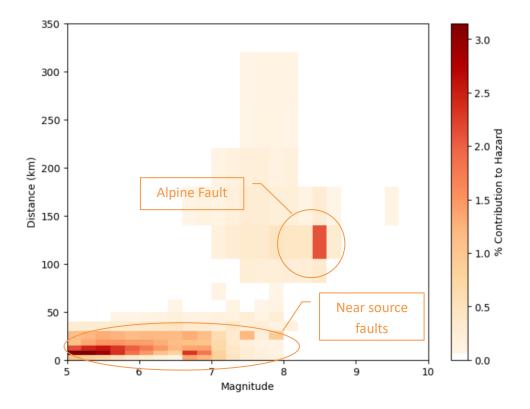
Importantly, the relative contribution of the Alpine Fault can be seen in 'disaggregation plots' (Figure 2). Here the Alpine Fault can be seen to contribute approximately 2% to the Christchurch earthquake hazard, with the highest contribution coming from smaller, nearby faults.

Figure 2 Disaggragation of seismic hazard for Christchurch (source NSHM2022)

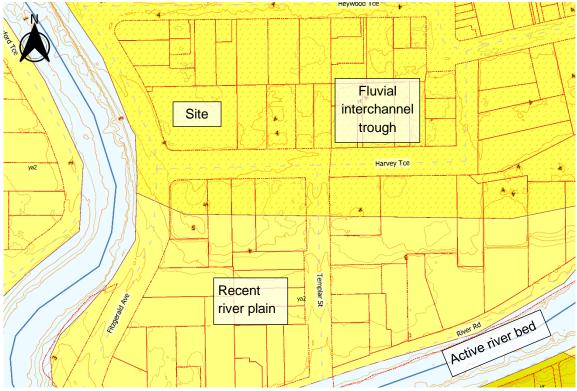
GNS Geological Map 3 (Begg, Jones, & Barrell, 2015) shows the site as being located on a fluvial interchannel trough or flat, part of the Yaldhurst member of the Springston Formation with a surface geology typically of alluvial sand and silt and an estimated maximum age of 3,000 years. To the south of Harvey Terrace is a 'recent river plain' with an estimated maximum age of 500 years.

Figure 2-1 Geomorphic map data (ref GNS Geological Map 3)

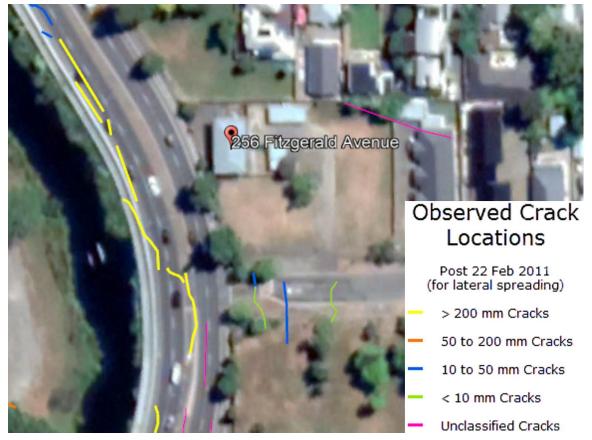
Ground cracks as recorded by consultants for EQC (EQC, 2012) are shown running along the river side of Fitzgerald Ave and out to the median strip opposite Harvey Terrace (Figure 4-1) Some relatively minor cracks (green are under 10 mm and blue are under 50 mm) are seen along Harvey Terrace adjacent to the site.

Only one crack is recorded on the site itself, an 'unclassified crack crossing the north-east edge of the site. Unclassified cracks are generally minor in nature and the orientation of this crack is not consistent with lateral spread.

Figure 4-1 Ground cracks as recorded for EQC (from NZGD)

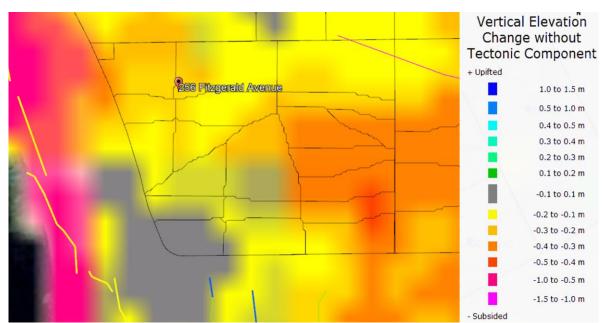
Settlements (as estimated from LiDAR) were variable across the site with the least settlement seen in the south west corner and the most on the east side where up to 0.5 m is indicated (Figure 4-2). The settlement associated with slope failure along the river edge is seen in pink to the left of this image.

Figure 4-2 Liquefaction settlements - all events

Interpretation of LiDAR surveys (EQC, 2012) suggests a total vertical elevation change of 0.4 m at the site with 0.16 m estimated as movement of the bedrock. The liquefaction induced settlement is thus 0.24 m over all of the main earthquake events.

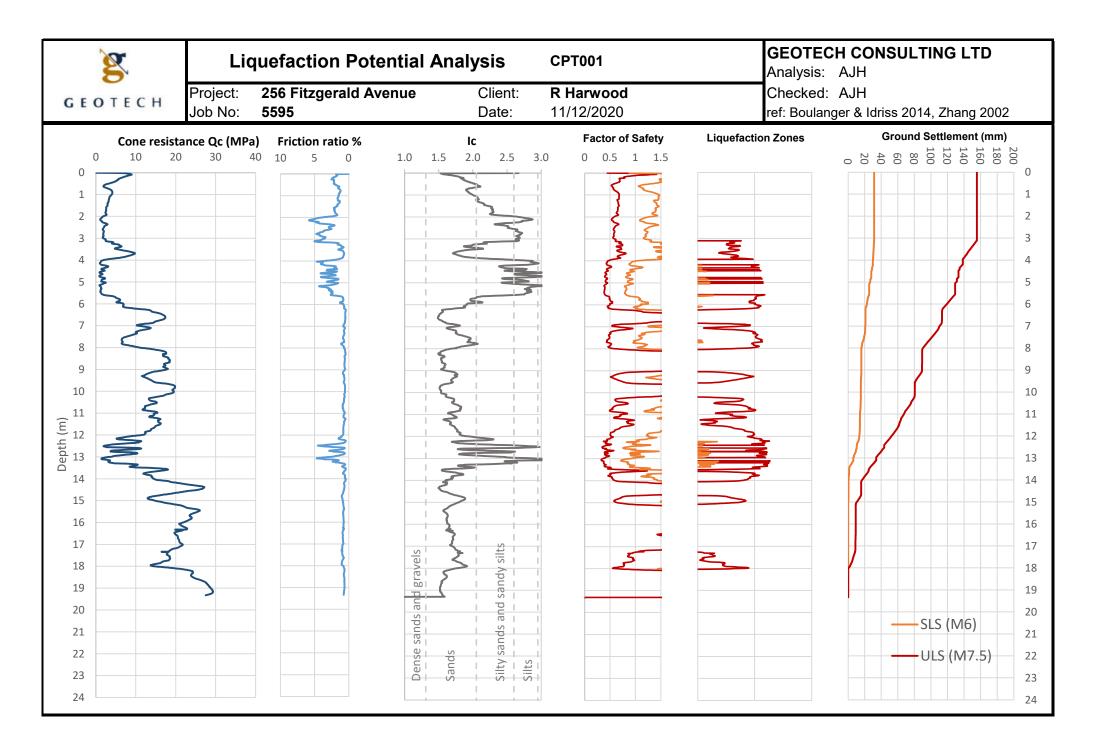
8	Liquefaction Potential Anal	ysis	CPT001		GEOTECH CONS Analysis: AJH	SULTING LTD		
GEOTECH	Project: 256 Fitzgerald Avenue	Client:	R Harwood		Checked: AJH			
	Job No: 5595	Date:	11/12/2020		ref: Boulanger & Idriss 2014, Zhang 2002			
Input Parameters	Groundwater depth = 3	m						
	Soil density $\gamma = 17$	kN/m ³						
	Fines fitting parameter $C_{fc} = 0$							
	Probability of Liquefaction = 0.15	(0.15 is sta	andard determ	ninistic model)				
	sigma(InR) = 0.2	,		,				
		ULS	at M7.5	SLS at M7.5	SLS at M6	22 Feb 2011		
	Seismic Load Cases	-	se 1	Case 2	Case 3	Case 4		
	Peak Ground Acceleration (PGA) =	0.	.35	0.13	0.19	0.45		
	Magnitude M =		.50	7.50	6.00	6.20		
	representative M =	6	.80	7.50	6.00	6.20		
	Summary Results							
	Overall settlement (Zhang) (mm):	1	55	20	31	149		
	Total liquefiable thickness (m):		.31	0.33	1.1	7.70		
	Settlement in top 10m (mm):		75	8	16	74		
	Liquefiable thickness in top 10m (m):		.62	0.00	0.47	3.56

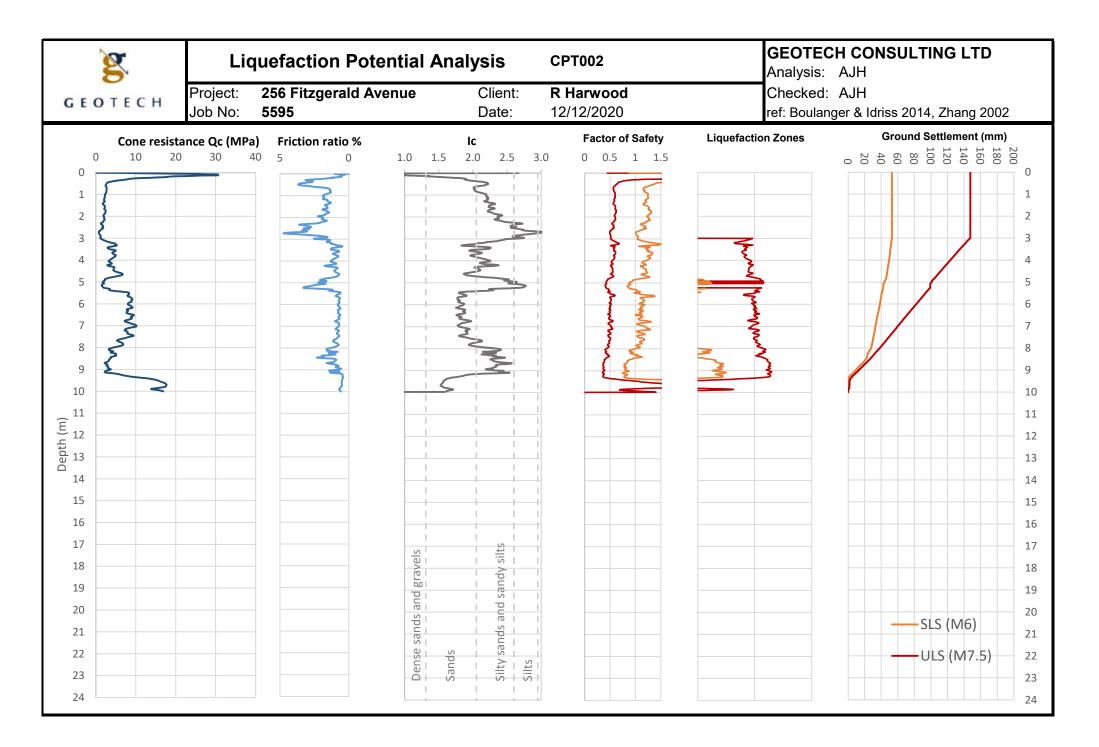
8	Liquefaction Potential Anal	ysis CPT002		GEOTECH CONSU Analysis: AJH	ILTING LTD		
GEOTECH	Project: 256 Fitzgerald Avenue	Client: R Harwo		Checked: AJH			
	Job No: <b>5595</b>	Date: 12/12/20	20	ref: Boulanger & Idriss 2014, Zhang 2002			
nput Parameters	Groundwater depth = 3	m					
	Soil density $\gamma = 17$	kN/m ³					
	Fines fitting parameter $C_{fc} = 0$						
	Probability of Liquefaction = 0.15	(0.15 is standard de	terministic model)				
	sigma(InR) = 0.2		-				
	Seismic Load Cases	Case 1 ULS at M7.5	Case 2 SLS at M7.5	Case 3 SLS at M6	Case 4 22 Feb 2011		
		ULS at M7.5	SLS at M7.5	SLS at M6	22 Feb 2011		
	Peak Ground Acceleration (PGA) =		0.13	0.19	0.45		
	Magnitude M =		7.50	6.00	6.20		
	representative M =	6.80	7.50	6.00	6.20		
	Summary Results						
	Overall settlement (Zhang) (mm):	147	27	53	147		
	Total liquefiable thickness (m):	6.33	0.75	1.5	6.29		
	· · · · · · · · · · · · · · · · · · ·			53	147

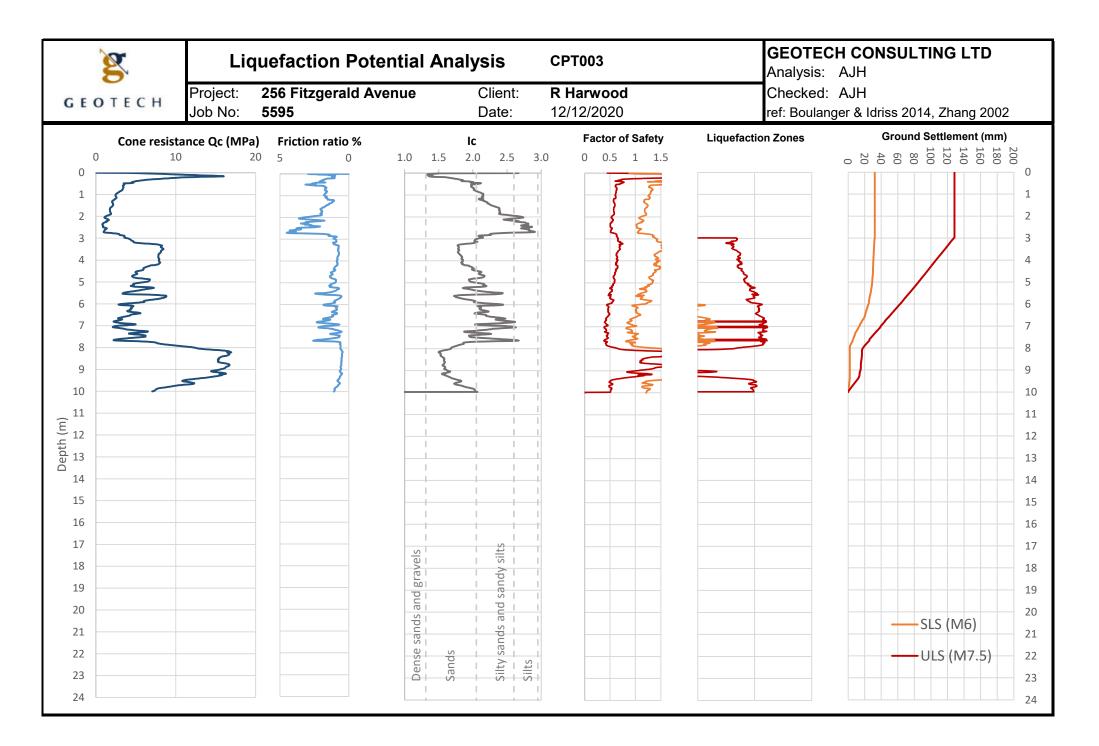
2	Liquefaction Potential Anal	ysis	СРТ003		GEOTECH CONS Analysis: AJH	ULTING LTD	
GEOTECH	Project: 256 Fitzgerald Avenue	Client:	R Harwood		Checked: AJH		
	Job No: <b>5595</b>	Date:	12/12/2020		ref: Boulanger & Idriss 2014, Zhang 2002		
Input Parameters	Groundwater depth = 3	m

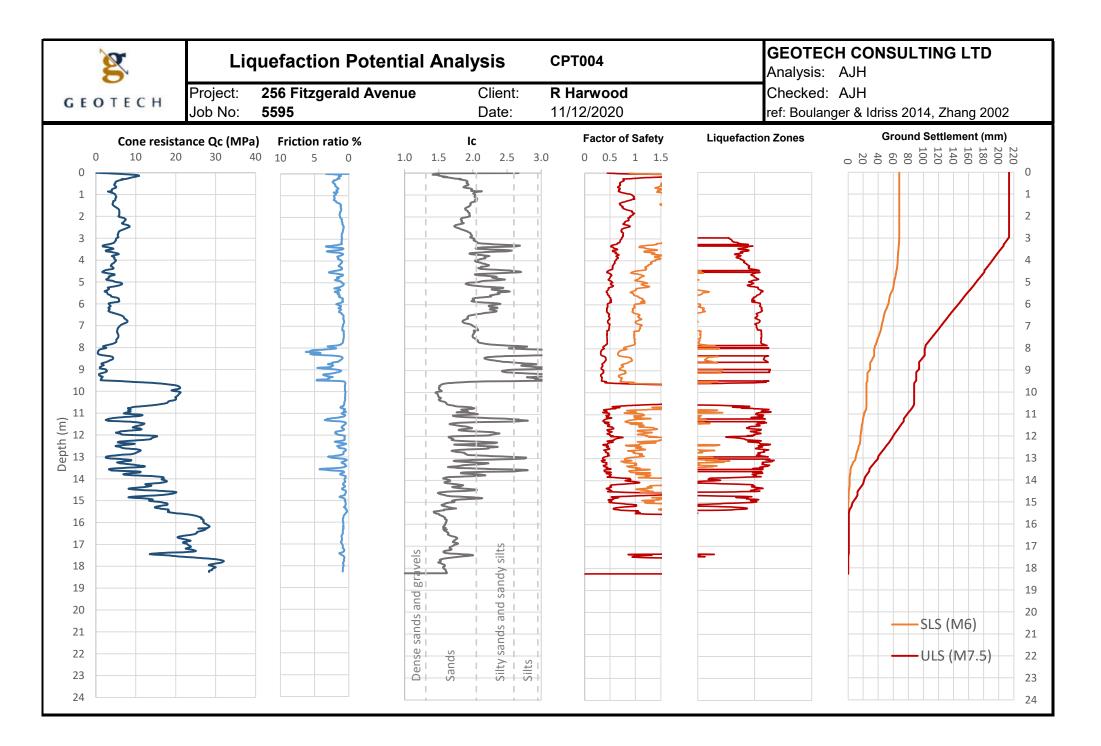
8	Liquefaction Potential Anal	ysis CPT	004	GEOTECH CONSU Analysis: AJH	ILTING LTD		
GEOTECH	Project: 256 Fitzgerald Avenue	Client: R Ha	rwood	Checked: AJH ref: Boulanger & Idriss 2014, Zhang 2002			
	Job No: <b>5595</b>	Date: 11/12	2/2020				
nput Parameters	Groundwater depth = 3	m
