Cashmere View Somerfield Area 'CSA'
Heritage and Character Assessment

Report April 2023

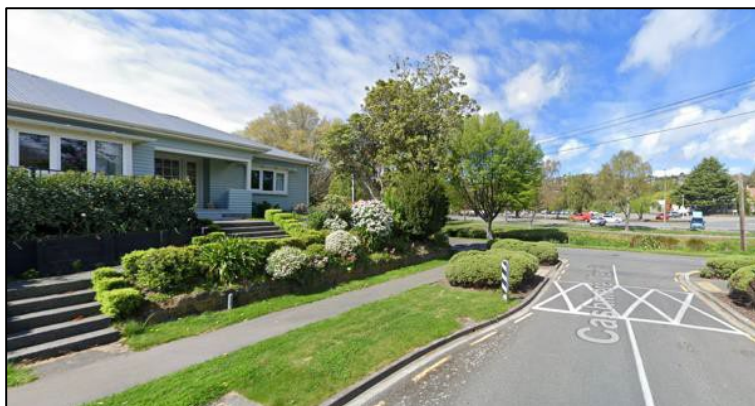
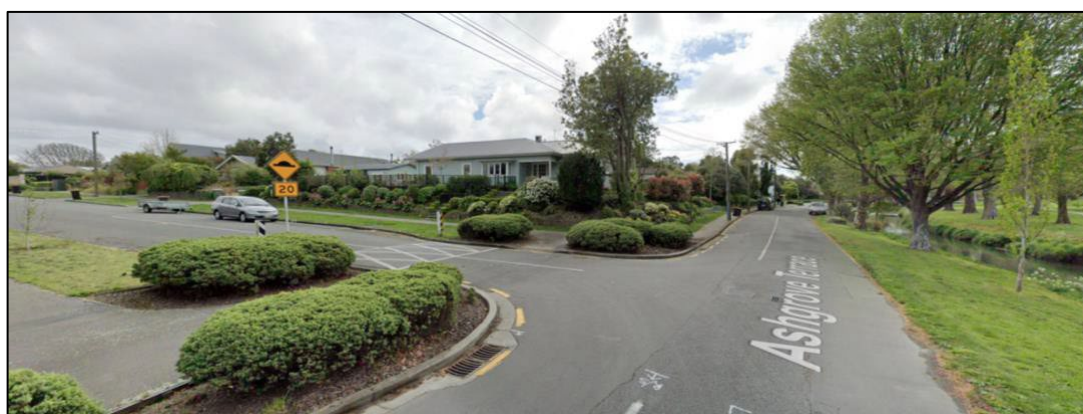
Setback from Street

Homes located within the area have a range of building setbacks from 4 – 20m apprx. Those on Cashmere View and Ashgrove Terrace have wider setbacks the setbacks seem to increase the closer to the Heathcote River the property is. Properties containing older housing stock average approximately 5 - 8m apprx. There is consistency along the streets.

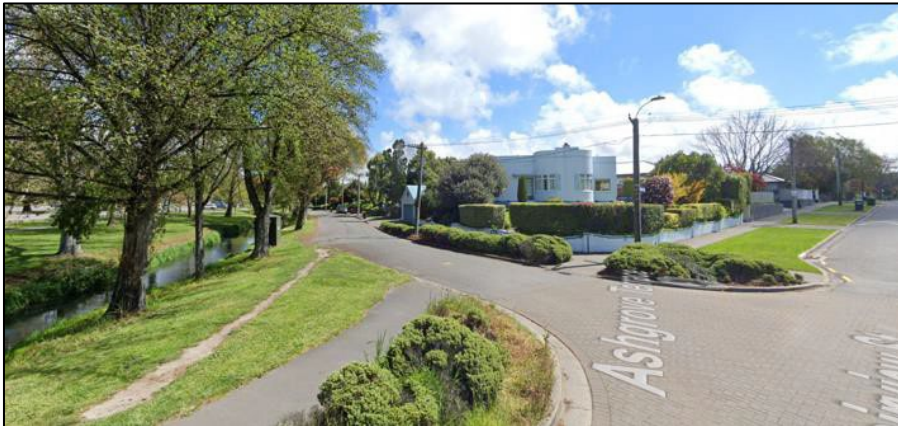
113 Ashgrove Terrace

- Wide Berms and set back
- Established Landscaping and Treescapes
- Excellent Art Deco Example
- Art Deco Detailing Retained and Renovated
- Heathcote Rivers Edge
- Home Architecturally Responds to Corner Site with set back and scale

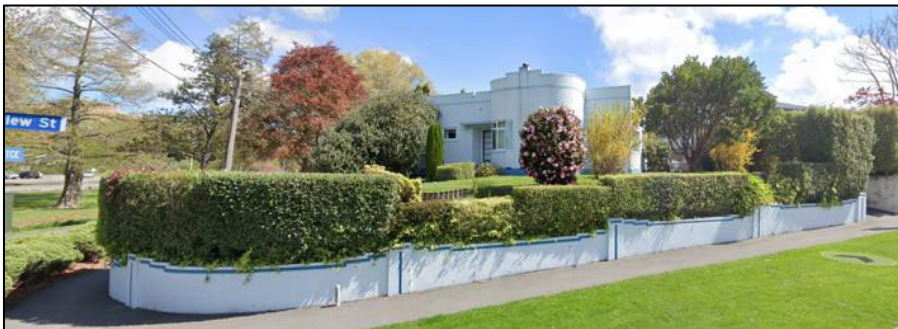
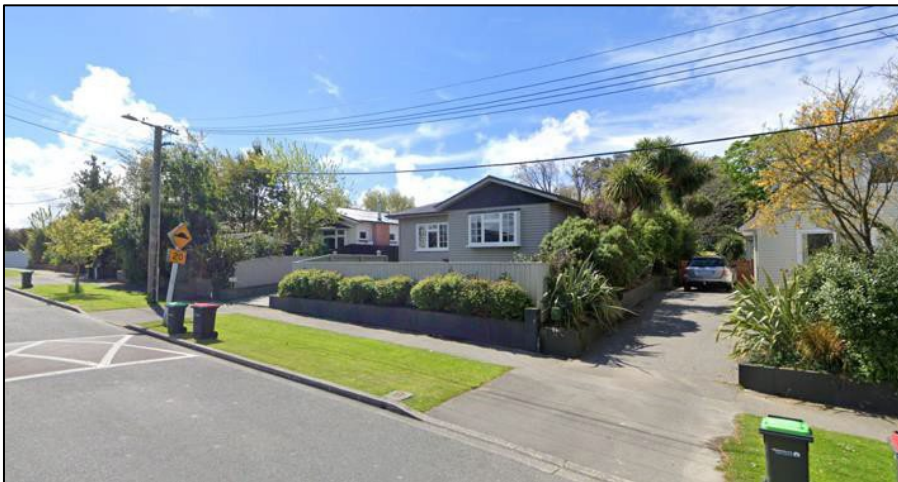
10 Fairview Street

- Wide Berms
- Established Landscaping
- Historical Complimentary Renovation
- Low Boundary Fences Unobstructed Views to and from House to Street
- Bungalow Architectural Detailing

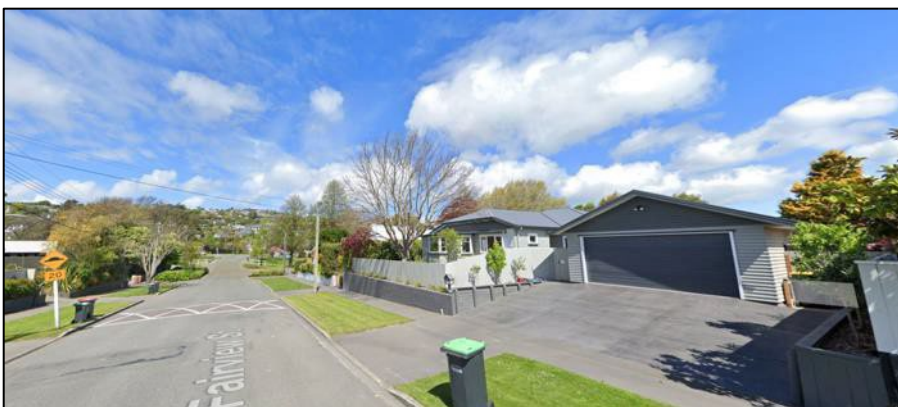
7 Fairview Street

- Wide Berms
- Historical Complimentary Renovation
- Low Boundary Fences Unobstructed Views to and from House to Street
- Bungalow Architectural Detailing
- Scale and Proportion of Bungalow Windows and Entrances leads to consistency along the street

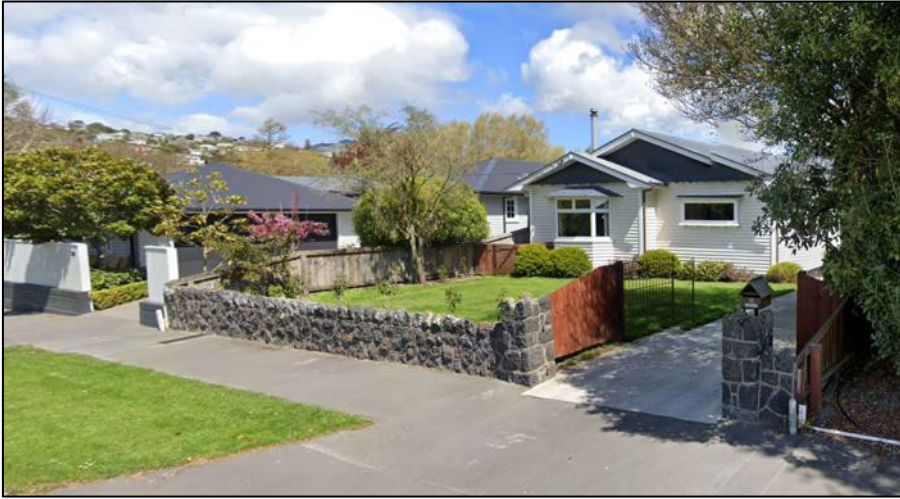
15 Fairview Street

- Original Low Volcanic Stone Boundary Fence
- Renovated Early 20th Century Bungalow
- Size form and scale of these Bungalow homes adds to the richness in neighborhood character.
- Wide grassed berm area

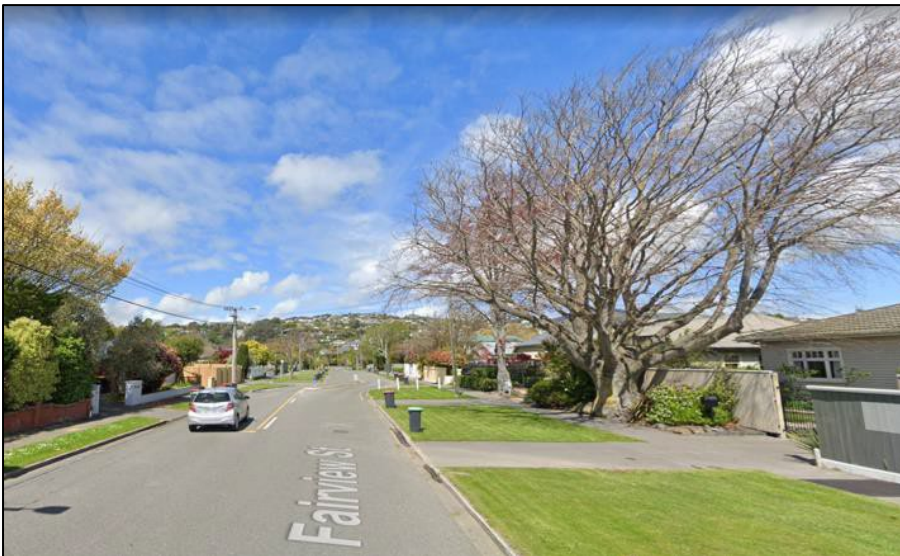
Fairview Street Scape

- Mature Trees planted during original sub division 1925 - 1935
- Wide grassed berm areas
- Majority Single Story Bungalows with weatherboard cladding

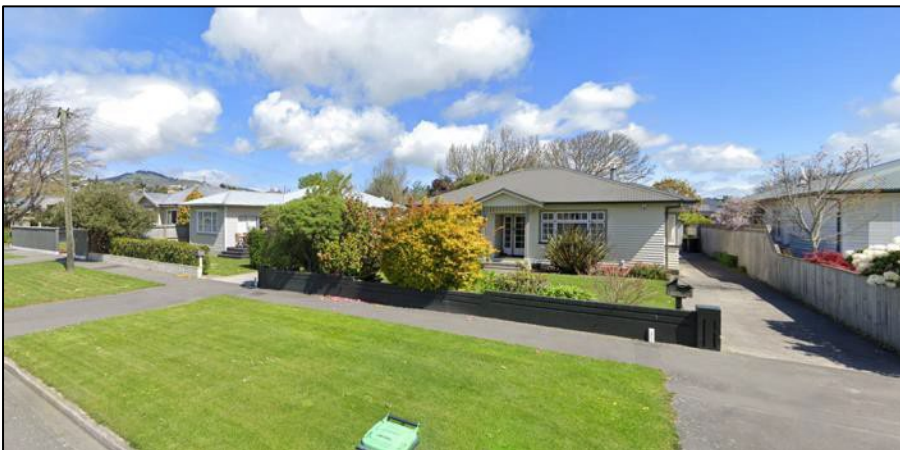
37 Fairview Street

- Alternative Layout Bungalow Later 1930s
- Established Landscaping and Treescapes
- Single Story Bungalow Detailing
- Unobstructed views to street and low boundary fence

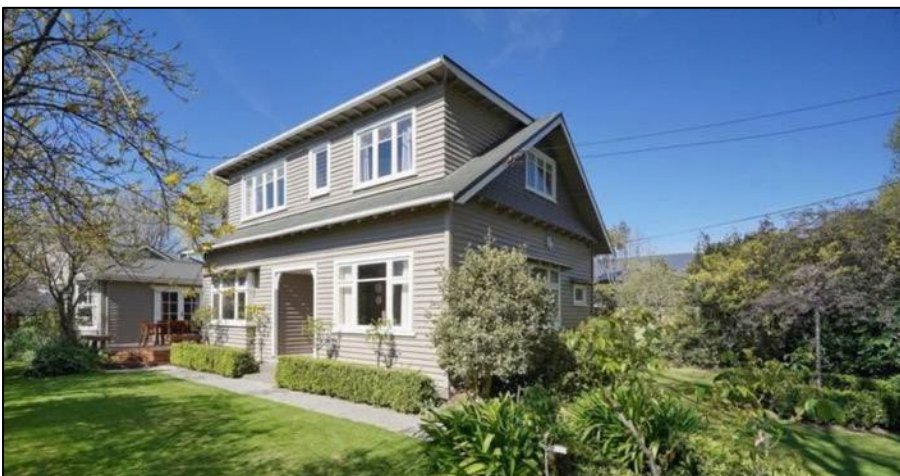
112 Rose Street

- Alternative Layout Bungalow Later 1930s Distinctive Detailing
- 2nd Story Renovation Likely Mid Century
- Bungalow Detailing
- Established Garden

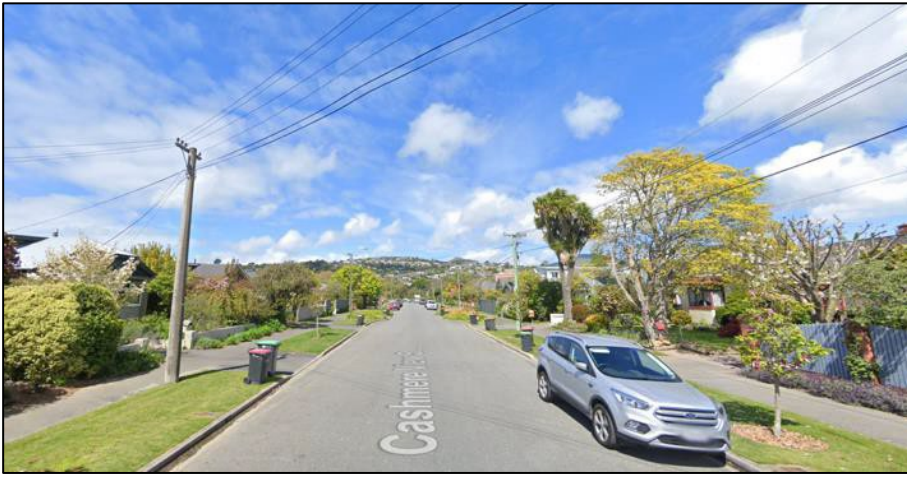
Cashmere View Street Scape

- Mature Trees planted during original sub division
- Wide Street and grassed berm areas
- Majority Single Story Bungalows
- Low fences for high visibility and street connection
- Established Gardens

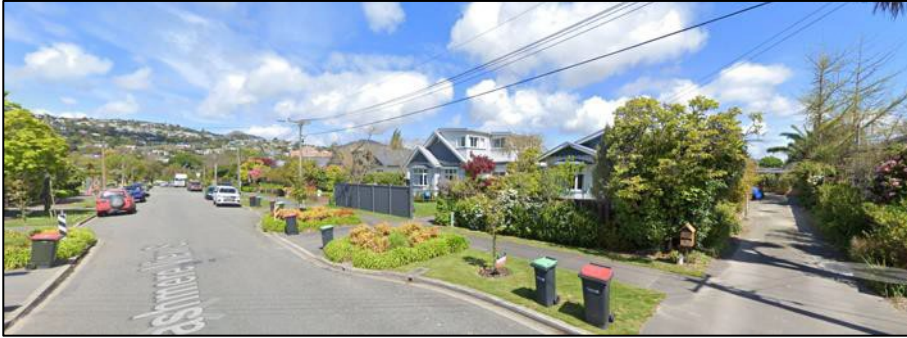
Cashmere View Street Bungalows

- Original Houses Renovated to retain architectural character
- Wide Street and grassed berm areas
- Low fences for high visibility and street connection
- Established Gardens

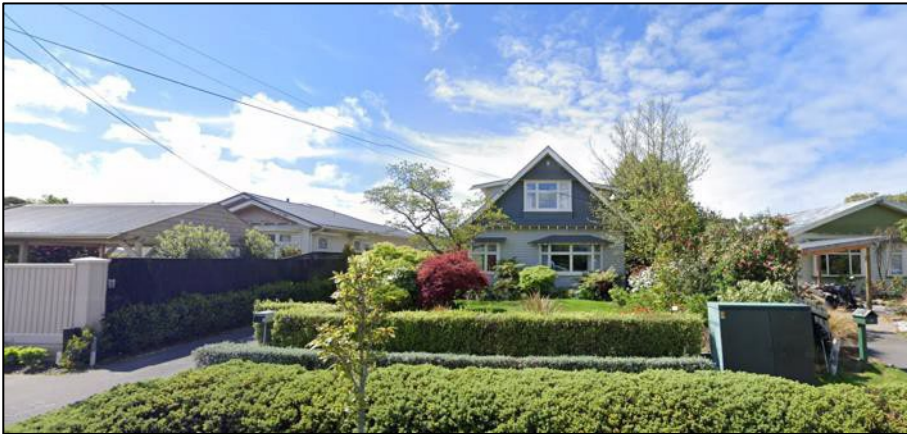
14 Cashmere View Street

- Original Houses Renovated to retain architectural character
- Wide Street and grassed berm areas
- Low fences for high visibility and street connection
- Established Gardens

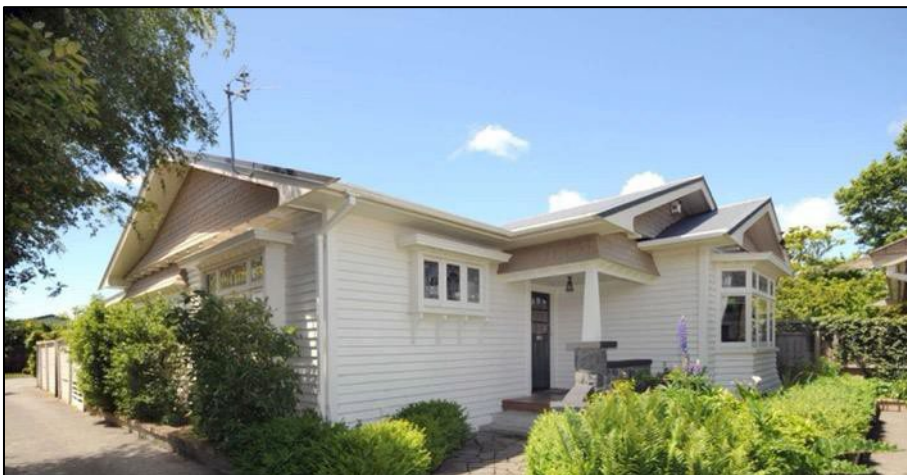
20 Cashmere View Street

- Original Bungalow Renovated to retain architectural character
- Wide Street and grassed berm areas
- Established Garden
- Significant Bungalow Architectural Detailing retained

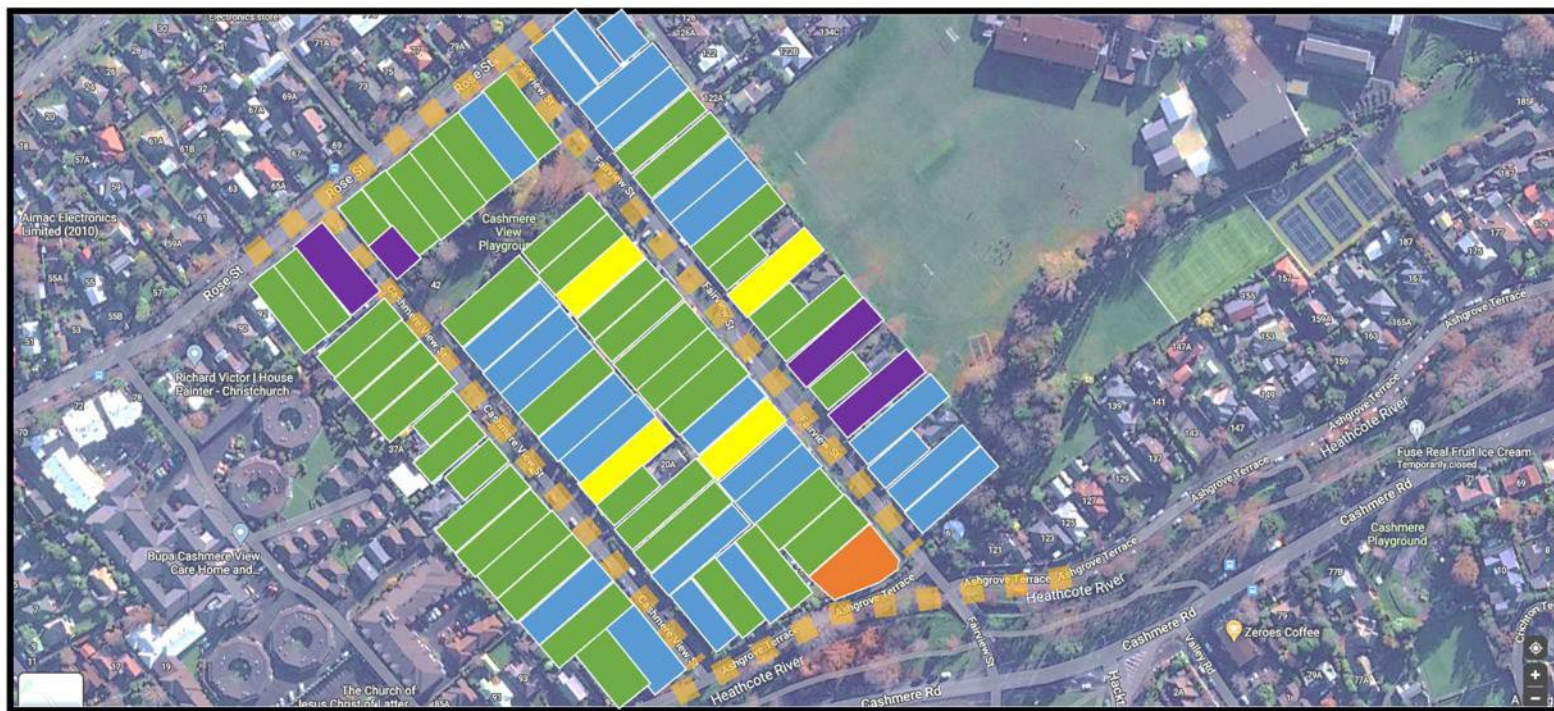
CSA Categorisation of Properties

This map seeks to illustrate the high percentage of heritage value properties that still exist in the CSA area.

- A. 89% of Properties Classic Examples of Bungalow Architecture 1925 – 1945.
- B. Only 5% (or 4 Properties) contemporary homes without any heritage value.
- C. 1 extraordinary example of Art Deco Architecture.
- D. 5% or 4 New builds with Bungalow type classical features fitting in with the neighbourhood.
