**BEFORE INDEPENDENT HEARING COMMISSIONERS
IN CHRISTCHURCH**

IN THE MATTER of the hearing of submissions on Plan Change 14 (Housing
and Business Choice) to the Christchurch District Plan

**STATEMENT OF PRIMARY EVIDENCE OF CLARA CAPONI ON BEHALF OF
CHRISTCHURCH CITY COUNCIL**

HERITAGE ENGINEERING

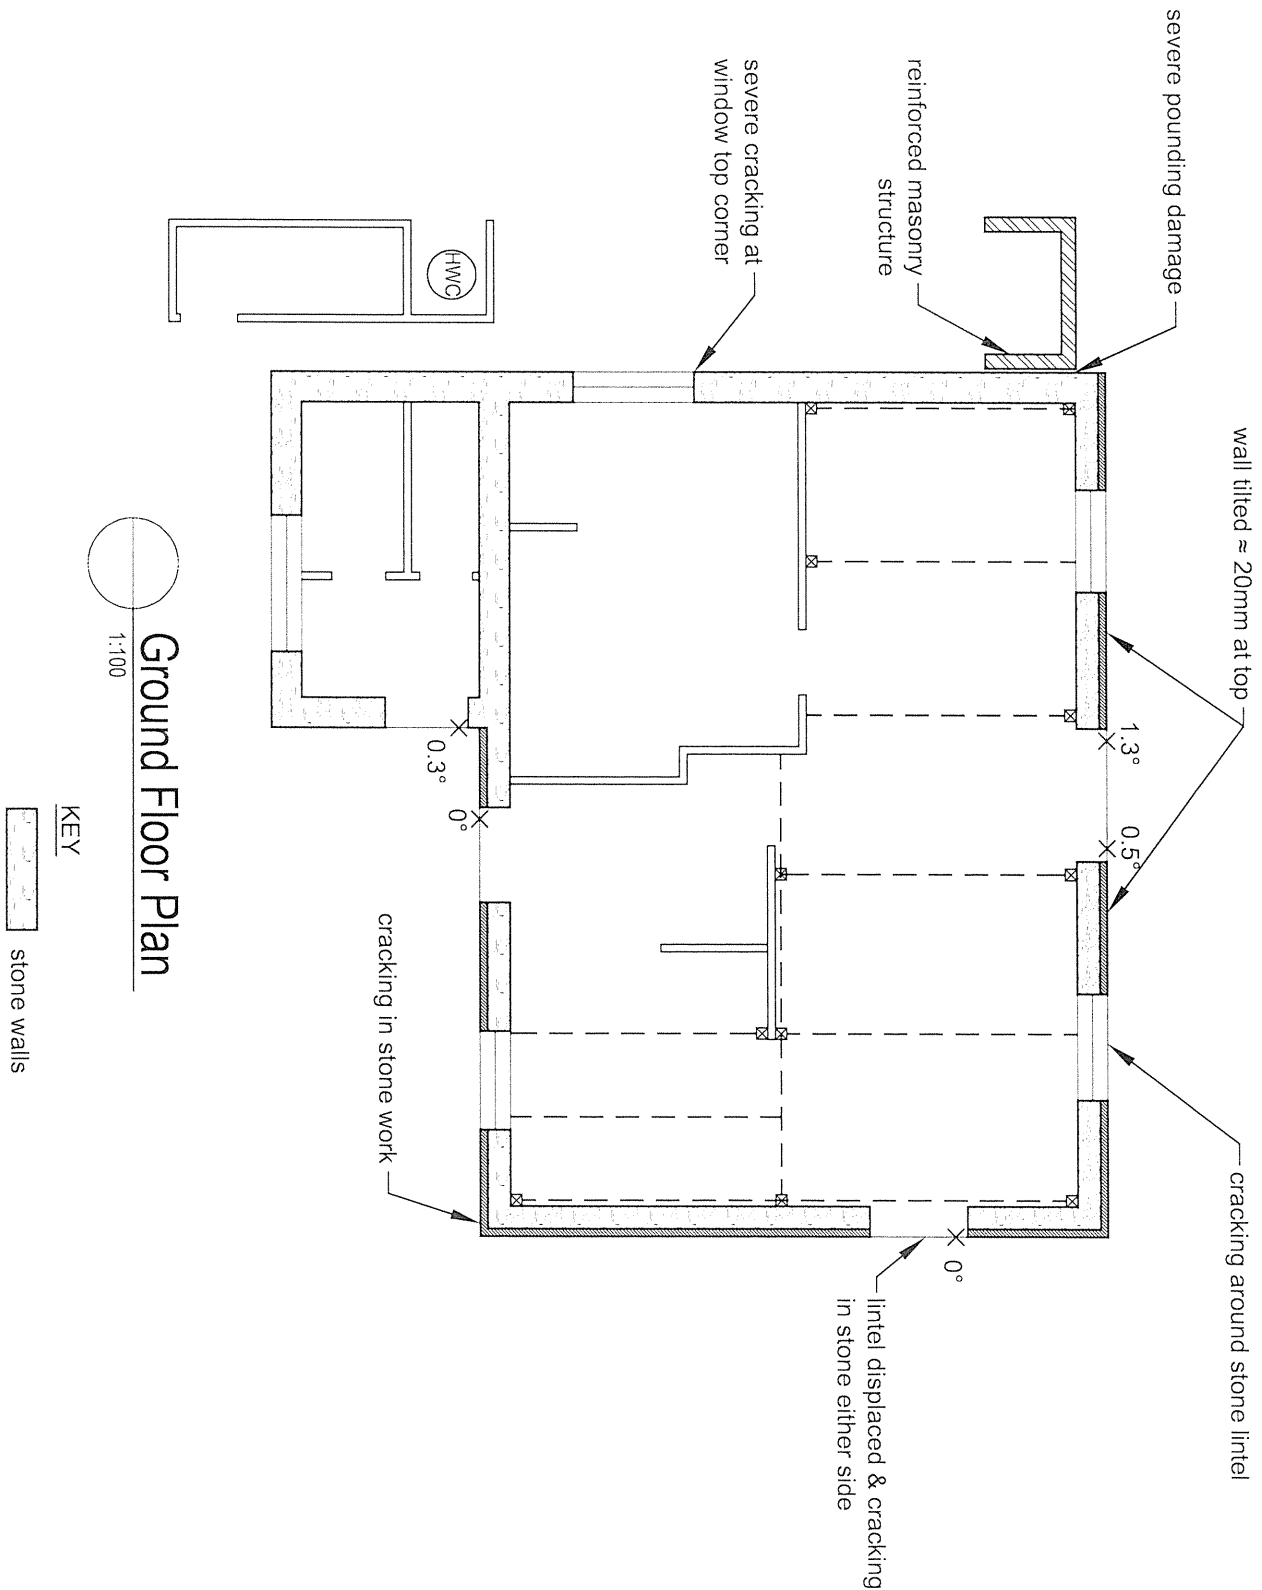
General Comment severe cracking in external stone walls

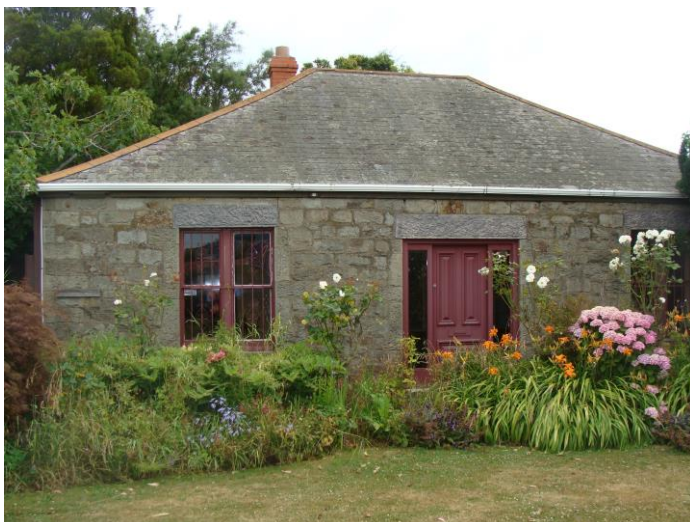
The building is single storey with a slate roof, rubble stone external walls and timber internal walls. The floor of the building appeared to be a concrete slab on grade. The roof is supported on timber trusses and a modern tiled ceiling has been installed. The building is believed to date from 1863 and is one of the last stone workers cottages remaining in Christchurch.

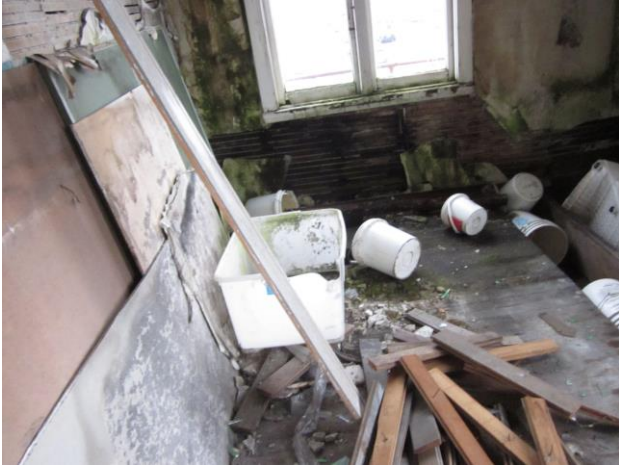
Damaged ceilings, walls/ mould /moisture and weather penetration damage

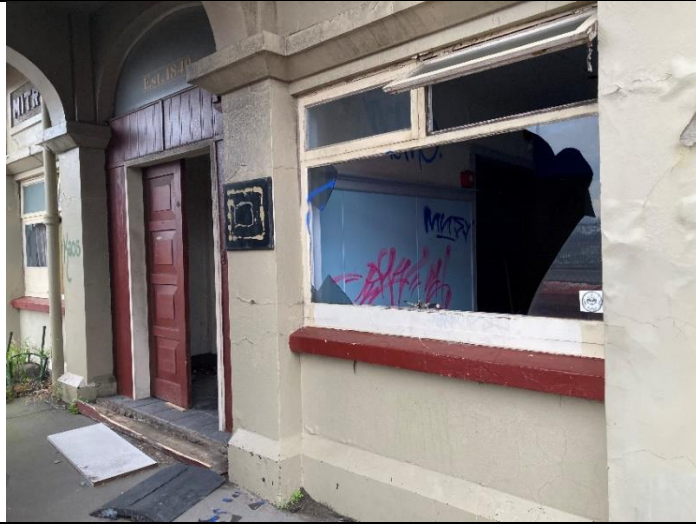
Photo 1 –View from the front (South)

3.5 There is also indication that someone from the outside have assessed the building (broken windows from photo 1, internal graffiti from photo 11 etc.). The timing of entrance is unknown to us. Regardless, I am concerned that these individuals may have been unaware of the hazard in a dilapidated structure and the imminent danger they had put themselves in.

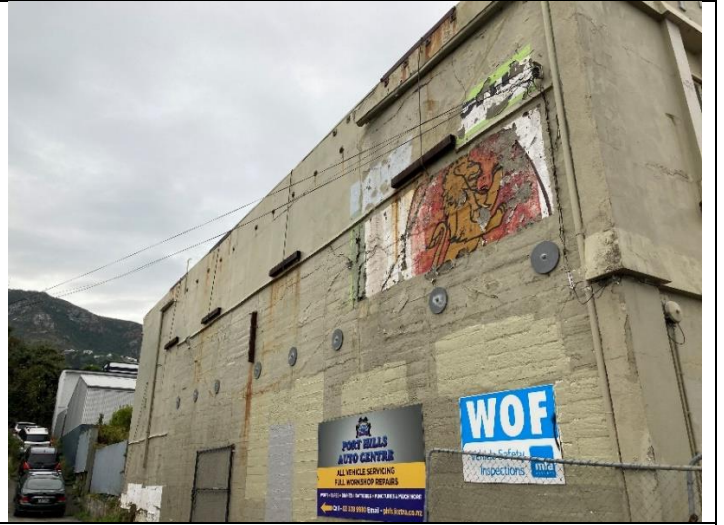
Photo 2 – View from West side wall

3.2. For the Western wall (photos 2, 8 & 9), it would appear there are further spalling and cracking of concrete to the exterior when compared to the photos in the previous 2020 report (section 1). Some of these cracks may have existed previously, being hard-to-notice type micro cracks. Possible reasons for continuing progression of the cracks included on-going vibration from heavy port vehicles using Norwich Quay and continuing aftershocks in the Canterbury region (refer Geonet for events sequences from past 12 months). Progression of cracking indicated this being an overall deteriorating structure, and its ability to stand up will continue to be undermined with each unfavorable event. The building is beside the harbour area so the corrosion risk of the wall reinforcement (now possibly exposed due to the cracks) will increase.

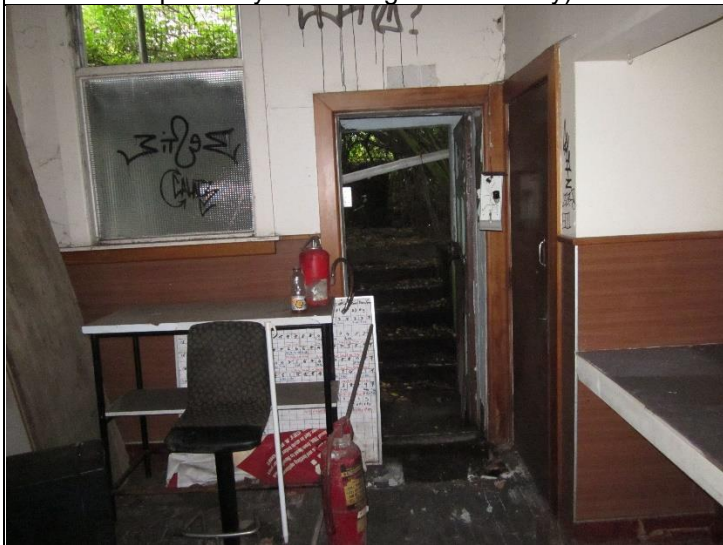
Photo 11 – View from interior. Another access to rear part of the building. It would appear the building had been assessed by others.
