**STATEMENT OF PRIMARY EVIDENCE OF PHILIP NEVILLE GRIFFITHS ON  
BEHALF OF CHRISTCHURCH CITY COUNCIL**

**QUALIFYING MATTER: HERITAGE (HERITAGE SITES)**

**Consent Documentation for  
Remediation of St. James  
Church, Riccarton**

**Report ref:** 213970  
23 April 2013  
Revision 1

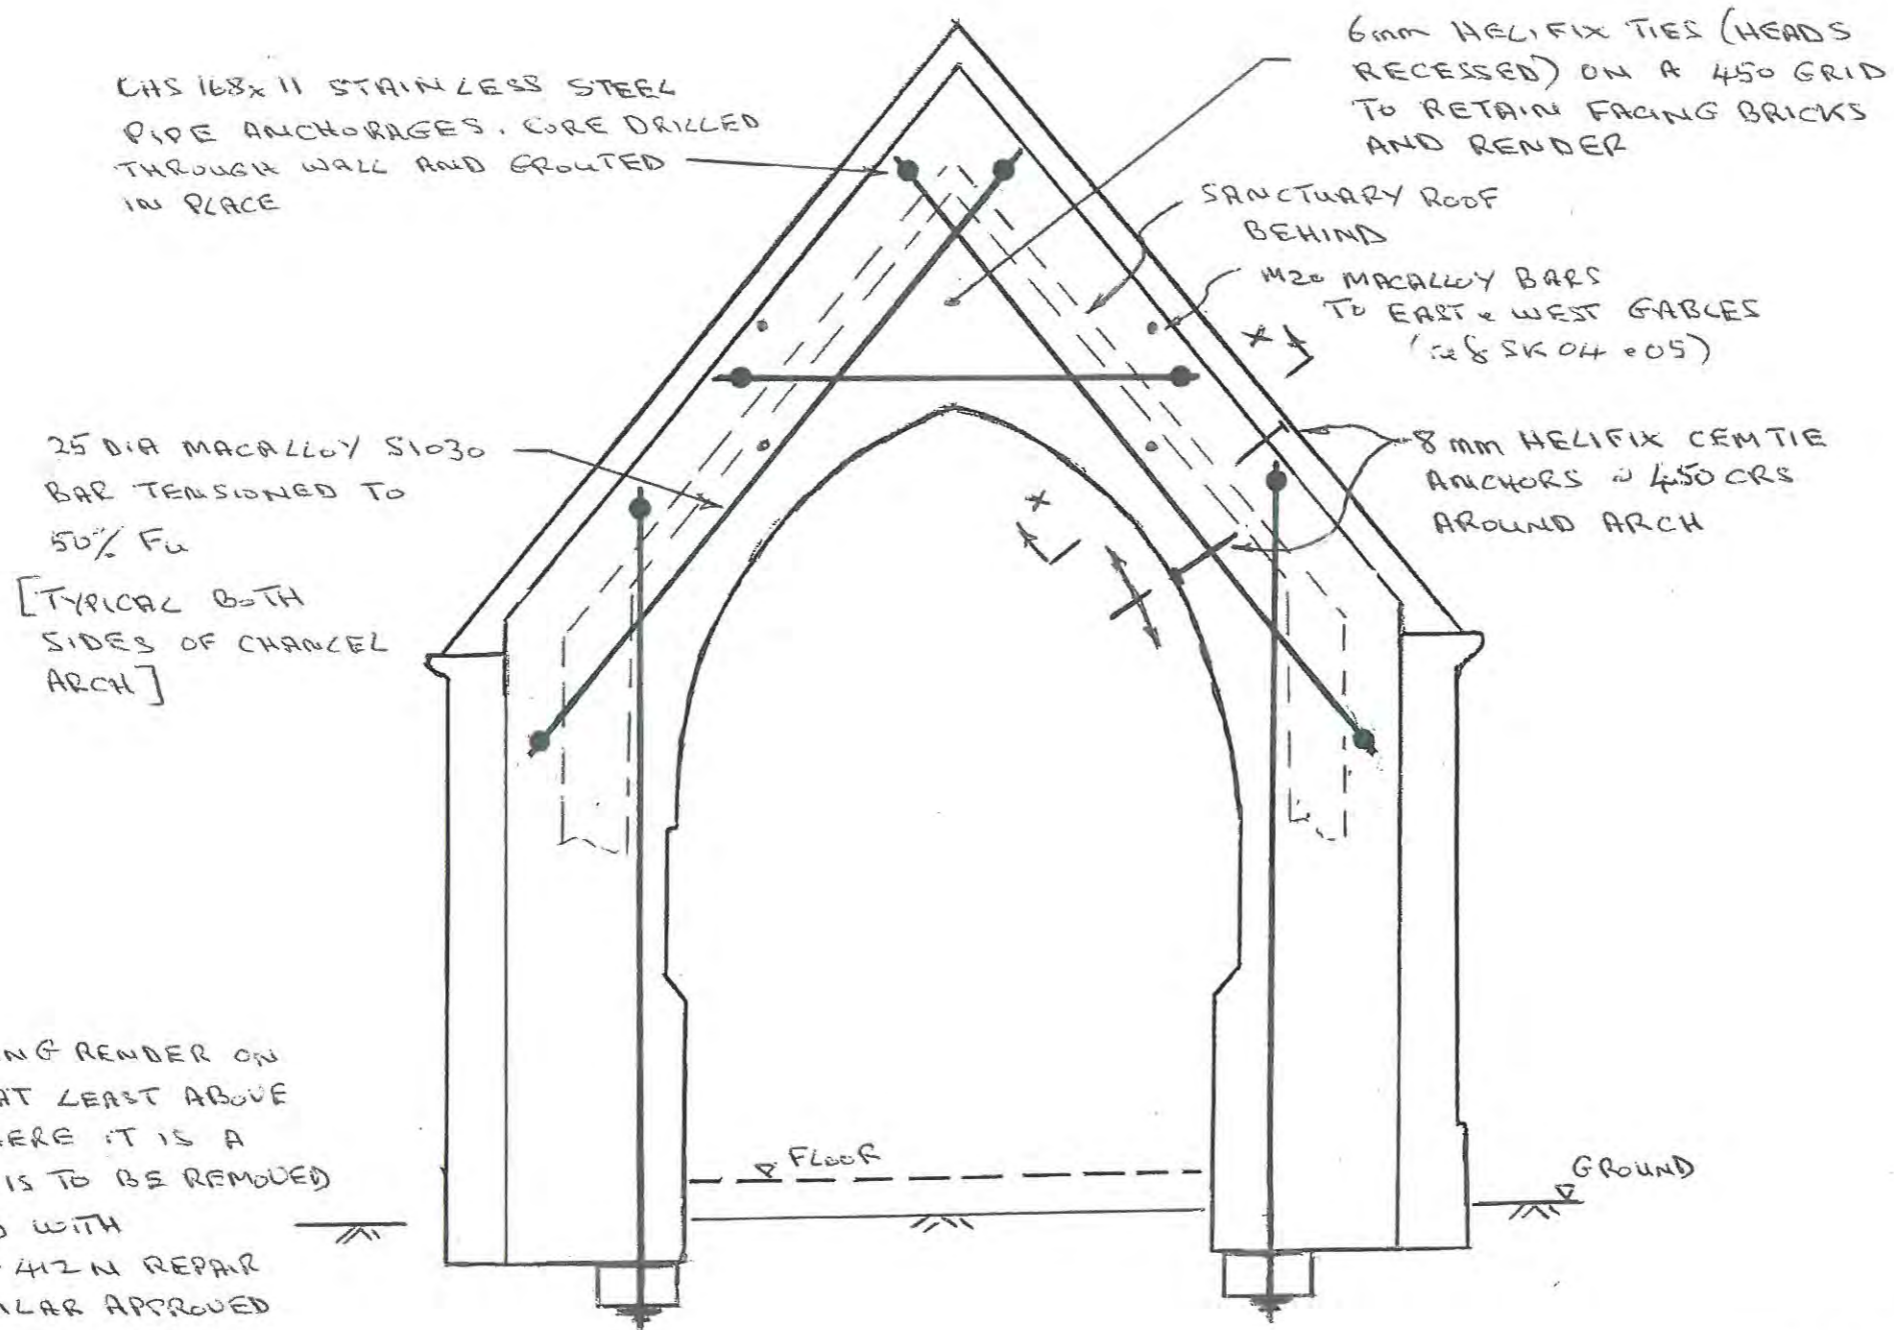
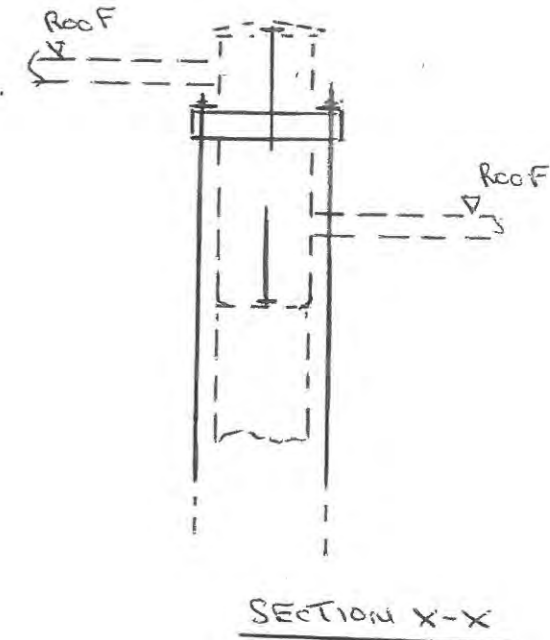
NOTE: ALL EXISTING RENDER ON CHANCEL ARCH, AT LEAST ABOVE EAVE LEVEL WHERE IT IS A FALL HAZARD, IS TO BE REMOVED AND REINSTATED WITH SIKR MONOTOP-412N REPAIR MORTAR OR SIMILAR APPROVED (TYPICAL ALL OPTIONS)

CRACK REMEDIATION IS REQUIRED PRIOR TO OTHER WORK ON THE CHANCEL (REFER TO SCOPE OF WORK ITEM 4)

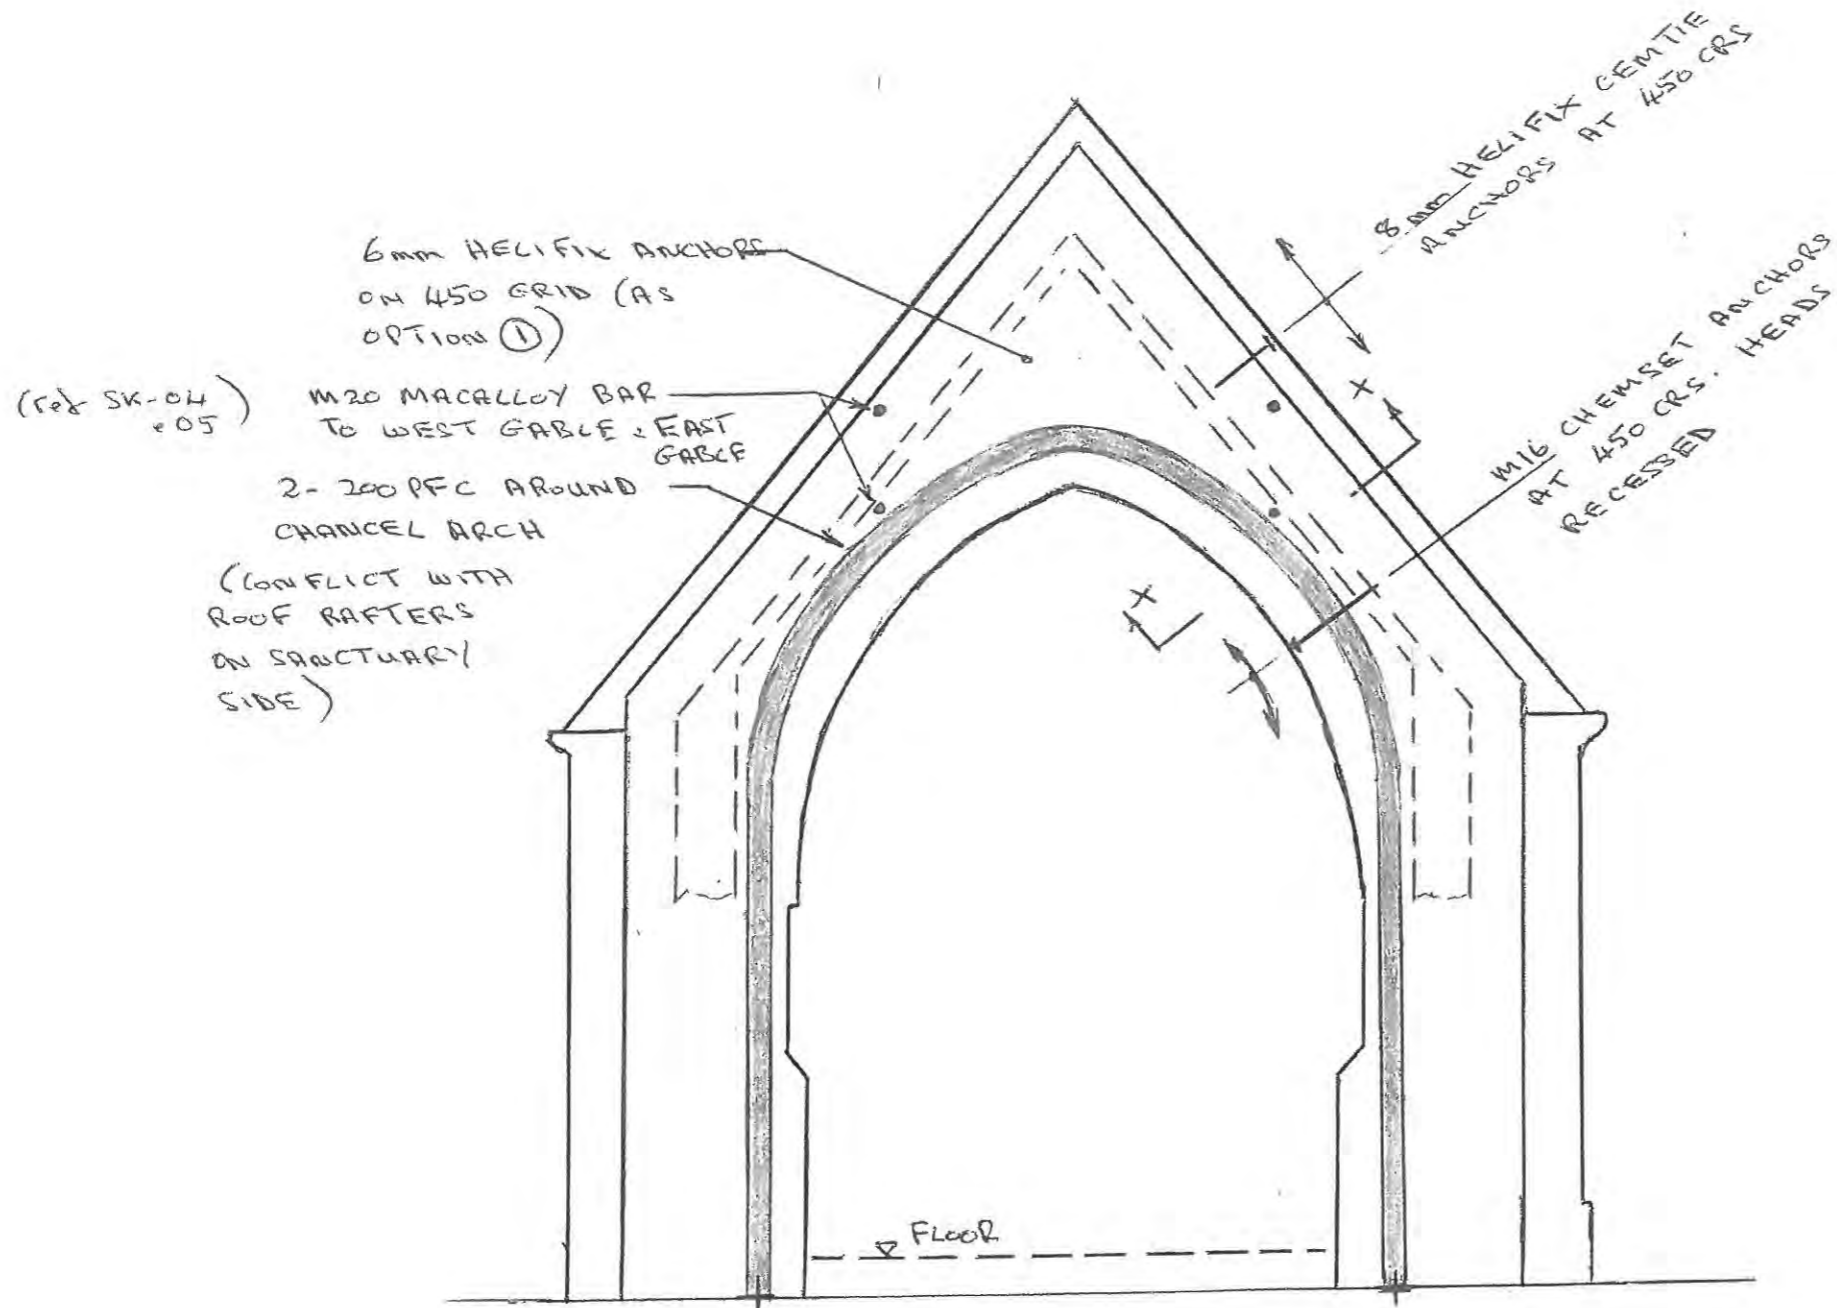
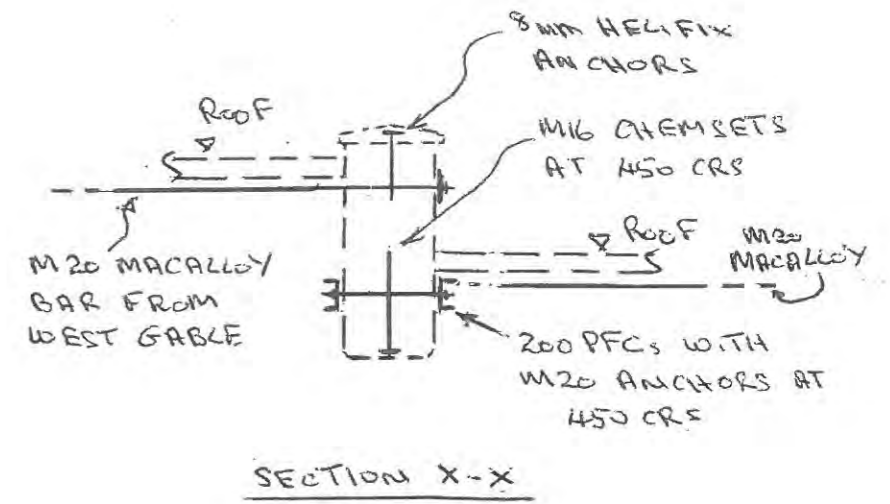
SK-02

ELEVATION LOOKING EAST  
ON CHANCEL ARCH

SECTION X-X

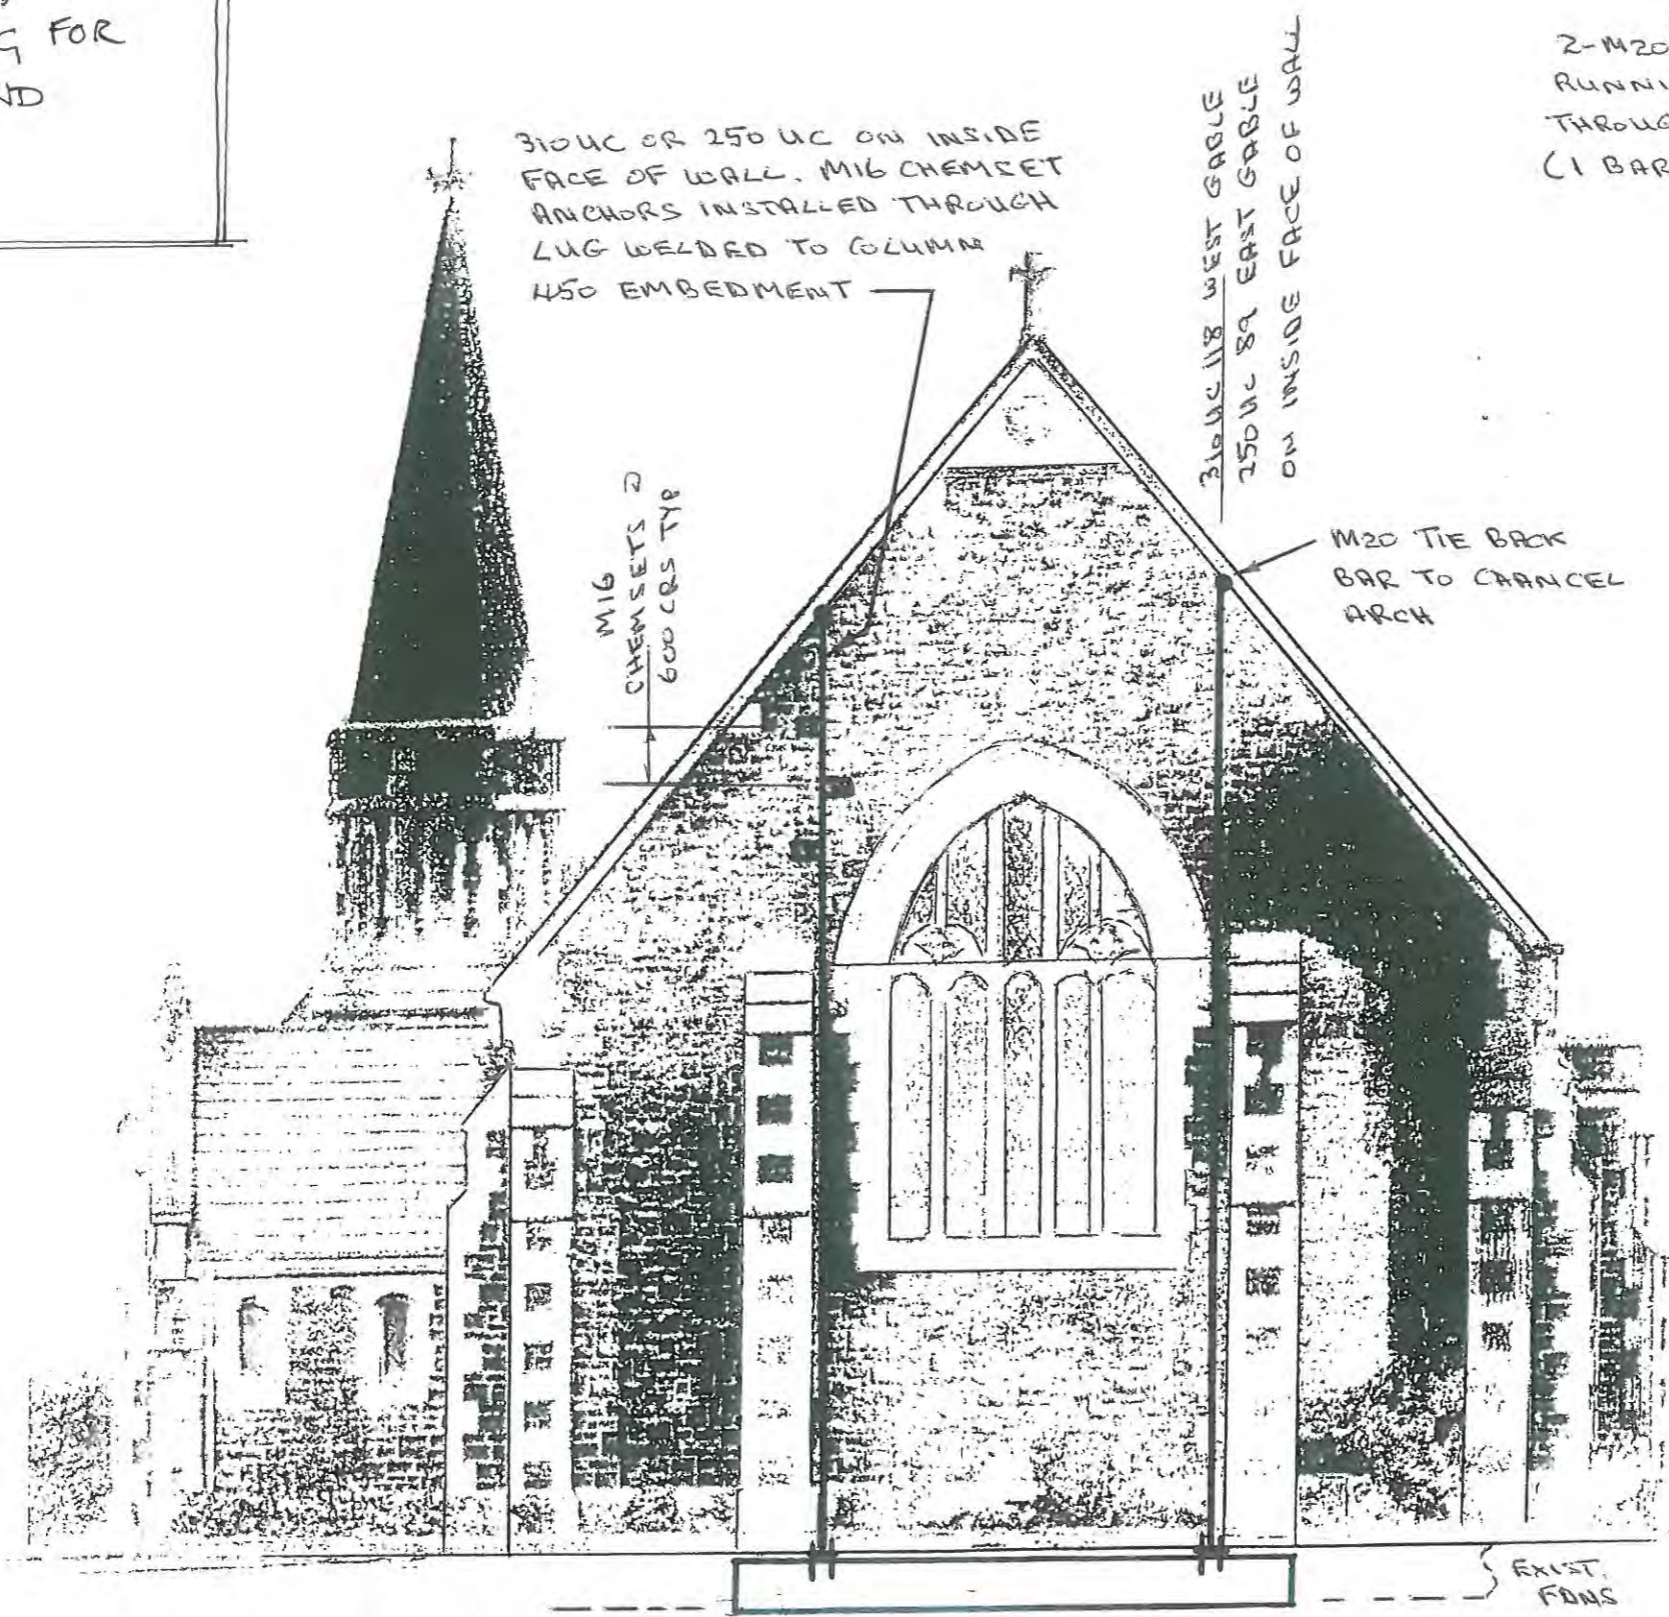
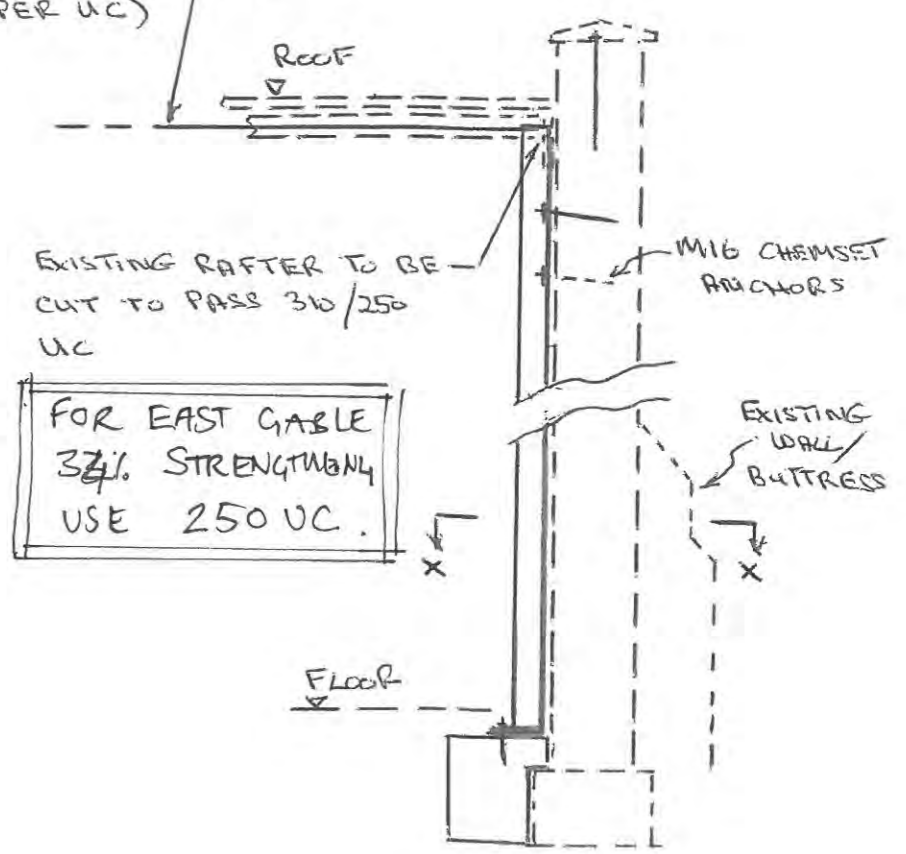
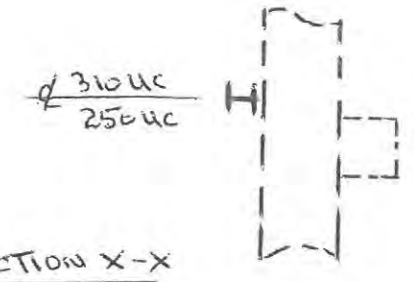
AURECON  
ST JAMES CHURCH - RICcarton  
WEST GABLE WALL REMEDIATION

TIE BACK  
2-M20 MACALLOY S1030 BARS  
RUNNING FROM STEEL UC'S  
THROUGH TO CHANCEL ARCH  
(1 BAR PER UC)

FOR EAST GABLE  
37% STRENGTHENING  
USE 250 UC.

⊛ PREFERRED OPTION OF  
CCC HERITAGE ENGINEER

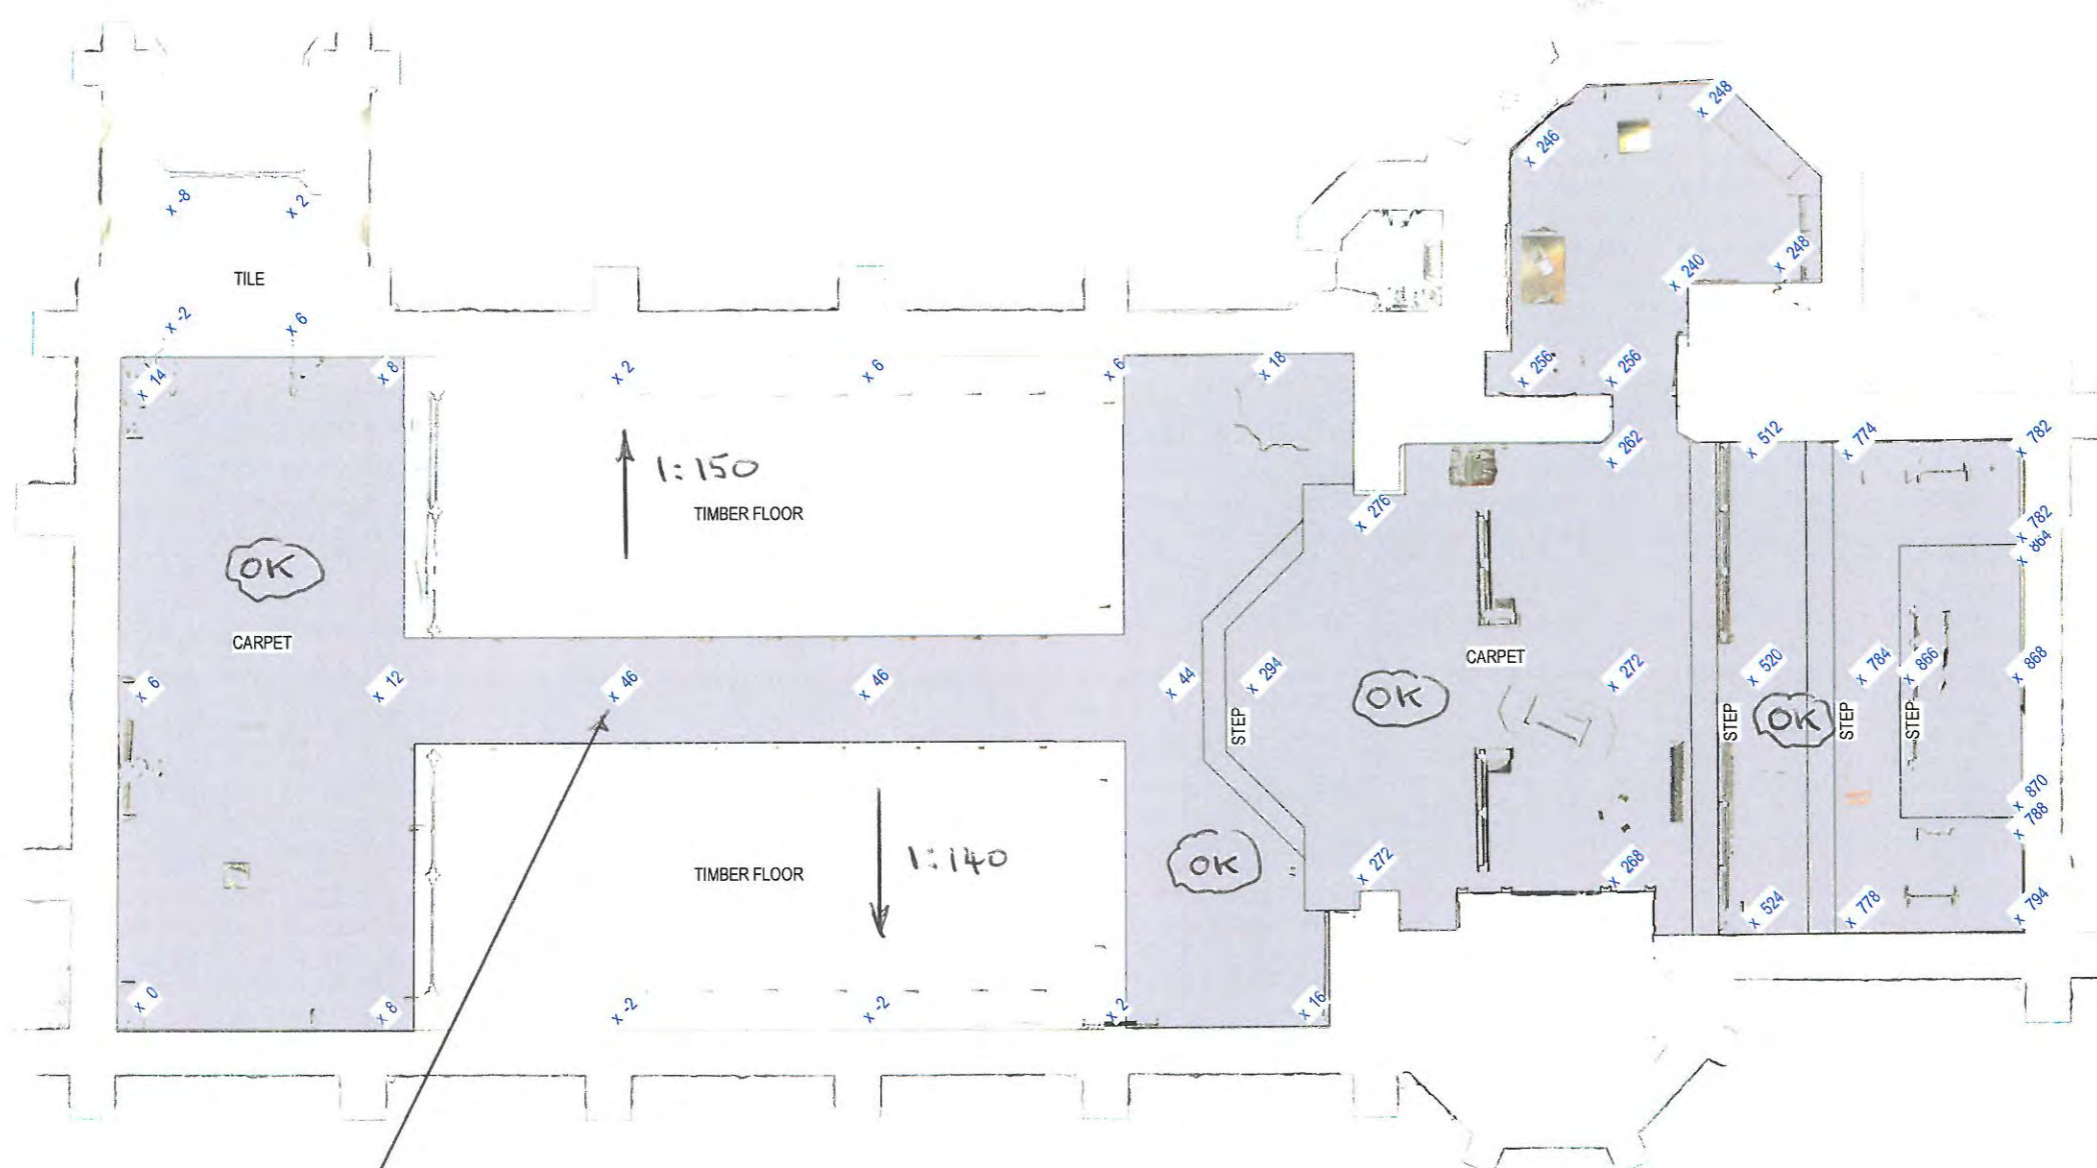
PRELIMINARY NOT FOR CONSTRUCTION
PROJECT No. 213970
SCALE 1:50
DRAWING No. SK-01-00
SIZE A1
REV

FLOOR LEVELS (OCTOBER 2012)  
SK-09

PROJECT
ST JAMES CHURCH 69 RICCARTON ROAD, CHRISCHURCH
TITLE
GROUND LEVEL SURVEY

REDUCE LEVELS ON  
CARPET BY 15mm
