IN THE MATTER of the hearing of submissions on Plan Change 14 (Housing and Business Choice) to the Christchurch District Plan

**STATEMENT OF PRIMARY EVIDENCE OF STEPHEN JAMES HOGG ON
BEHALF OF CHRISTCHURCH CITY COUNCIL**

HERITAGE ENGINEERING

Dated: 11 August 2023

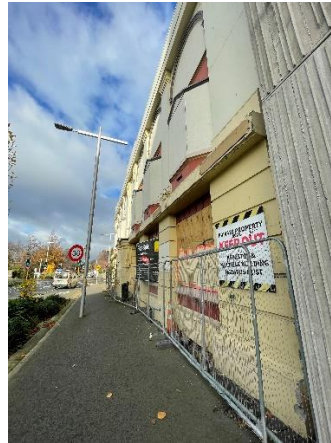
A barricade fence was installed adjacent to this section and is currently in place. However, it is noted that the barricade is located hard up against the building and does not have the suggested 1m minimum gap (see photo below).

It appears that it is not possible to ensure that the barricade is maintained at the recommended safe distance from the building.

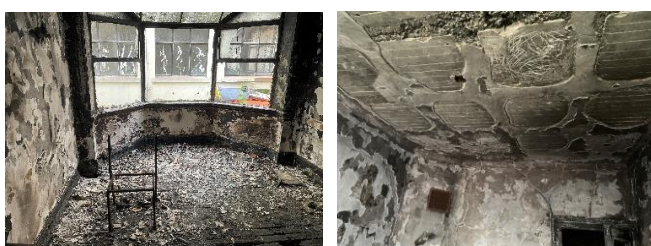
The ceiling has been burnt out and it appears that the soffit of the concrete floor above was exposed to the fire.

Also, extensive spalling occurred to the plaster finishes of the internal breeze block wall.

This has likely resulted in a reduction in loadbearing capacity of the floor in this localised area.

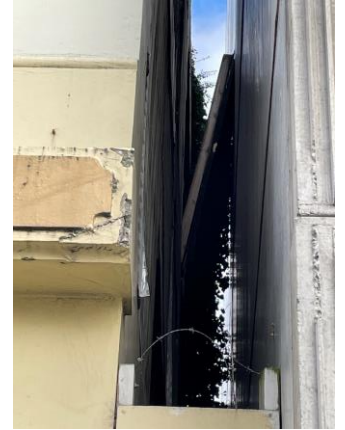
- (f) Temporary timber infill to a north side window appears to have fallen out towards the adjacent building at 141 Cambridge Terrace.

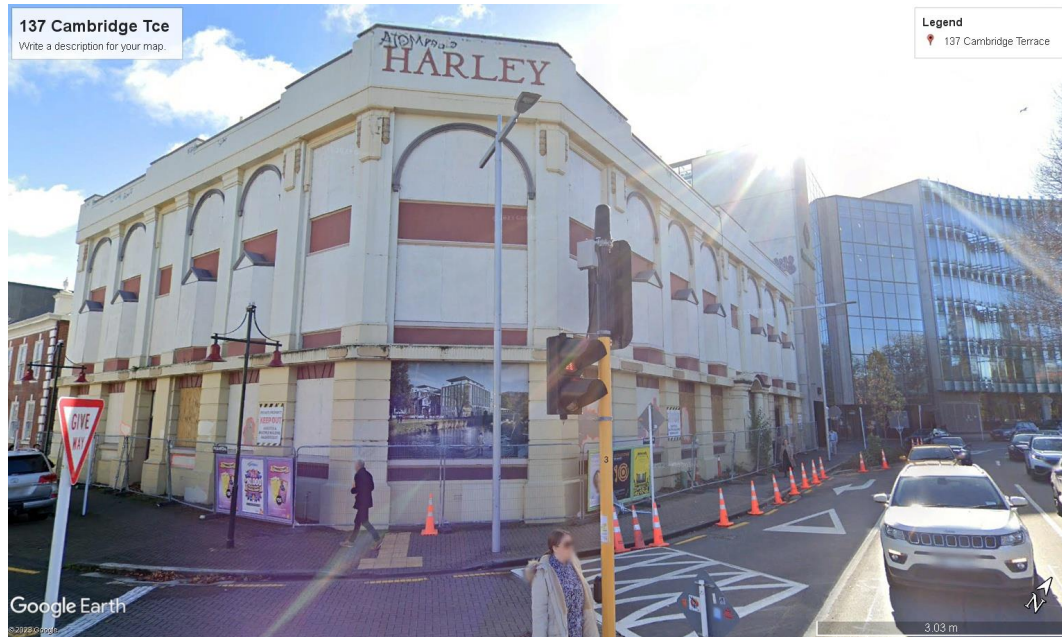
Figure 2 Google Earth photos of building south-east elevation

As noted by Heritage New Zealand the building is concrete and originally constructed in 1929 and extended in 1934 as a medical use building. We have not had an opportunity to review any original construction documents. The roof and floors are noted in the reports to be concrete supported on concrete columns and beams with brick infill. The foundations reportedly have a partial basement and deeper foundation. Figure 2 below is a picture of the exterior elevation of the corner of the building illustrating the current condition of the major damage or deterioration.

As noted in the Quoin Structural letters the building has a current strength rating of 15%-40%NBS for the North Building and 34%NBS for the Southern Building. The damage and deterioration of the building leads to several items of safety concerns in future events and even structural capacity.

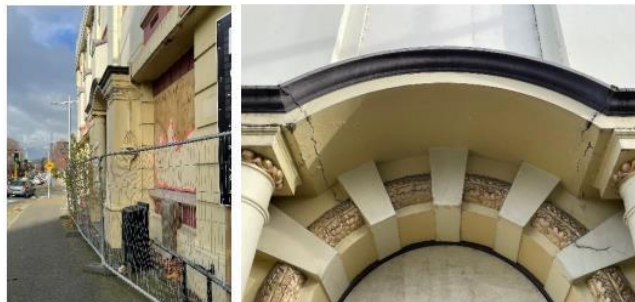
This means that if any part of the canopy apron were to spall, or collapse under a moderate earthquake, then the barricade may not prevent serious injury to the passing public.

Quoin recommends immediate reinstatement of the barricade fence at 1m distance from the front face, or demolition of the apron canopy, or installation of temporary propping beneath the canopy.

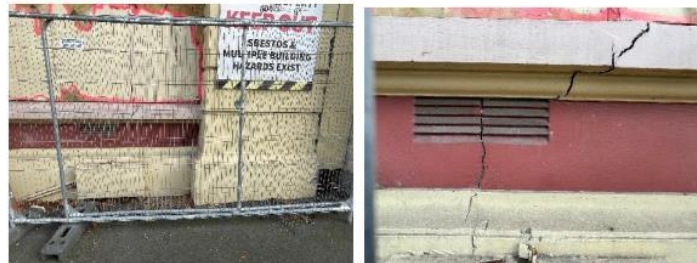
With the basement being full of stagnant water for long periods of time, and having been through numerous attempts to dewater, plus the settlement that has occurred and that appears to be ongoing, there is likely to be added degradation to the structure that includes but may not be limited to:

- i. More extensive contamination of the concrete to the basement walls and base slab.
- ii. Added degradation of the reinforcing, typically at the crack locations.
- iii. Added stresses in the corner column and adjacent beams, over the height of the building, as caused by the settlement. Such cumulative added stresses reduce the residual strength of the affected column and adjacent beams.

A barricade may be required at some stage. As noted above, a barricade is in place, albeit hard up against the building and not 1m away from the building as is the suggested minimum distance should small debris fall from the building.

Quoin recommends a closer inspection be completed to assess if any material is loose and this should include the close inspection noted in (b) above.

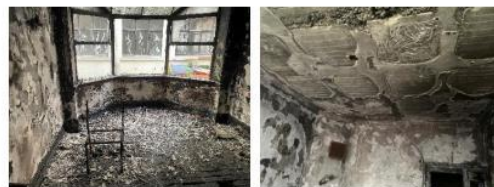
Also, extensive spalling occurred to the plaster finishes of the internal breeze block wall.

This has likely resulted in a reduction in loadbearing capacity of the floor in this localised area.

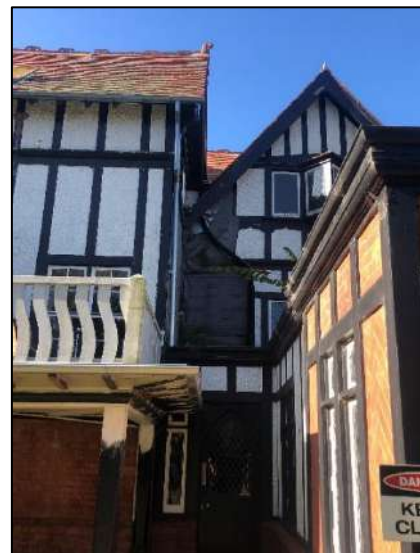
West elevation (right). Note failure of internal gutter resulting in extensive internal water damage.

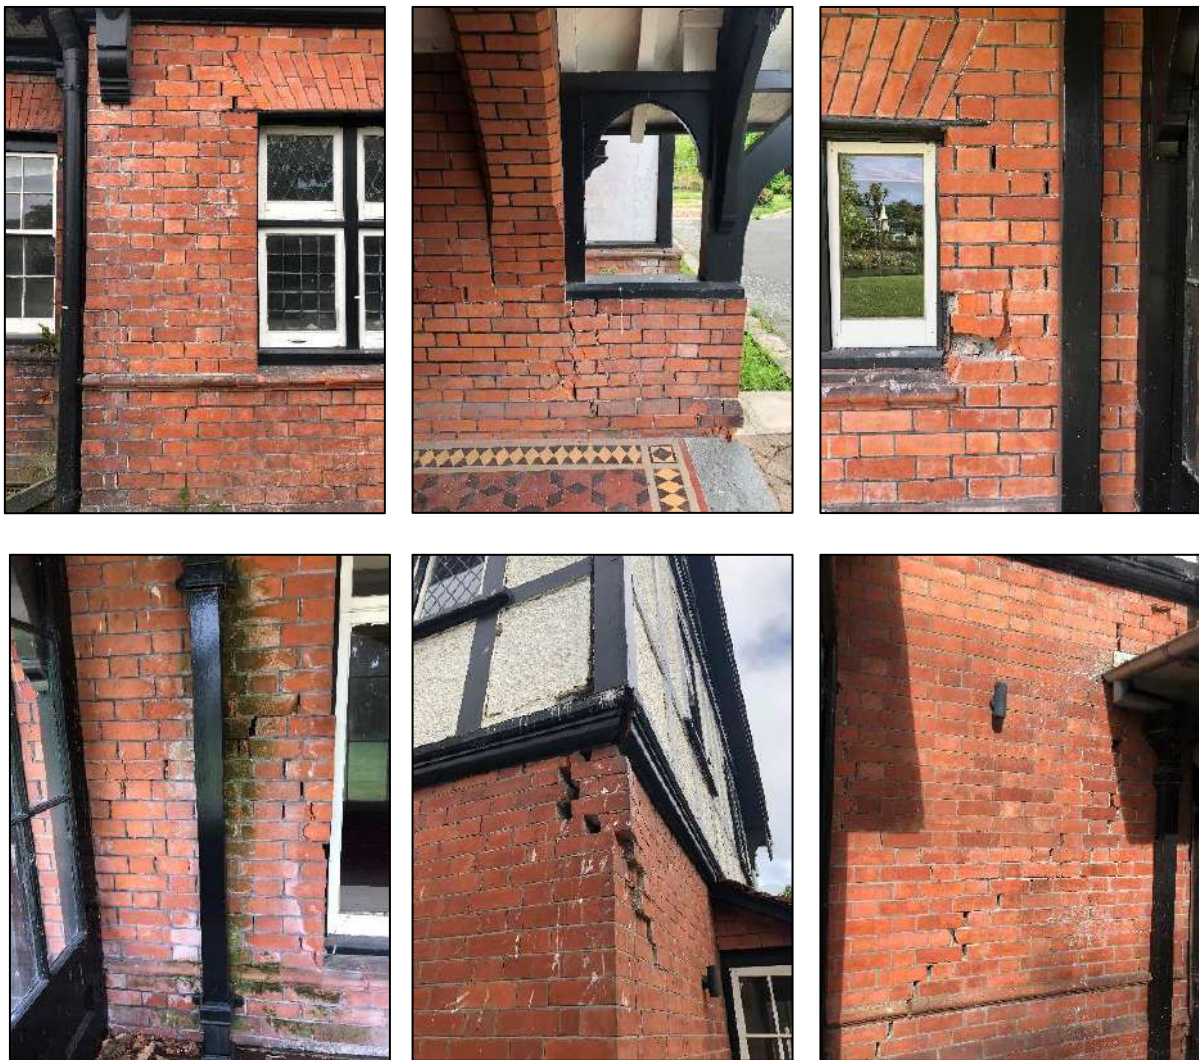
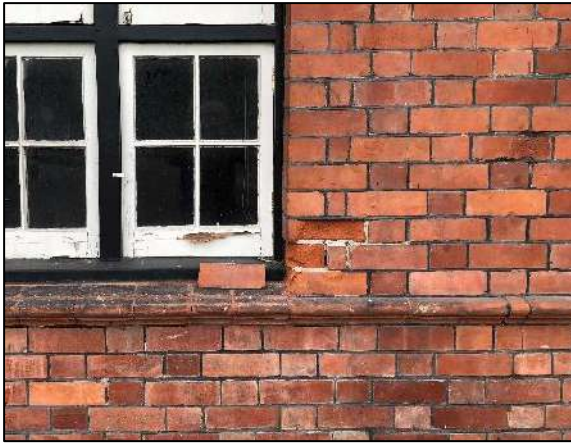
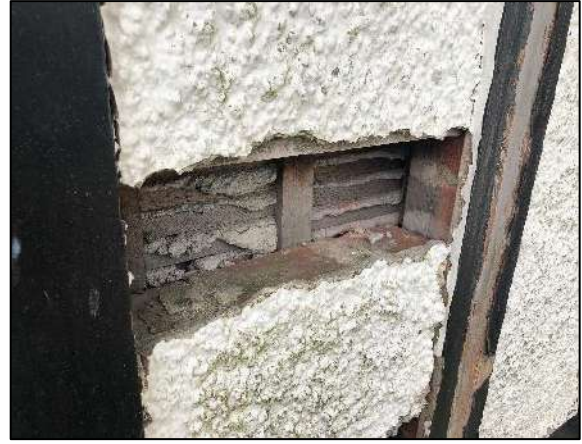
The photographs that follow provide an indication of the types of damage that have occurred to the external walls but are representative only and do not include every defect. Defects include crushing and fracturing of bricks, movement along mortar joints, movement at window heads, loss of mortar and outward displacement of bricks.

The structural engineer requires that the brickwork on the lower floor be dismantled to enable new foundations to be constructed. The inner wythe will then be replaced with timber framing. On the upper floor, the brick nogging is to be removed to reduce the load on the foundations.

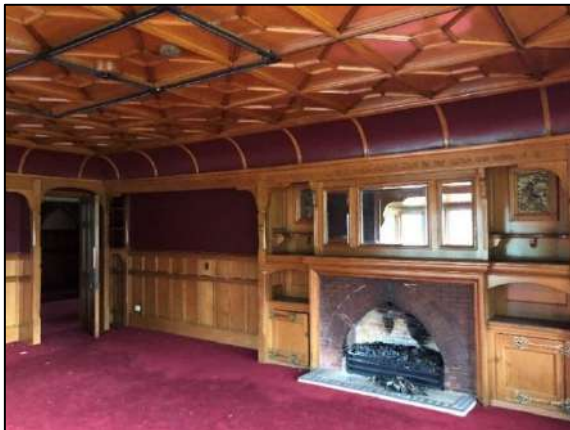
Room G-01

Defects as a result of the earthquakes include cracks in the plaster wall linings and movement between the bricks in the fireplace. Other defects include sun damage to varnished surfaces and bowing leadlight windows

The external walls including joinery are proposed to be deconstructed to enable new foundations to be constructed, as required by the structural engineer. To enable this to occur, the internal walls including timber panelling and the first section of the timber ceiling will need to be carefully dismantled. The ceiling and wall panelling will be reinstated once the external walls have been reconstructed to return the room to its original form as near as possible.

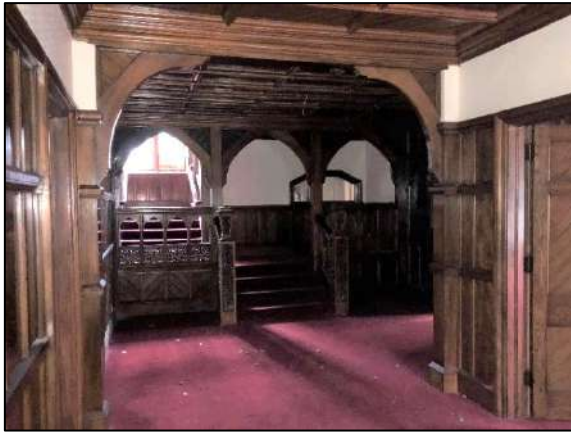
Defects as a result of the earthquakes include extensive water damage to wall panelling and trim due to roof leaks after an internal gutter between the two gables on the western façade failed.

Proposed work will include repairs to substrates as required, followed by replacement of water damaged timber panelling and trim with new timber of the same species finished to match the original.

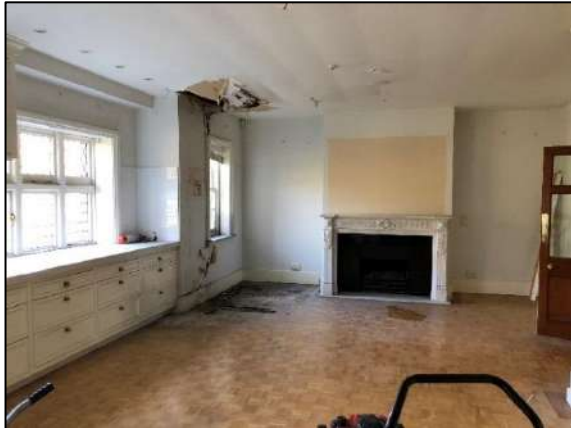
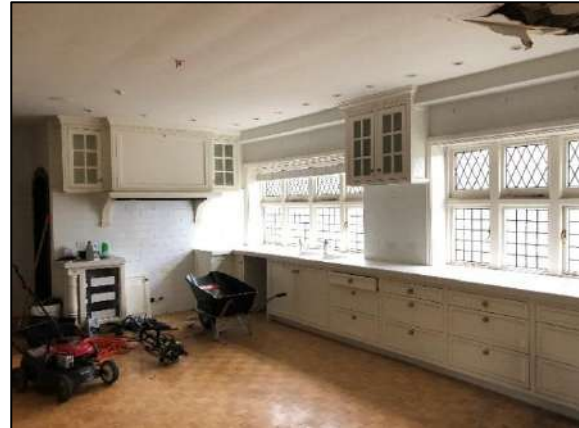
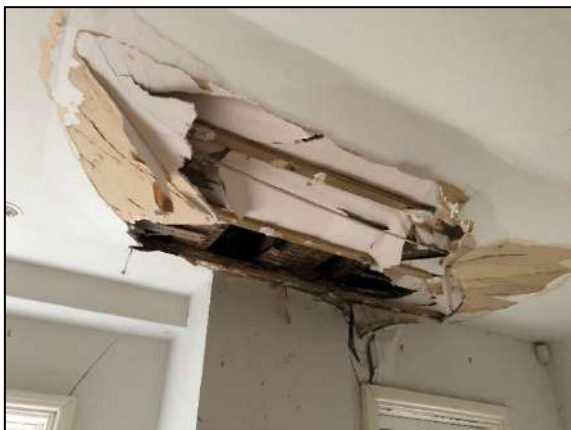
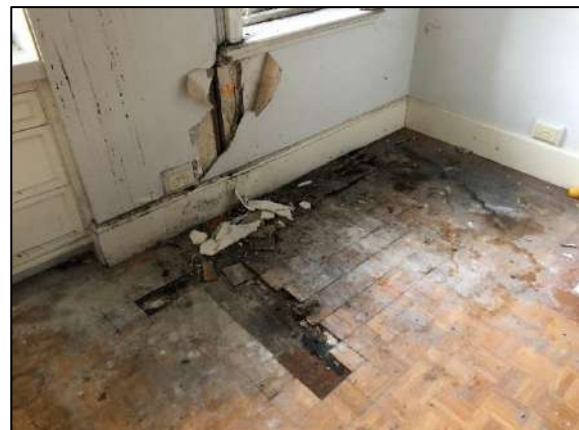
Room G-03

Defects as a result of the earthquakes include extensive damage to wall surfaces and trim and window reveal due to roof leaks after a chimney collapsed and fell through the roof. Cracks are also evident in the plaster wall surfaces.

The external walls complete with joinery will be dismantled to enable new foundations to be constructed as required by the structural engineer. The walls will then be reconstructed and repairs made to the ceiling and floor where these have suffered structural and water damage. The collapsed chimney is unlikely to be rebuilt due to cost constraints.

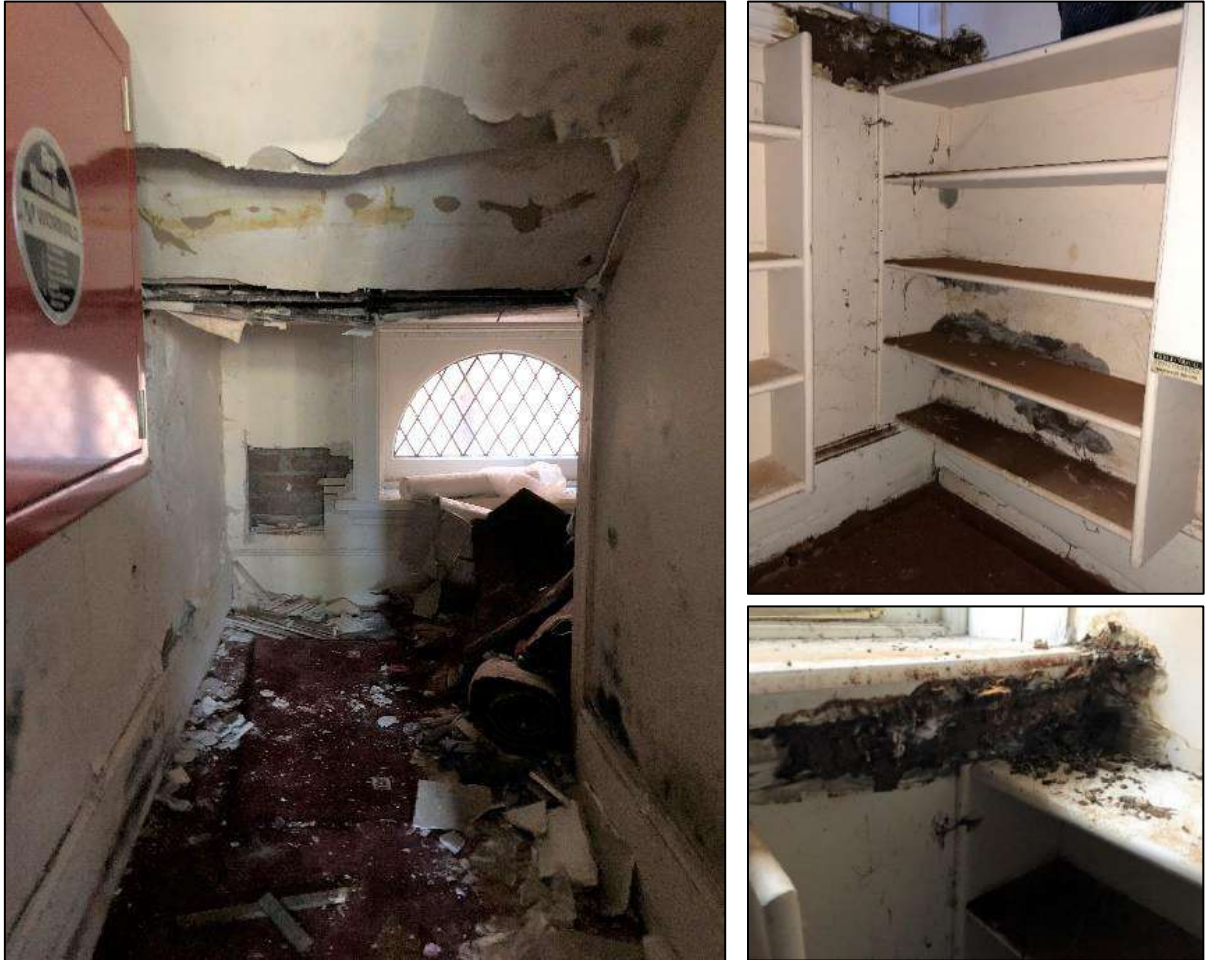
Rooms G-13, G-14, G-15

These spaces have been extensively water damaged following the Canterbury earthquakes due to the failure of an internal gutter. Damage has occurred to walls and ceilings and extensive fungal growth is also present.

The priority is to ensure that repairs are carried out to the roof and gutter where water has been entering the building. Following that, work is likely to include removal of all fungal growth and treatment and repair of substrates and linings.

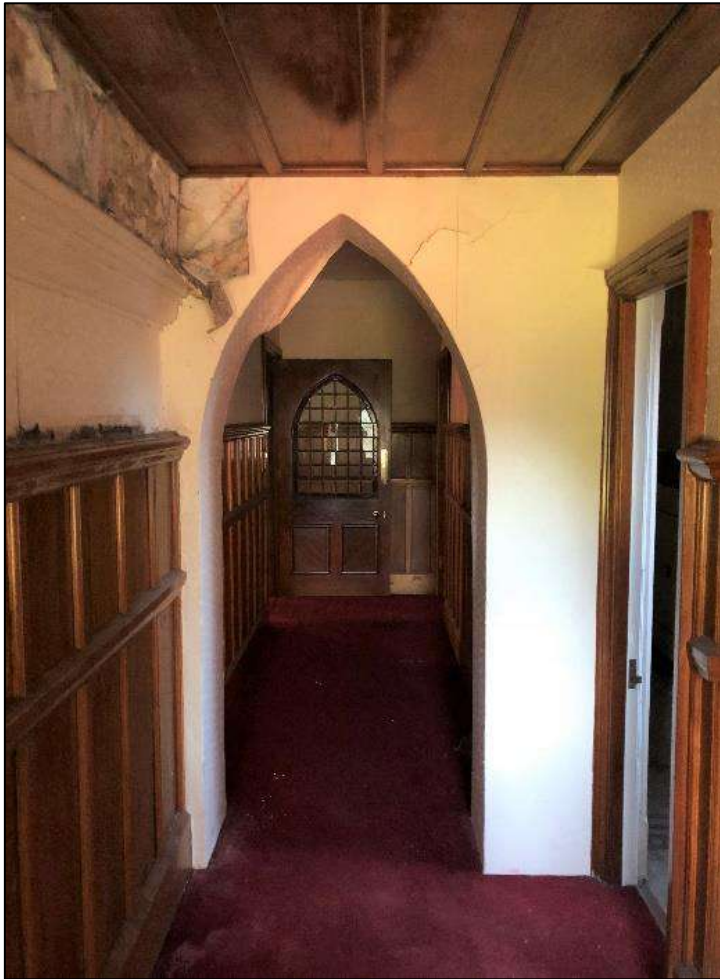
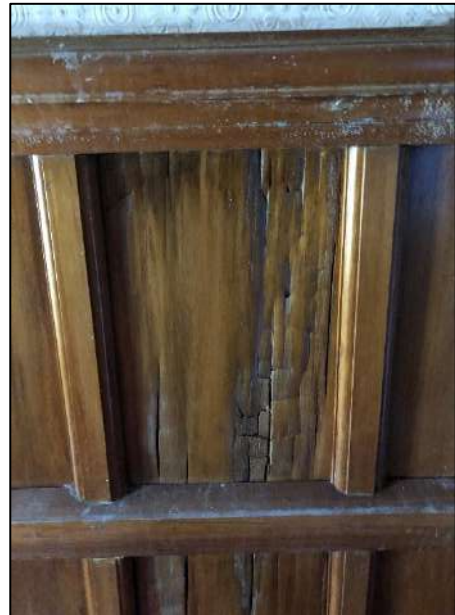
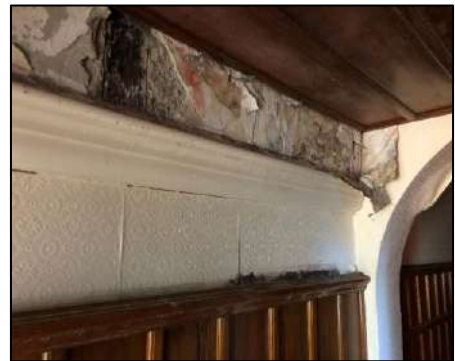
Room G-18

Following the failure of an internal gutter, the walls and ceiling of the passage have been extensively water damaged with mildew and fungal growth evident on the walls and ceiling and dry rot in the wall panelling.

The priority is to ensure that repairs are carried out to the roof and gutter where water has been entering the building. This will be followed by the replacement of water damaged timber panelling and trim with new timber of the same species finished to match the original.

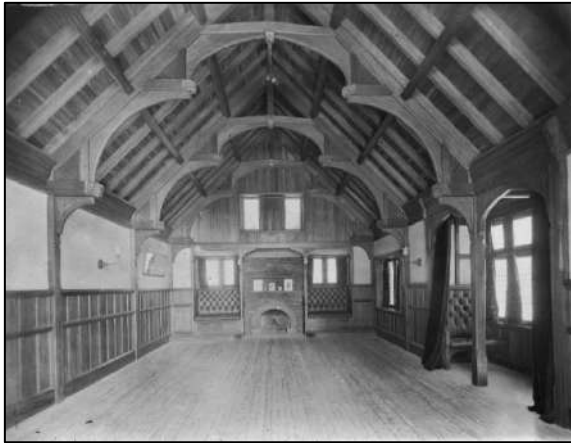
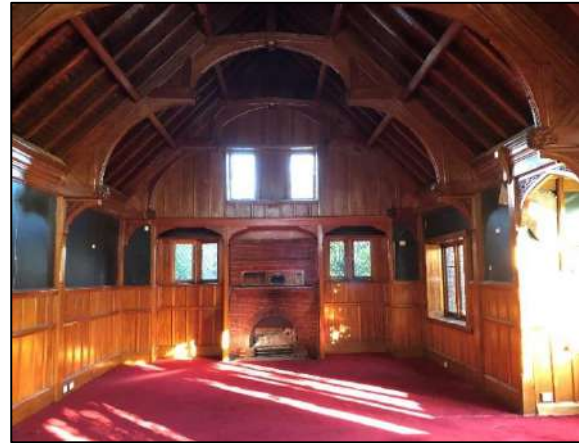
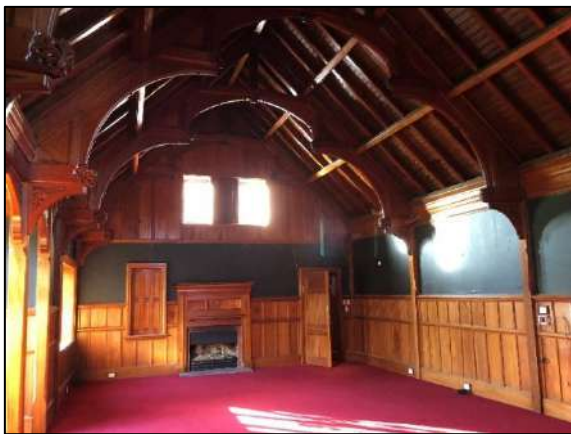
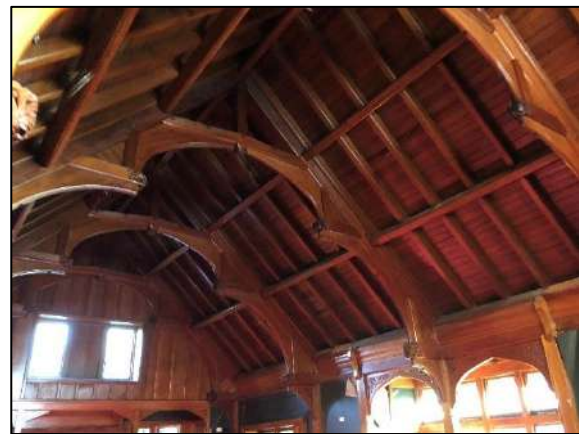
Room G-20

Defects as a result of the earthquakes include cracks in plasterwork and some spalling plaster. Movement has occurred in various locations. The chimney at the southern end of this space has collapsed and dampness is evident in the alcove above the fireplace and also at the north east corner. Cracks are also evident on the brick surround to the southern fireplace. Other defects include sun and moisture damage to joinery sashes, doors and sills.

The chimney at the southern end of the Billiard Room is proposed to be rebuilt. Once this has occurred, flashings will be made good to exclude moisture. Work will then be undertaken to remedy internal defects including repairing of cracks in plasterwork. The brick fire surround will also be repaired with joints mortared as required.

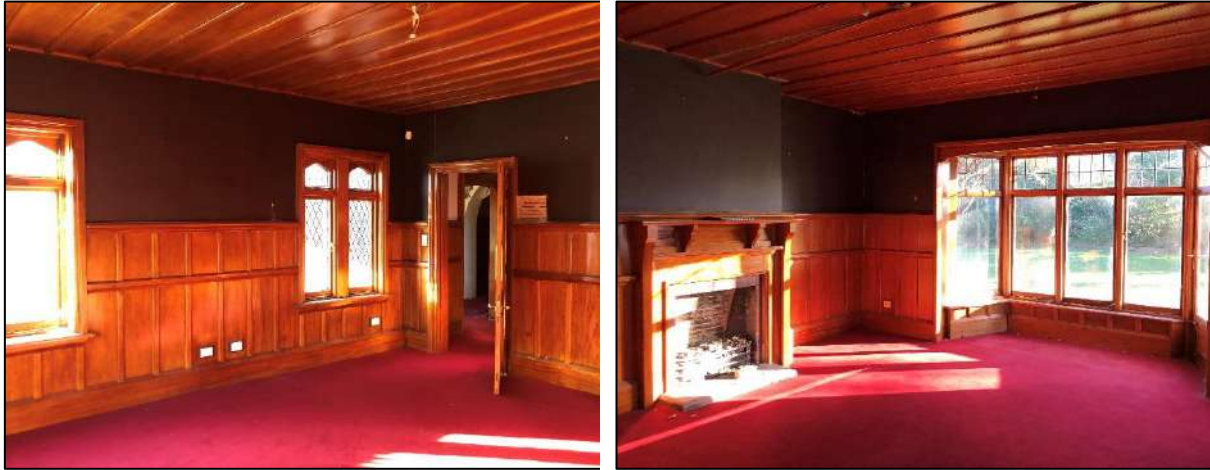
Room G-21

Defects as a result of the earthquakes include cracks in plasterwork at various locations. The brick fireplace also incurred minor damage. Other defects include sun and moisture damage to joinery sashes, doors and sills.

Proposed work is likely to include remedial work to cracked plaster. Remedial work will also be carried out to timber joinery, doors and sills. The fireplace in this space appears to have been constructed at the same time as the room. Due to cost constraints, it is unlikely that the chimney will be able to be rebuilt although the fire surround could be retained.

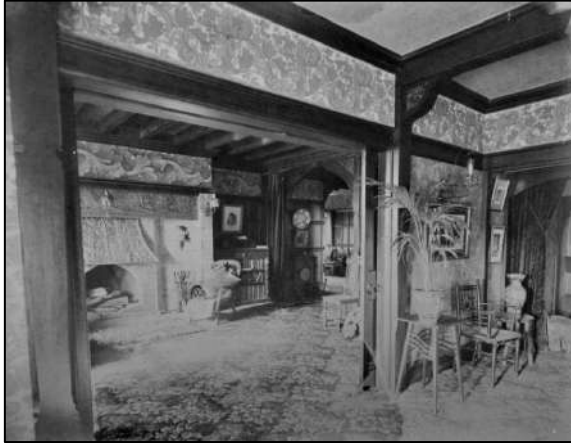
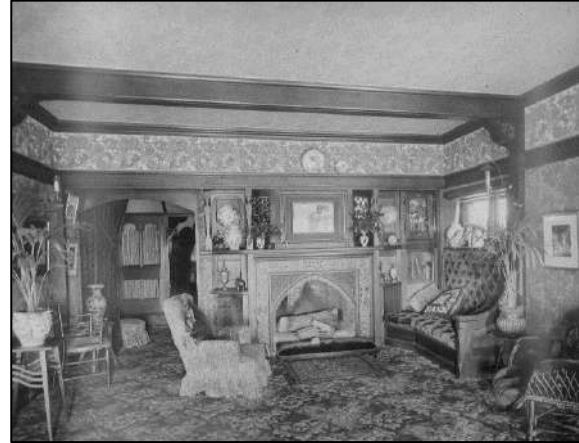
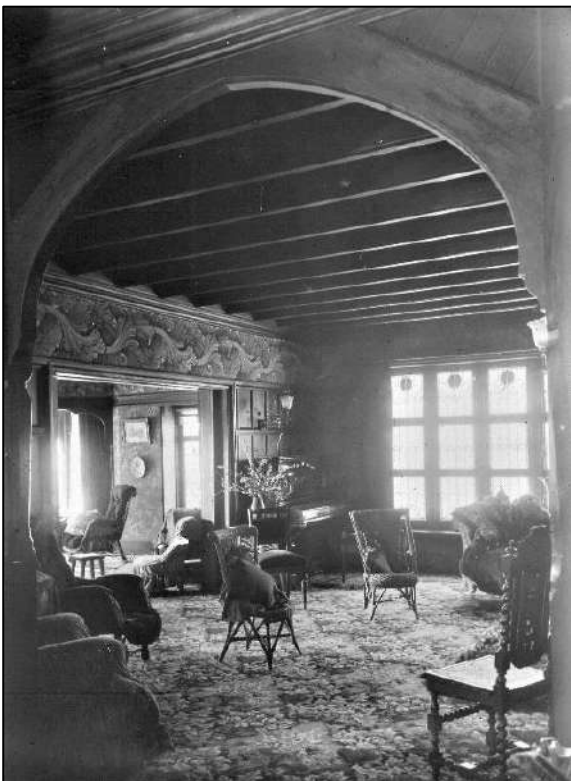
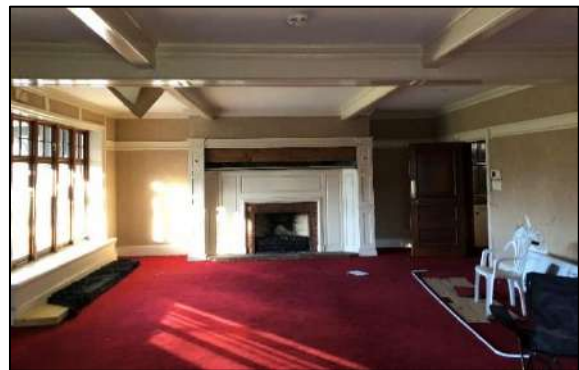
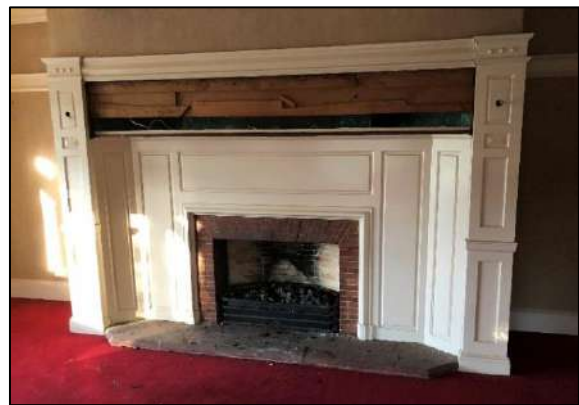
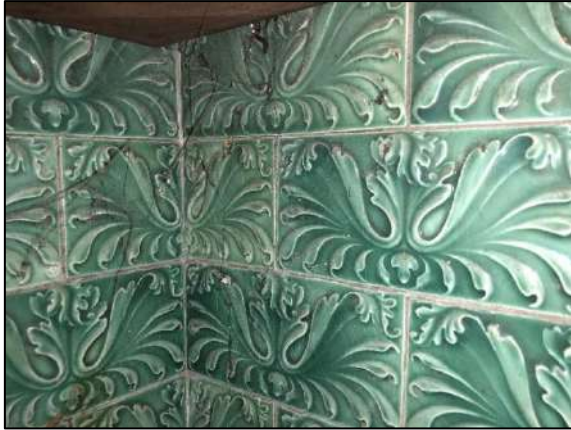
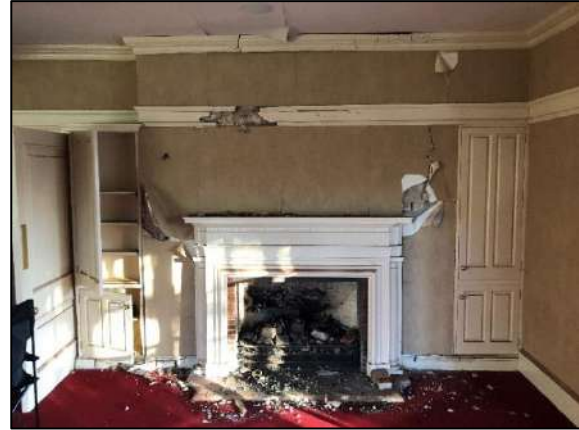
The existing fire surround at the eastern end of the room is a later modification and conceals tiles from an earlier fire surround. The fireplace on the southern wall is also not original. The fabric around this fireplace has been extensively water damaged after the chimney above collapsed.

Defects as a result of the earthquakes include extensive damage to wall and ceiling surfaces and trim due to roof leaks after a chimney collapsed and fell through the roof. Cracks are also evident in the plaster wall surfaces. Other defects include sun and moisture damage to joinery in the west wall.

Proposed work is likely to include repairs to wall and ceiling surfaces to remedy earthquake and water damage. The eastern fireplace and the chimney above will be retained and consideration will be given to restoring the fireplace to its earlier form by exposing the tiles. The later ceilings in this area could also be removed to expose the earlier beamed ceiling if this is found to still exist.

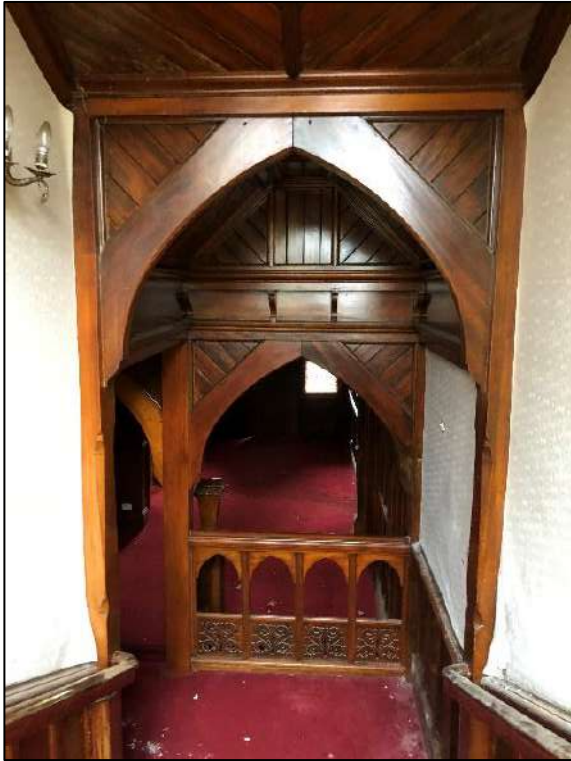
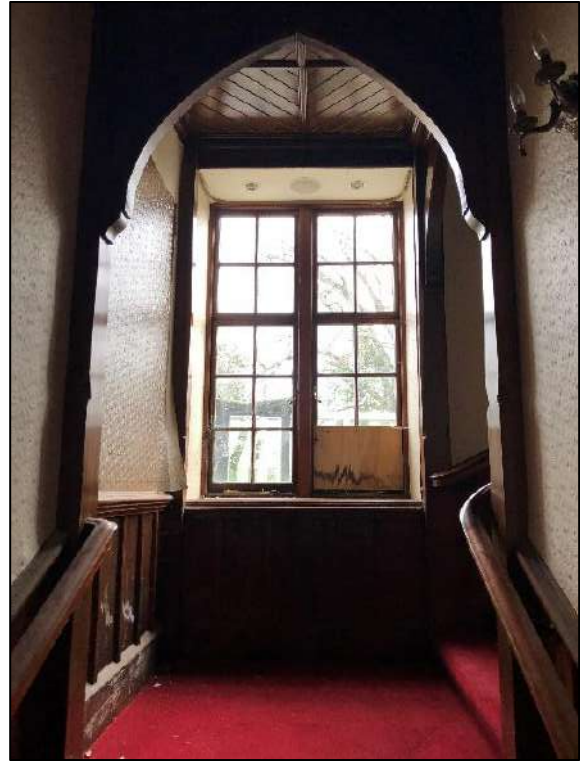
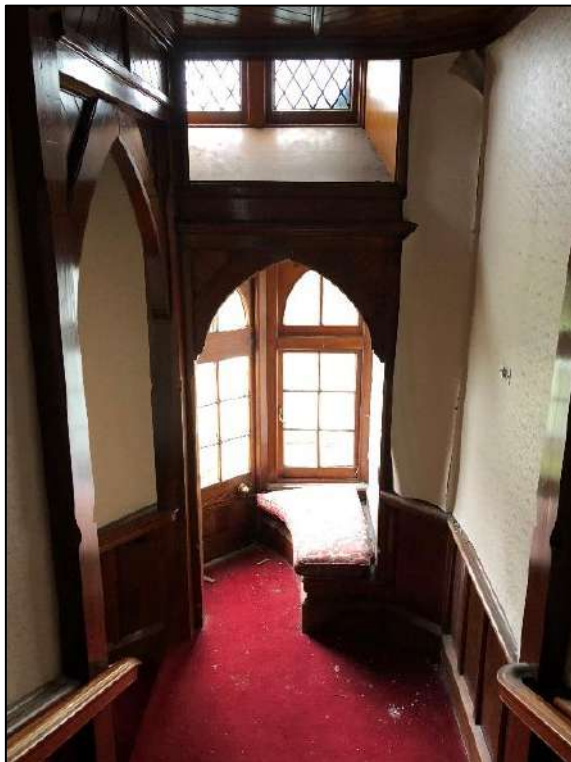
Main Stairs

Defects as a result of the earthquakes include minor damage to ceilings and more extensive damage to wall panelling and trim due to roof leaks after a chimney collapsed and fell through the roofs. Defects include fungal damage, mould, decay and dry rot. Lath and plaster wall linings have also been water damaged.

Following repairs to the roof, remedial work to the stairs is likely to include replacement of water damaged ceilings and wall panelling and trim. Fabric damaged by decay, mould and fungal growth will be replaced.

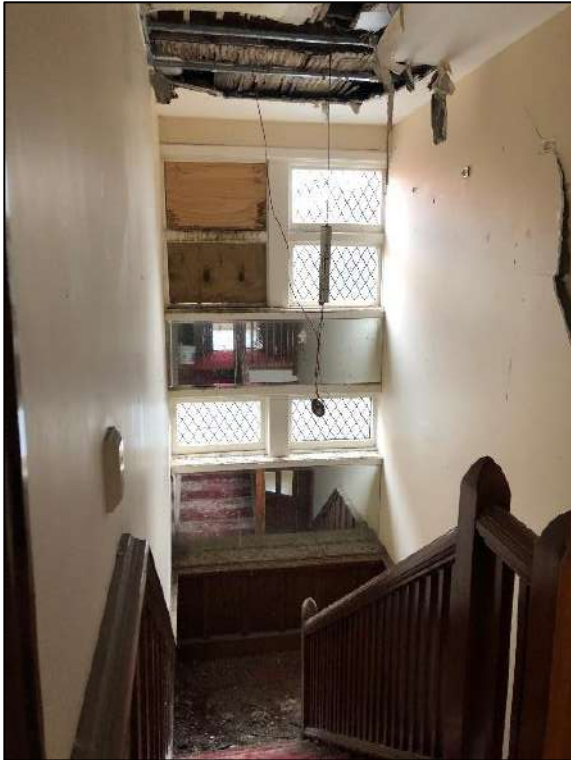
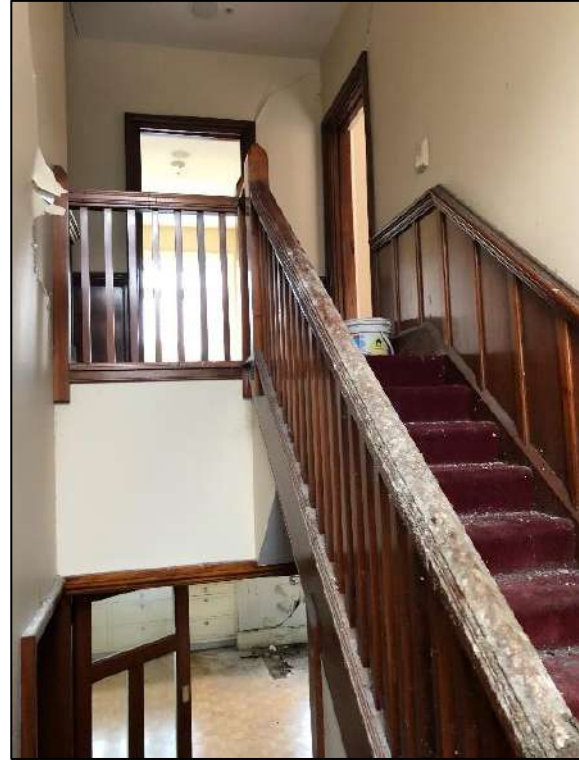
Back Stairs

Following the earthquakes, defects include extensive damage to the ceiling and plasterboard wall surfaces due to roof leaks, possibly caused by a failed gutter. Leadlight sashes are missing.

Following repairs to the roof, remedial work to the stairs is likely to include replacement of water damaged ceilings and wall panelling and trim. Missing sashes should be reinstated or new ones provided.

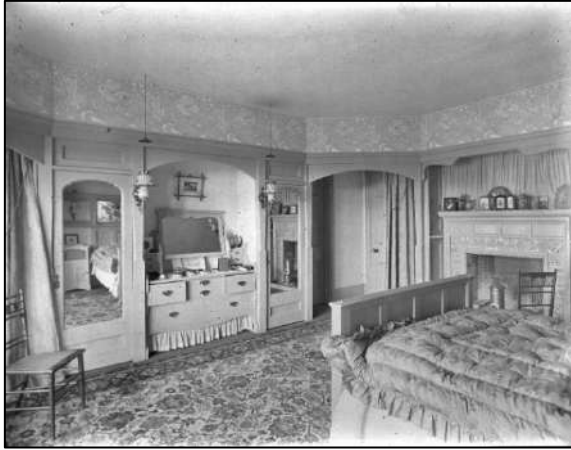
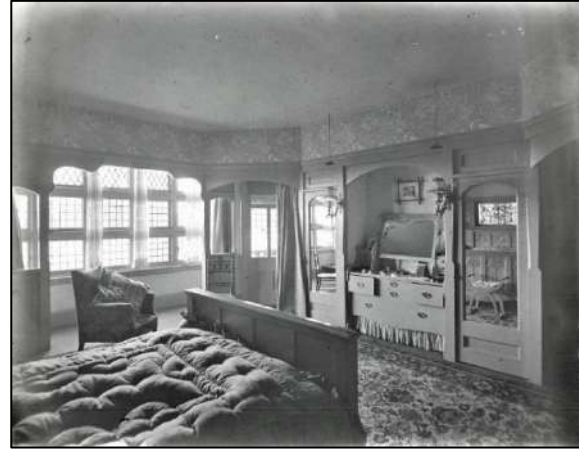
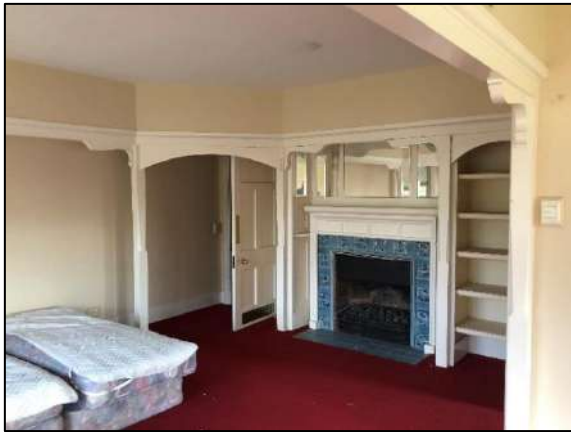
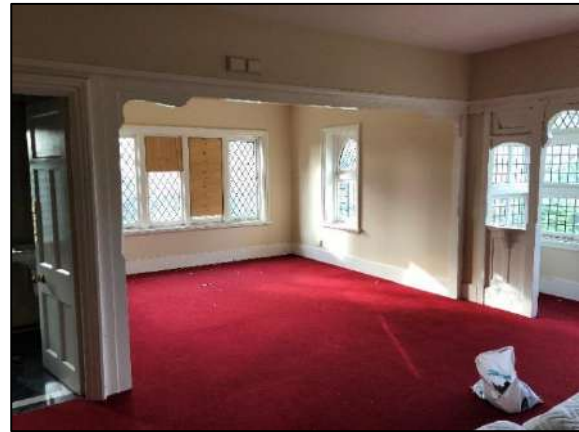
Room 1-01

Defects as a result of the earthquakes include cracks in the plasterwork and evidence of movement between plasterwork and timber trim. Some leadlight windows are broken.

Remedial work is likely to include repairs to plasterwork and trim. Broken windows will be repaired.

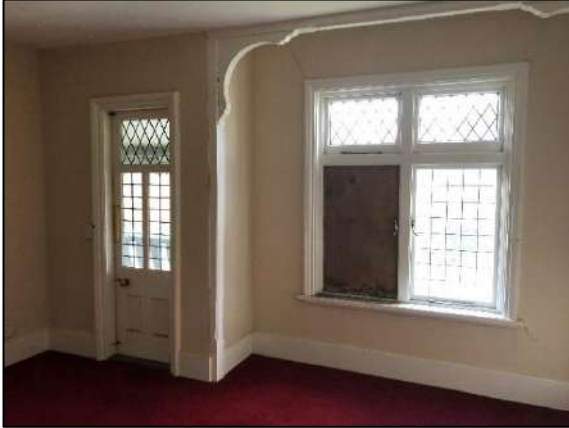
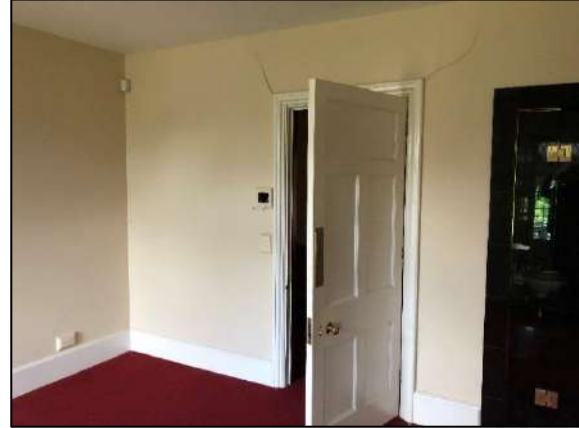
Room 1-02

Defects as a result of the earthquakes include cracks in the plasterwork and evidence of movement between plasterwork and timber trim. A leadlight window sash is also missing.

Remedial work is likely to include repairs to plasterwork and trim. The missing sash should be reinstated or a new one provided.

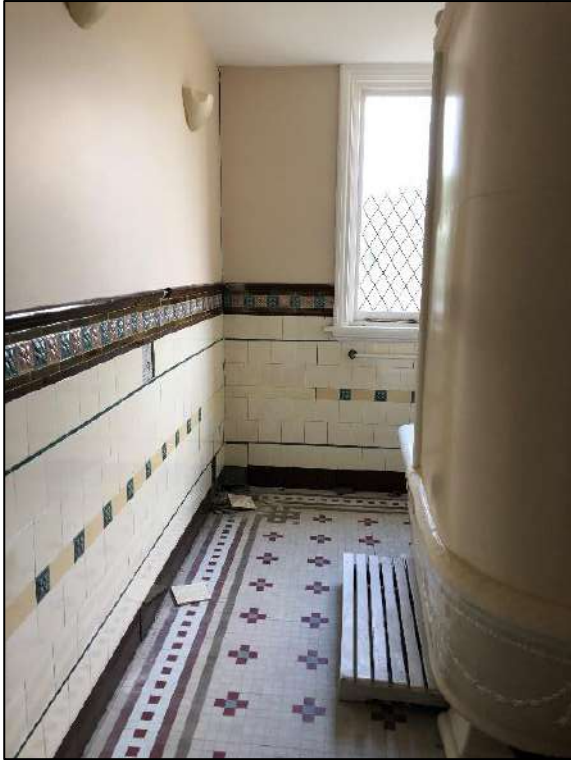
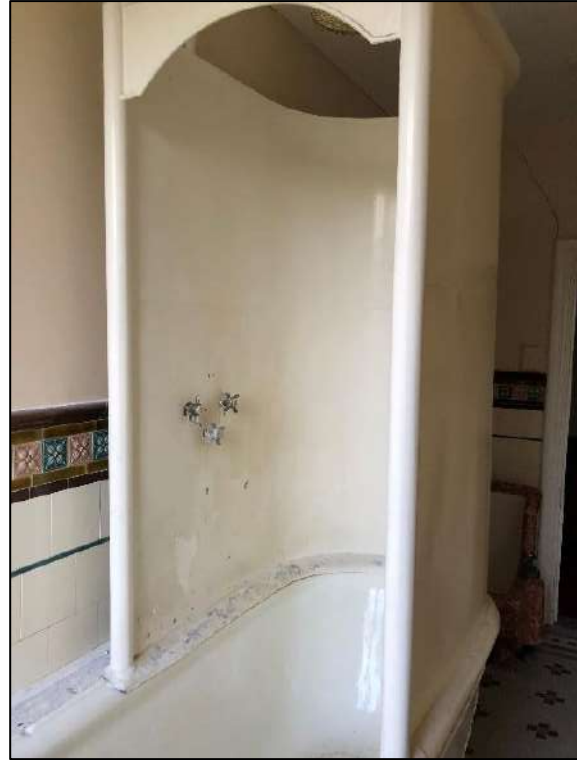
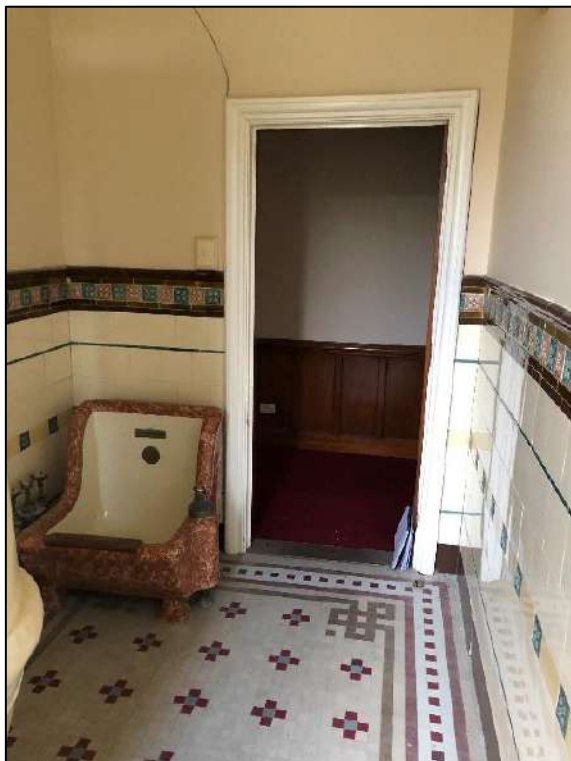
Room 1-03

Defects as a result of the earthquakes include cracks in the plasterwork and evidence of movement at wall and floor junctions and between tiles. Some tiles have become dislodged and some have broken.

Remedial work is likely to include repairs to plaster wall surfaces. Damaged tiles should be repaired and dislodged tiles re-fixed.

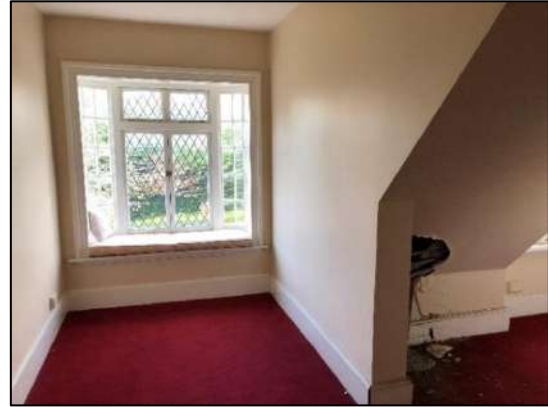
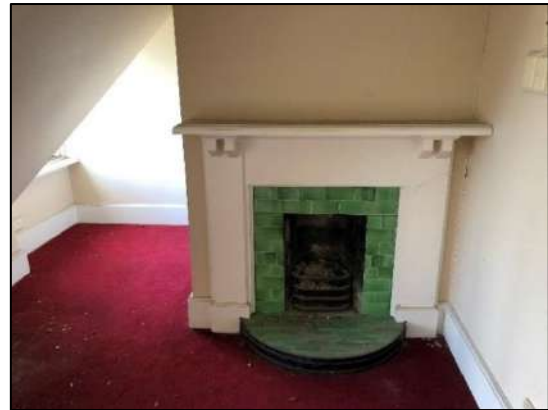
Room 1-05

Defects as a result of the earthquakes include extensive damage to the ceiling and plasterboard wall surfaces due to roof leaks after a chimney collapsed and fell through the roofs. Some evidence of movement is apparent between the tiles and the bricks to the fireplace.

Due to cost constraints, it is not proposed to reconstruct the chimney above this room. The fireplace could therefore be removed and the space reconfigured. Remedial work is likely to include repairs to wall and ceiling surfaces following remedial work to the roof. The fire surround could be retained as a non-functional artefact.

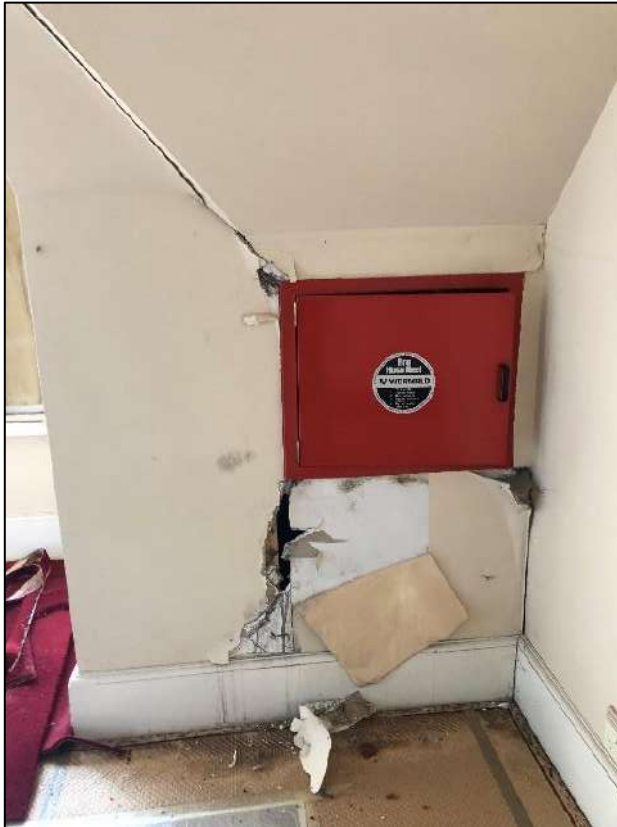
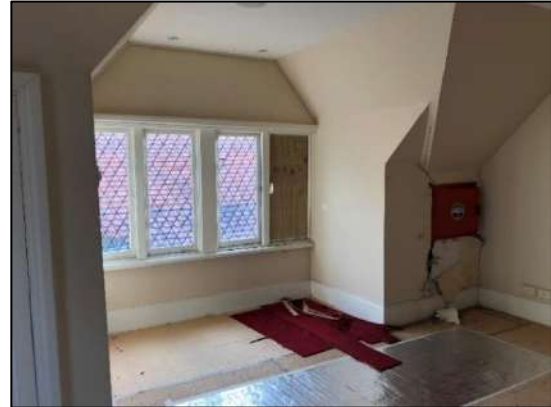
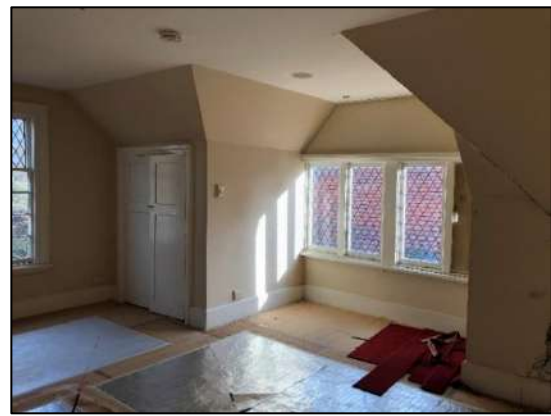
Room 1-07

Defects as a result of the earthquakes include cracking in ceiling and wall surfaces. There is also evidence of past water leaks in the area around the fire hose reel, possibly due to a failed internal gutter. A sash has been boarded up where the leadlight glazing has been damaged.

Remedial work is likely to include repairs to ceiling and wall surfaces following remedial work to the roof. Damaged joinery should be repaired.

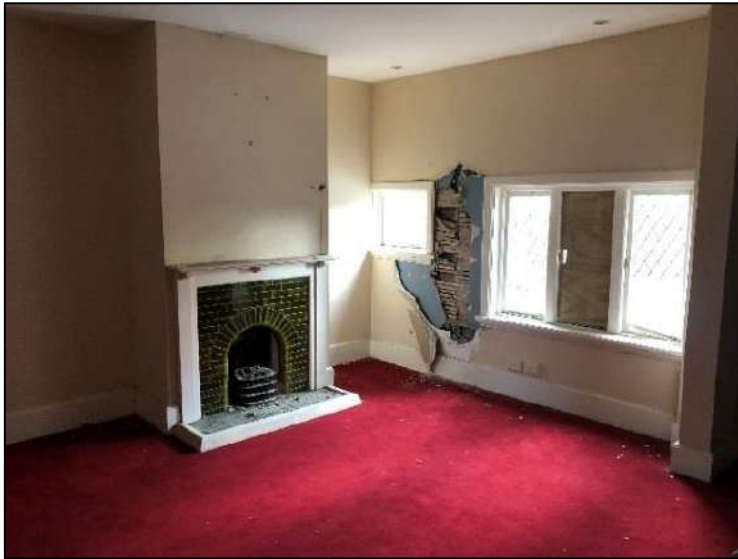
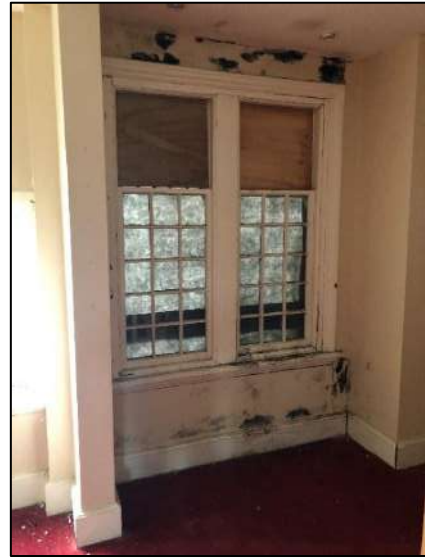
Room 1-08

Defects following the earthquakes include water leaks in the ceiling along the line of the west wall and more extensively above and below one of the windows, probably due to a failed internal gutter. Extensive mould growth is apparent above and below the window. Some windows are also broken.

Other remedial work is likely to include repairs to wall and ceiling surfaces after the roof has been repaired. Repair work should be undertaken to the windows.

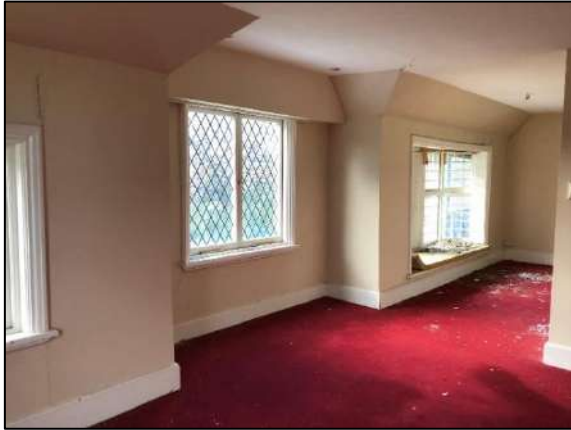
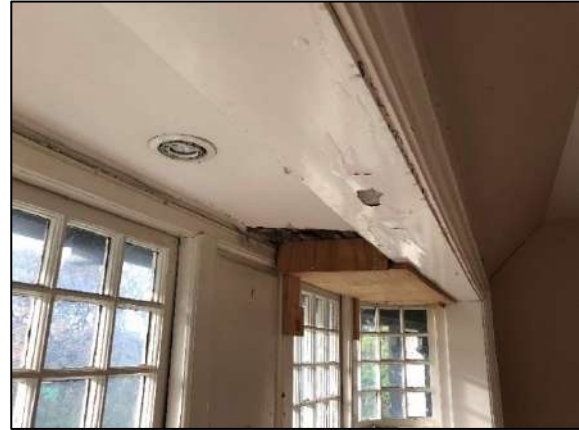
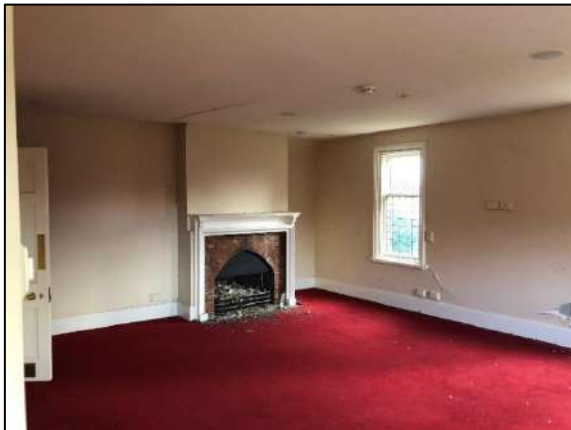
Room 1-09

Earthquake damage includes visible cracks in walls and the ceiling. Extensive water damage has occurred to the soffit to the bow window in the north wall, possibly the result of broken tiles. There is some evidence of movement within the brick fireplace and some unevenness is apparent in the floor.

Due to cost constraints, it is not proposed to reconstruct the chimney above this room and the fireplace could be removed. External remedial work is likely to include repairs to the roof over the bow window. Internal work may include repairs to the soffit to the bow window following repairs to the roof above. Wall and ceiling surfaces will also need to be repaired.
