IN THE MATTER of the hearing of submissions on Plan Change 14 (Housing and Business Choice) to the Christchurch District Plan

**STATEMENT OF PRIMARY EVIDENCE OF STEPHEN JAMES HOGG ON
BEHALF OF CHRISTCHURCH CITY COUNCIL**

HERITAGE ENGINEERING

Dated: 11 August 2023

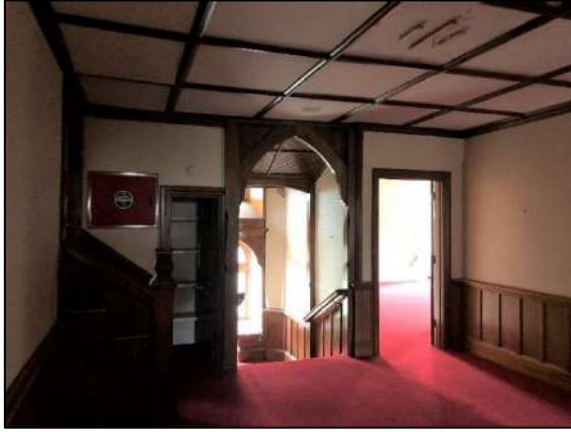
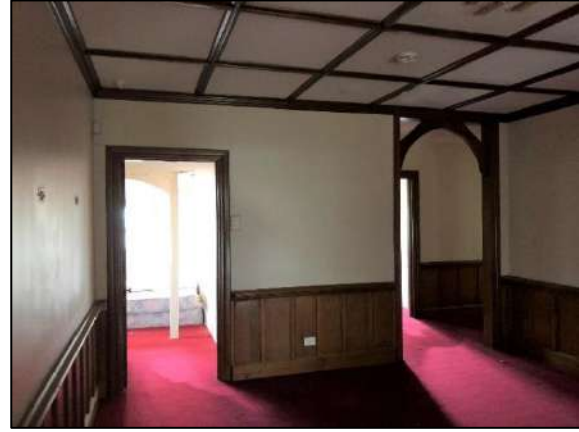
Room 1-11

The floor is uneven, probably as a result of the earthquakes. Some cracks are evident in the plasterboard walls and one sheet is loose. The ceiling panels are also sagging.

Remedial work is likely to include repairs to the ceiling and walls. The unevenness in the floor should be investigated and remediated.

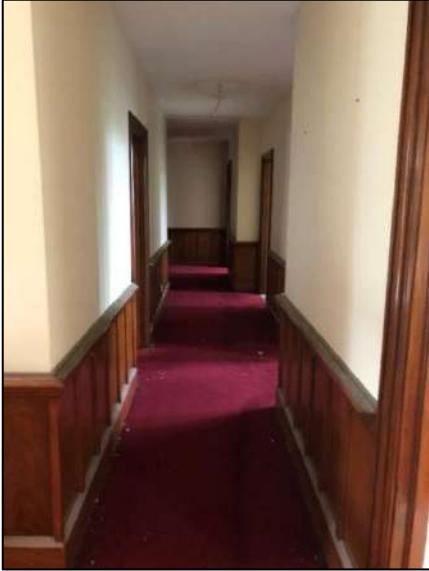
Room 1-12

Defects include cracks in the plaster wall and ceiling surfaces and evidence of movement at wall and ceiling junctions. Some unevenness in the floor is also evident.

Remedial work is likely to include repairs to the ceiling and walls. The unevenness in the floor should be investigated and remediated.

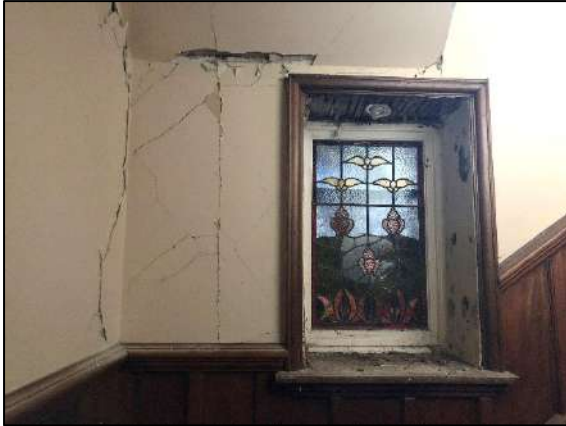
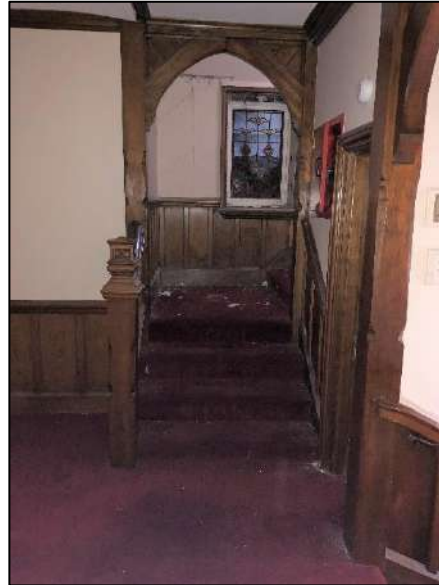
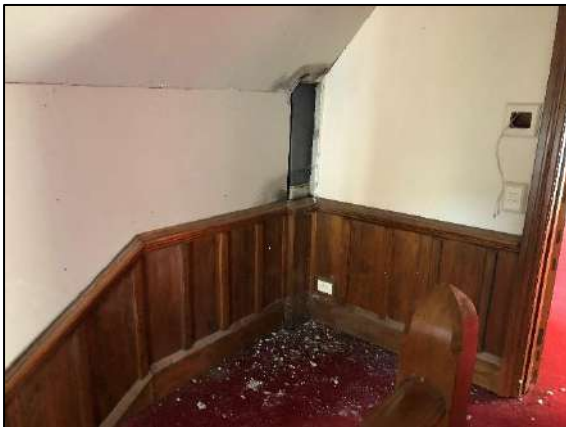
Stairs to Second Floor and Landing 2-05

Defects include damage to plaster wall surfaces caused by water ingress as the result of a failed gutter and a collapsed chimney. In particular, the small stained-glass window up the stairs has sustained extensive damage to the sash and the reveals.

Remedial work is likely to include repairs to the ceiling and walls and the stained-glass window following repairs to the roof and gutters.
