**STATEMENT OF PRIMARY EVIDENCE OF GARETH WRIGHT ON BEHALF OF
CHRISTCHURCH CITY COUNCIL**

QUALIFYING MATTER: HERITAGE (LISTED HERITAGE ITEMS)

3. My evidence relates to those District Plan provisions applicable to the removal of the former Dwelling and Setting, 471 Ferry Road (the **Building**) from the Schedule of Significant Historic Heritage Items in Appendix 9.3.7.2 (the **Schedule**) in the District Plan.

**APPENDIX A: L2 STRUCTURAL REPORT, DON THOMSON CONSULTING
ENGINEERS, JULY 2011**

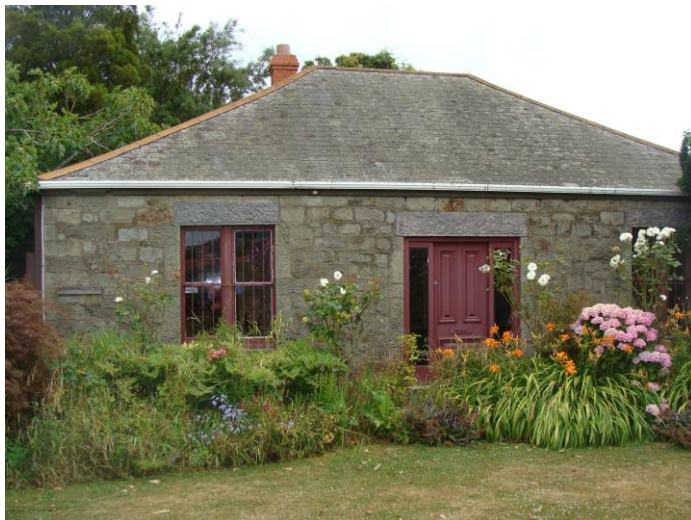
The building is single storey with a slate roof, rubble stone external walls and timber internal walls. The floor of the building appeared to be a concrete slab on grade. The roof is supported on timber trusses and a modern tiled ceiling has been installed. The building is believed to date from 1863 and is one of the last stone workers cottages remaining in Christchurch.

The building has suffered from shaking damage from the earthquake swarm beginning on 4th September 2010. This is evidenced by movement cracking to the external walls principally at the corners and adjacent to openings. Inside the building the plaster and some of the stone rubble has loosened and in some places fallen as shown in the photo below.
