UNDER the Resource Management Act 1991
IN THE MATTER of proposed Plan Change 14: Housing and Business
Choice to the Christchurch District Plan
AND
IN THE MATTER of Cambridge 137 Limited (Submitter 1092)

**JOINT STATEMENT OF EVIDENCE OF JONATHAN LYTTLE AND MICHAEL
DOIG ON BEHALF OF CAMBRIDGE 137 LIMITED**

QUALIFYING MATTER: HERITAGE (HERITAGE SITES)

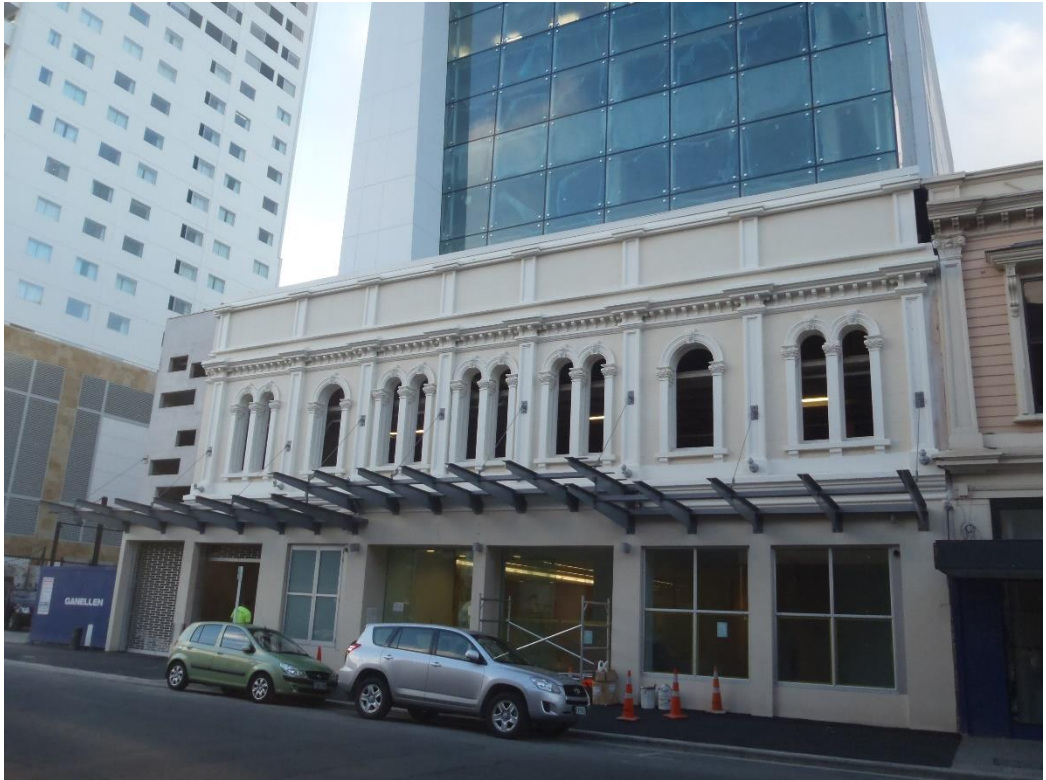
Photograph 1: 158 Gloucester Street, Christchurch – pre February earthquake

85 Photograph 1 shows the original heritage façade, taken shortly before the February 2011 earthquake.

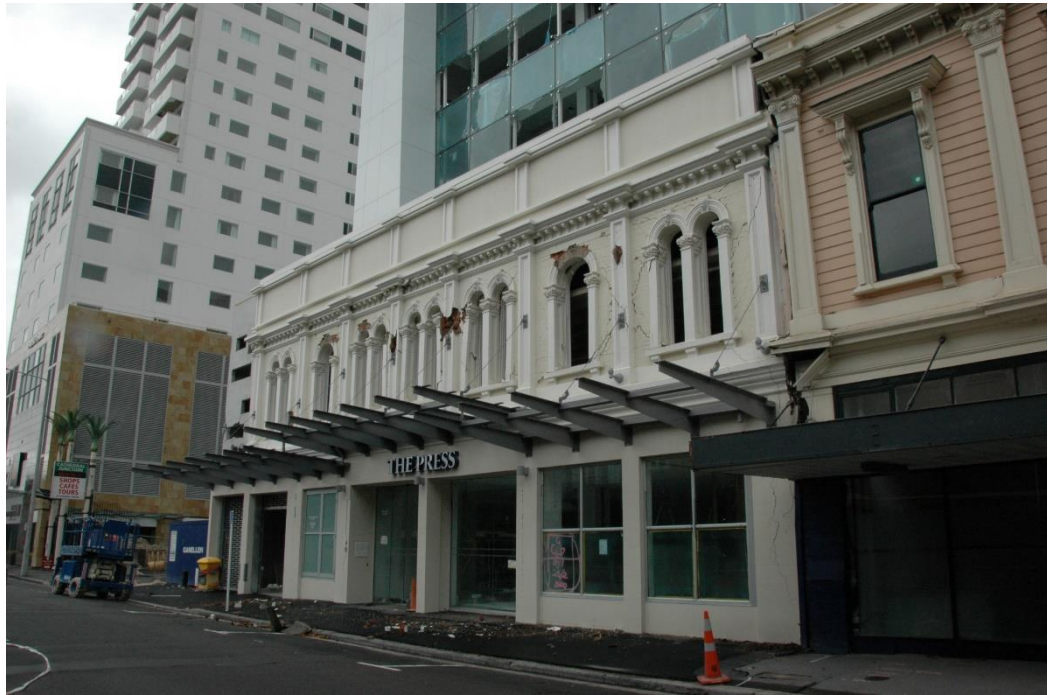
Photograph 2: 158 Gloucester Street, Christchurch – post February earthquake

- 86 The second and third photographs were taken immediately after the February earthquake.
- 87 The February earthquake caused diagonal cracking and the shear failure of all the brick piers and masonry walls. We also lost some of the decorative reliefs/keystones.

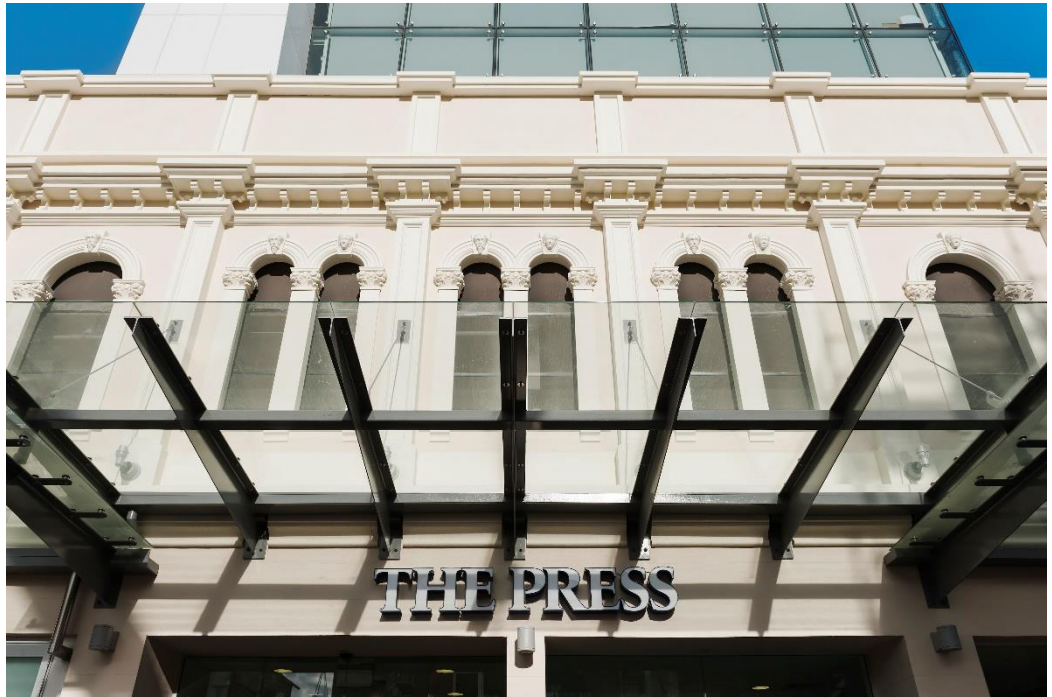
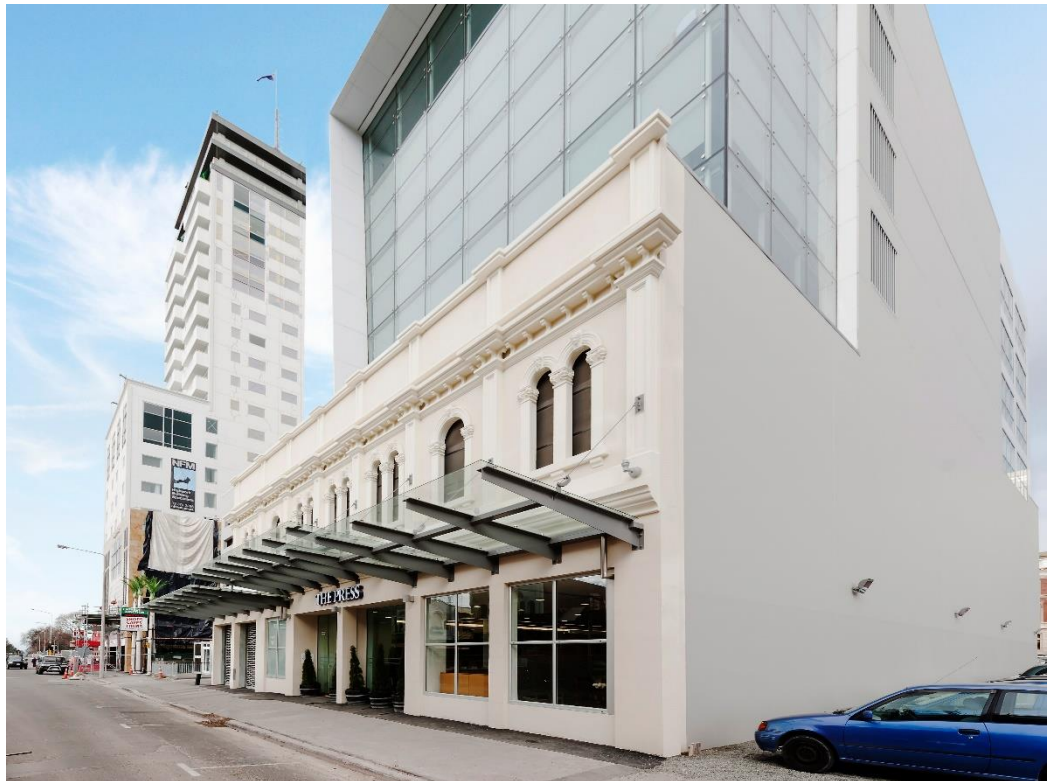
- 89 The final two photographs show the completed replica façade, being a fair face pre-cast panel with the arch openings and a combination of glassfibre reinforced concrete (GRC) mouldings for the reliefs and cement render over compressed polystyrene for the dentils.

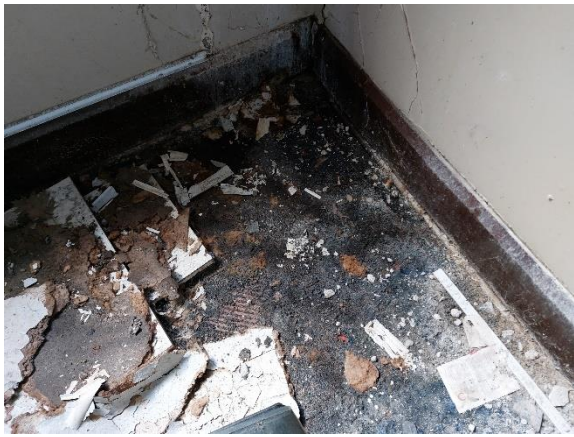
Photo 13: Water damaged area (GF Room 8)

Areas where water/moisture is entering the building need to be identified and repaired. In addition to this, the areas significantly impacted by water ingress may need to be dried out as part of the remediation work. The basement will need to be emptied of the flood water, dried out and assessed for the presence of potential hazards (such as asbestos, damaged plant/machinery etc.) and any risks determined and controlled before any work is undertaken.

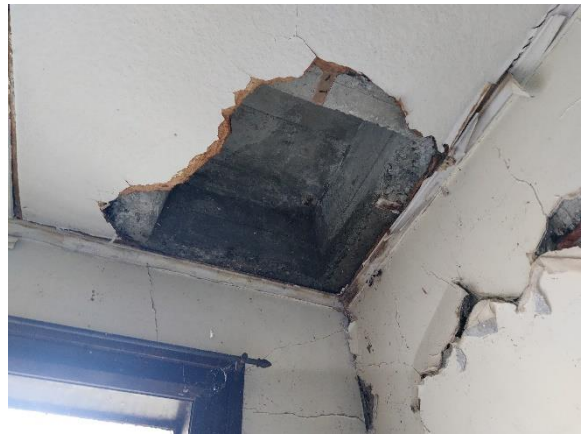
Photo 14: Example of structural damage

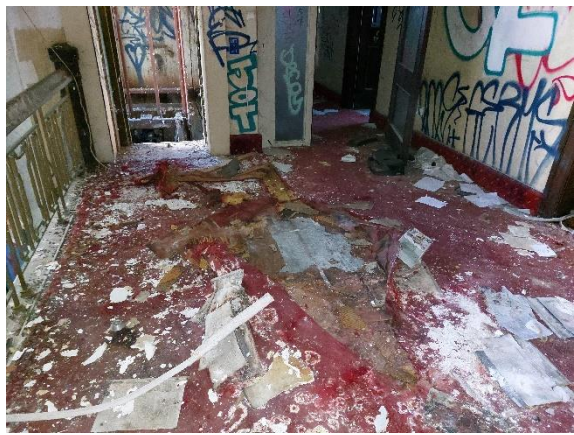
Photo 15: Evidence of condition (L1 Landing)

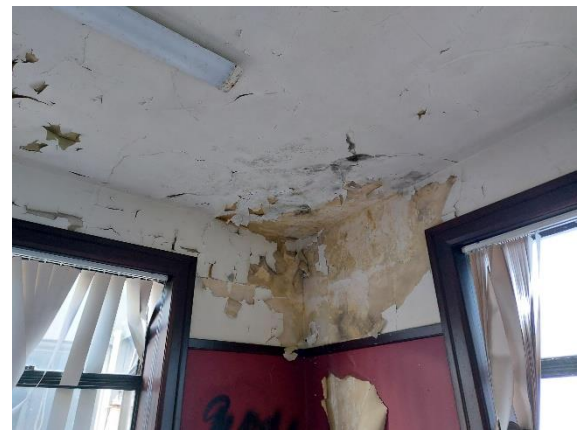
Photo 16: Water damaged area (L1 Room 11)

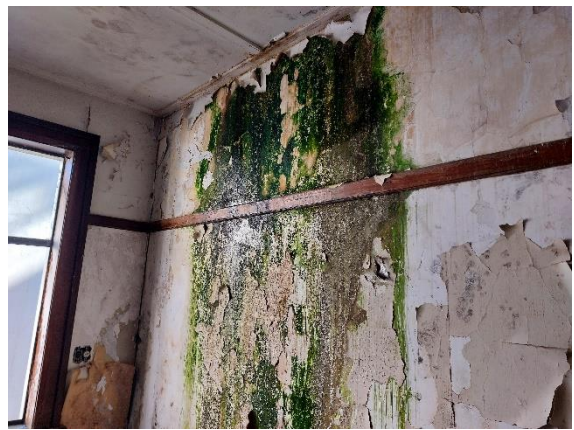
Photo 17: Water damaged area (L2 Room 9)

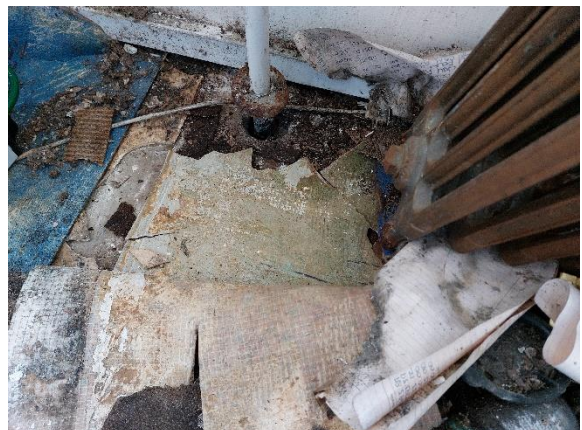
significant water ingress. The elevated result in Room 29 on the second floor is likely due to the water damage observed in the timber floor, carpet and underlay area around the radiator.

Photo 18: Water damaged area (L2 Room 29)

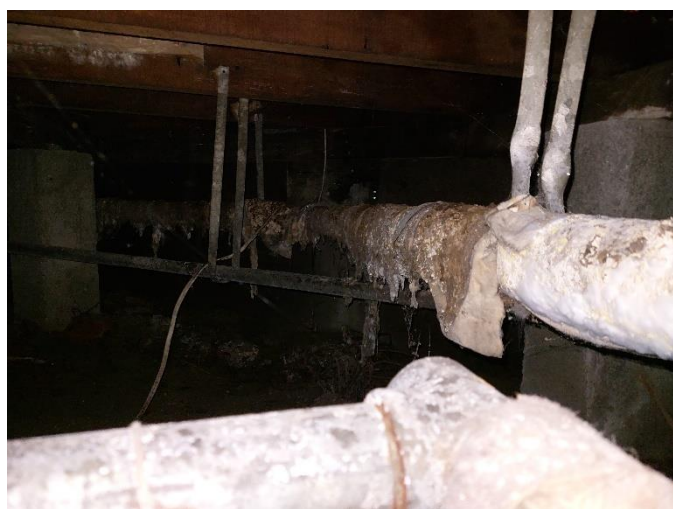
Photo 3: Subfloor – Lagged pipes

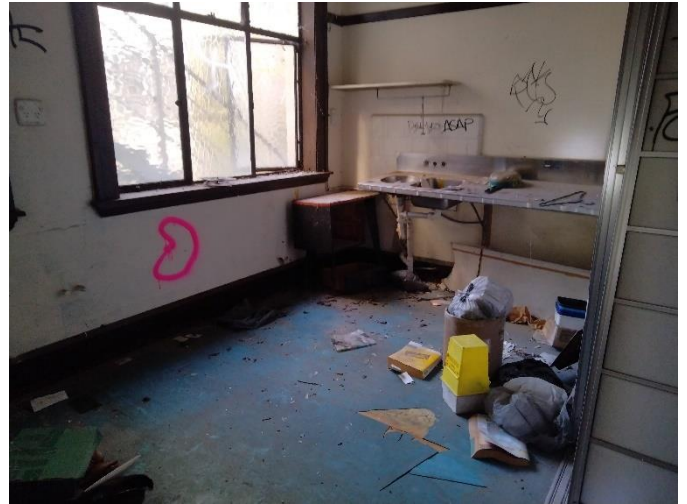
Photo 8: Evidence of condition – Room 9

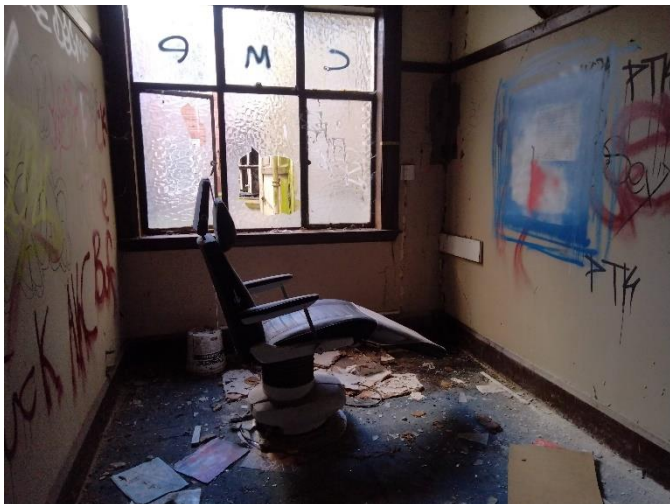
Photo 9: Evidence of condition – Room 9

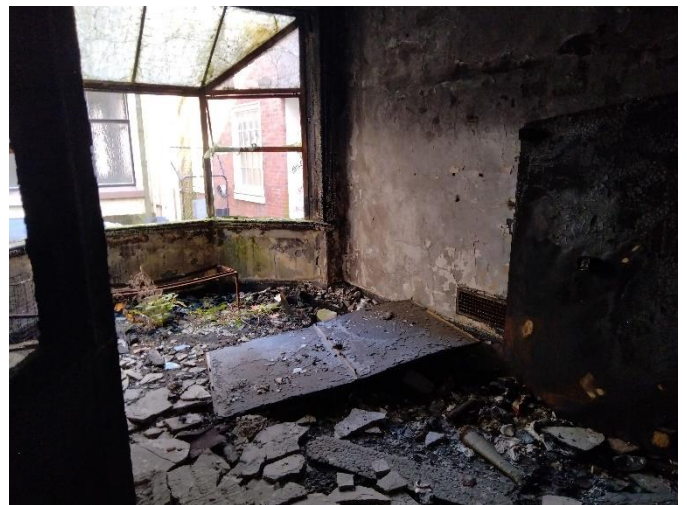
Photo 12: Evidence of condition – Fire damaged parts of Room 1

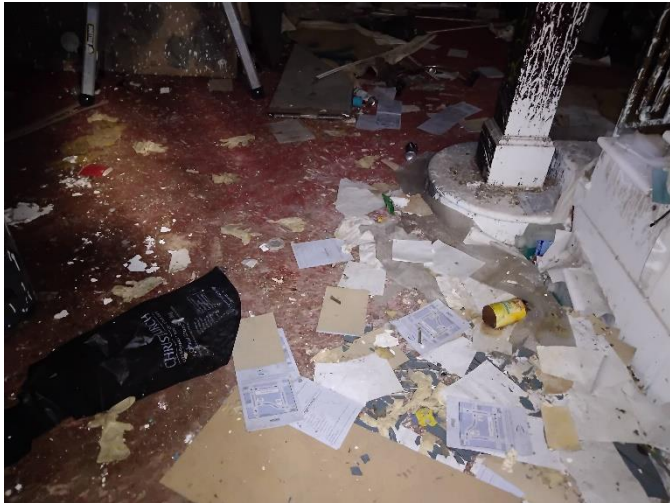
Photo 15: Evidence of condition – Ground Floor Lobby

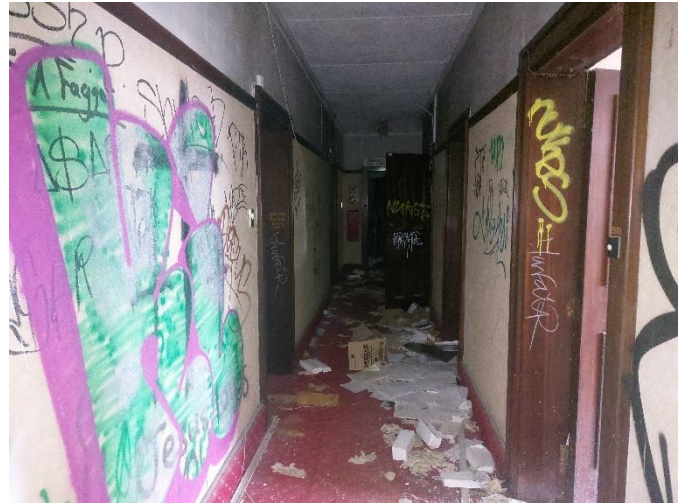
Photo 16: Evidence of condition – First Floor Hallway

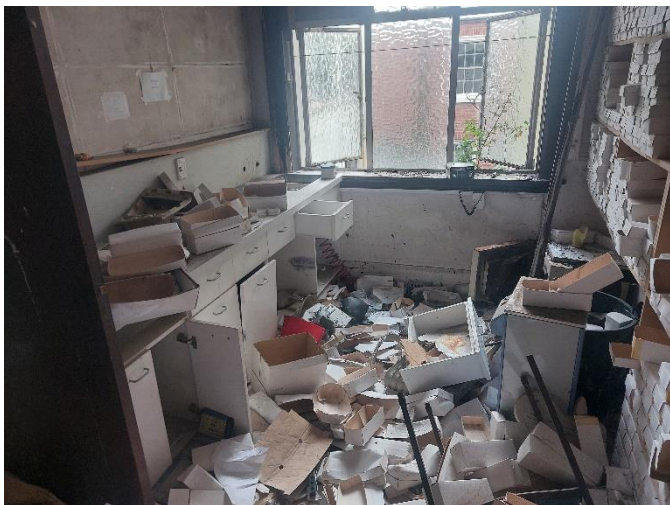
Photo 17: Evidence of condition – Room 20

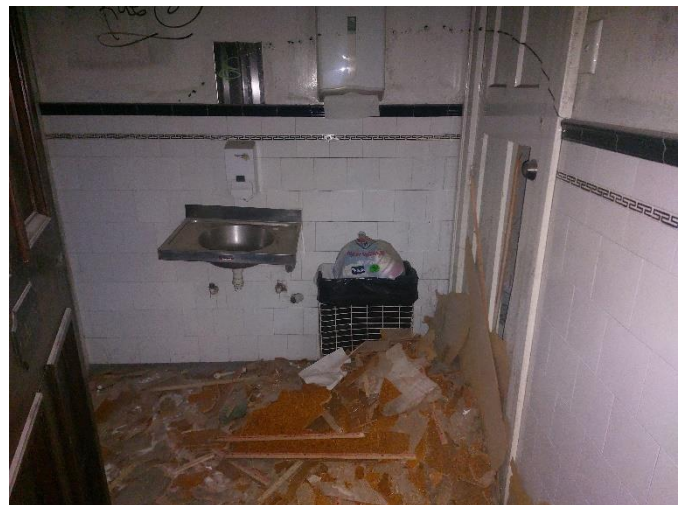
Photo 18: Evidence of condition – First Floor Ladies W/C

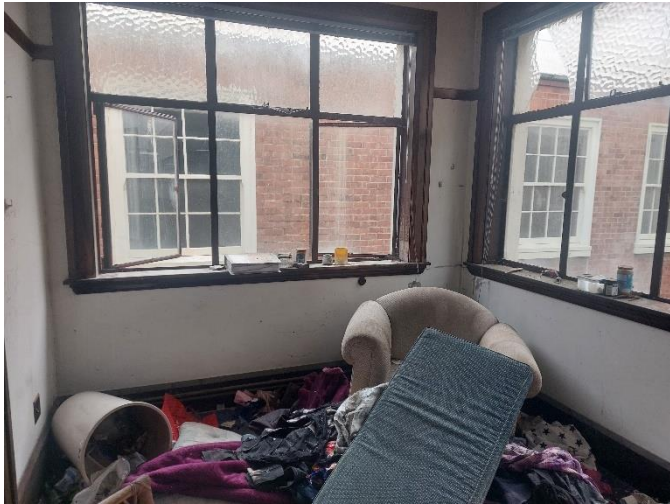
Photo 19: Evidence of condition – Room 19

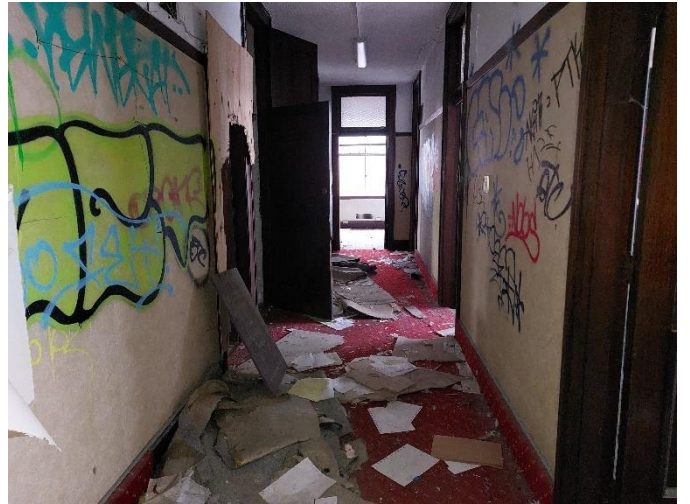
Photo 20: Evidence of condition – Second Floor Hallway

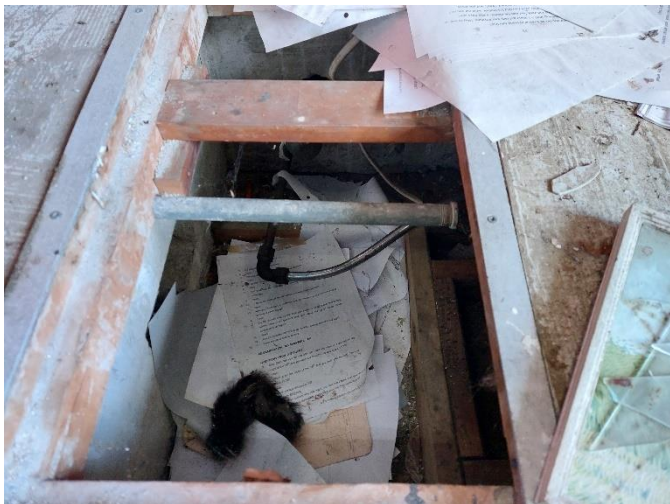
Photo 21: Evidence of condition – Floor space in Room 29

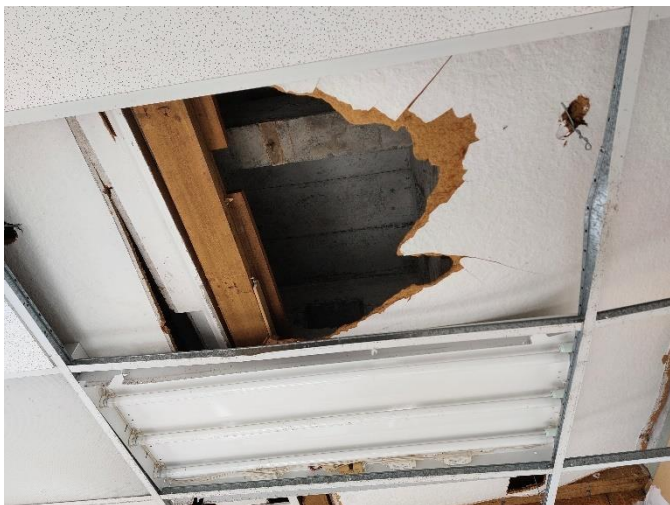
Photo 23: Evidence of condition – Room 30 ceilings

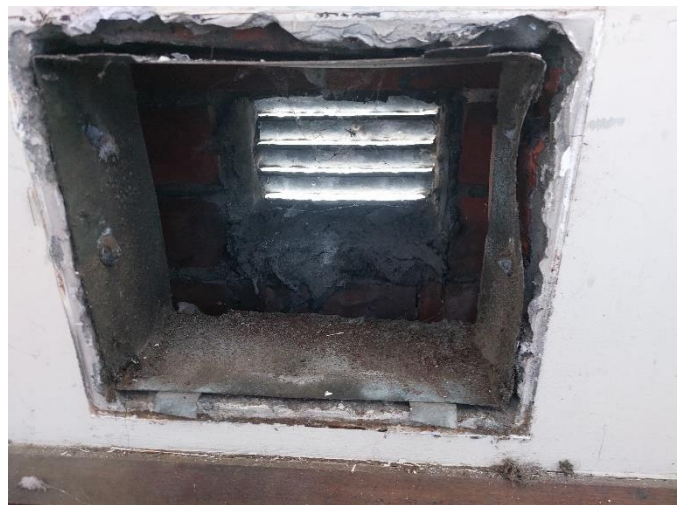
Photo 24: Evidence of condition – Vent to wall

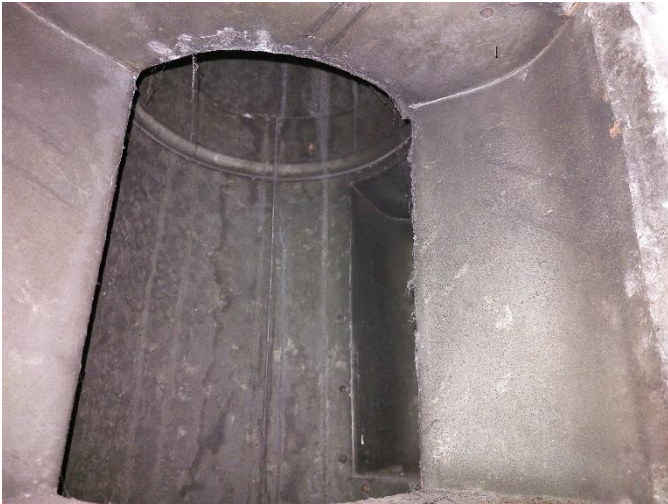
Photo 25: Evidence of condition - Flue within wall in Room 21

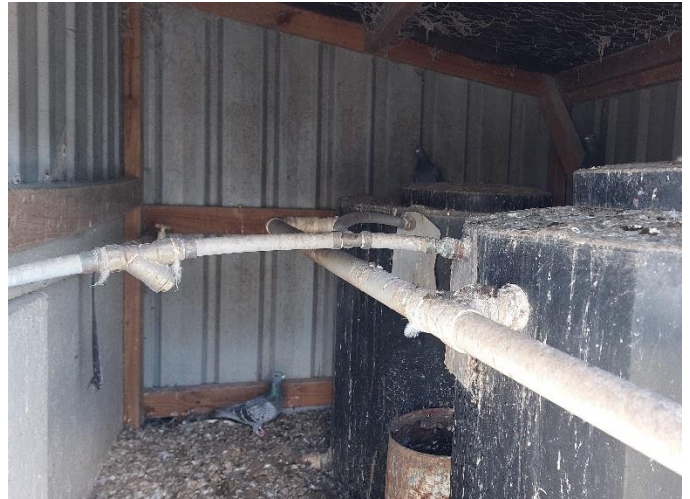
Photo 26: Evidence of condition - Water tanks on roof

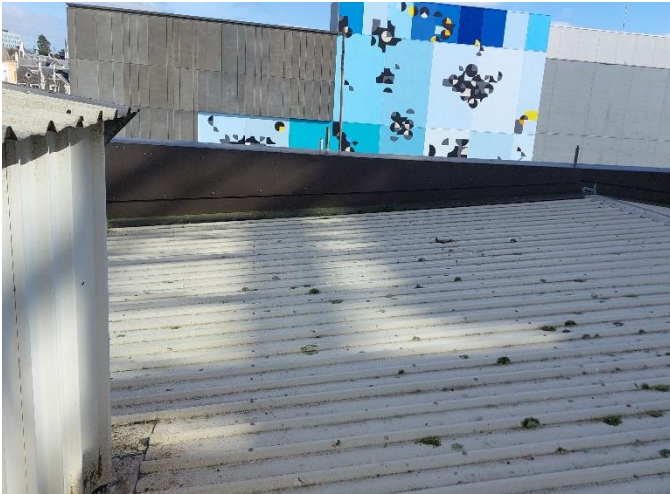
Photo 27: Evidence of condition - Roof to northern section of building

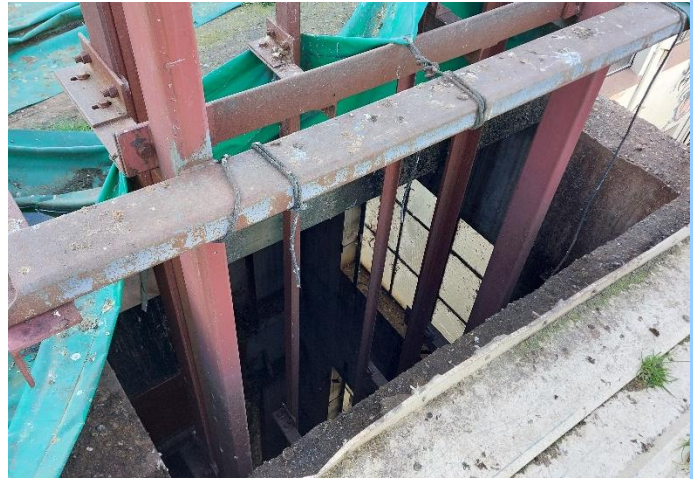
Photo 28: Evidence of condition - Top of lift shaft

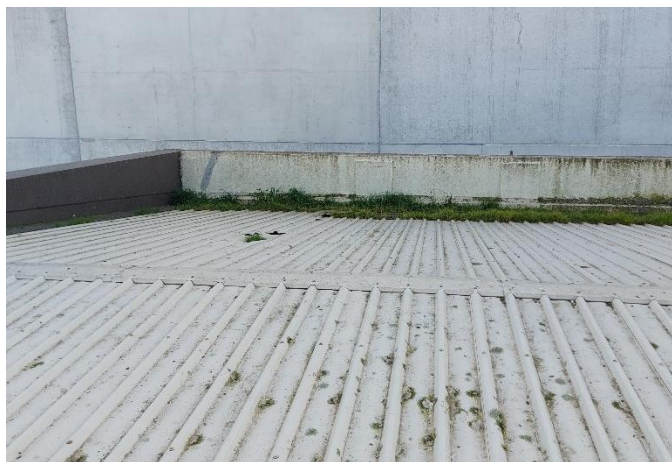
Photo 30: Evidence of condition - Roof to northern section of building
