**STATEMENT OF REBUTTAL EVIDENCE OF CLARA CAPONI ON BEHALF OF
CHRISTCHURCH CITY COUNCIL**

HERITAGE ENGINEERING

CITY-WIDE QUALIFYING MATTERS: HISTORIC HERITAGE

Dated: 9 October 2023

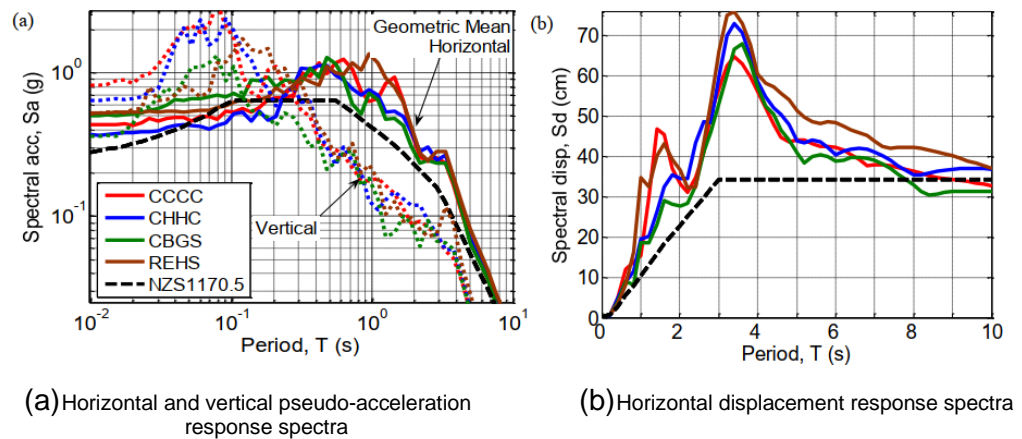
- the seismic demands imposed by the 22 February Earthquake were actually above the 475-year return period design ground motion for Christchurch site class D as specified by the New Zealand Loading Standard NZS1170.5 (see Fig 2(a));
- for structures whose secant period at peak displacement is in the region of 1.5 or 3.5 seconds (as likely would be the case for the St. James Church), the displacement demands imposed by the ground motion were in order of two times the seismic design level (see Fig 2(b)).

Fig 2. Comparison of response spectra from four strong motion stations located in Christchurch Central Business District (CBD).

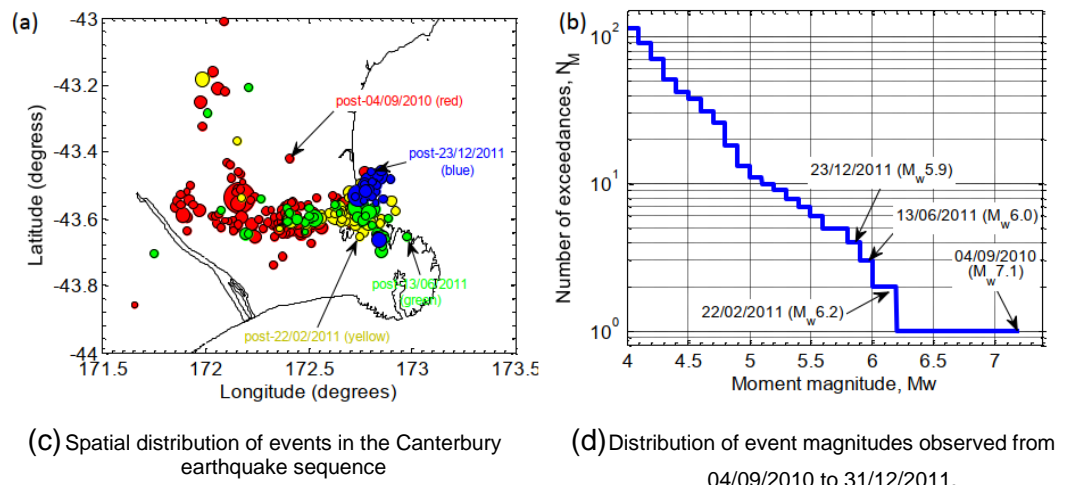
Fig 3. Spatial and magnitudes distribution of the events in the Canterbury earthquake sequence from 04/09/2010 to 31/12/2011.

The data provided in Fig 3(a) and Fig 3(b) demonstrate that St James Church sustained several earthquakes of significant magnitude and from different directivities. Specifically, the building sustained over:
