**STATEMENT OF REBUTTAL EVIDENCE OF JOHN DAVID THORNTON ON
BEHALF OF CHRISTCHURCH CITY COUNCIL**

**Significant Horizontal Elm (*Ulmus glabra* 'Horizontalis') District Plan Tree ID
Number T1118 (300 Stanmore Street)**

Dated: 9 October 2023

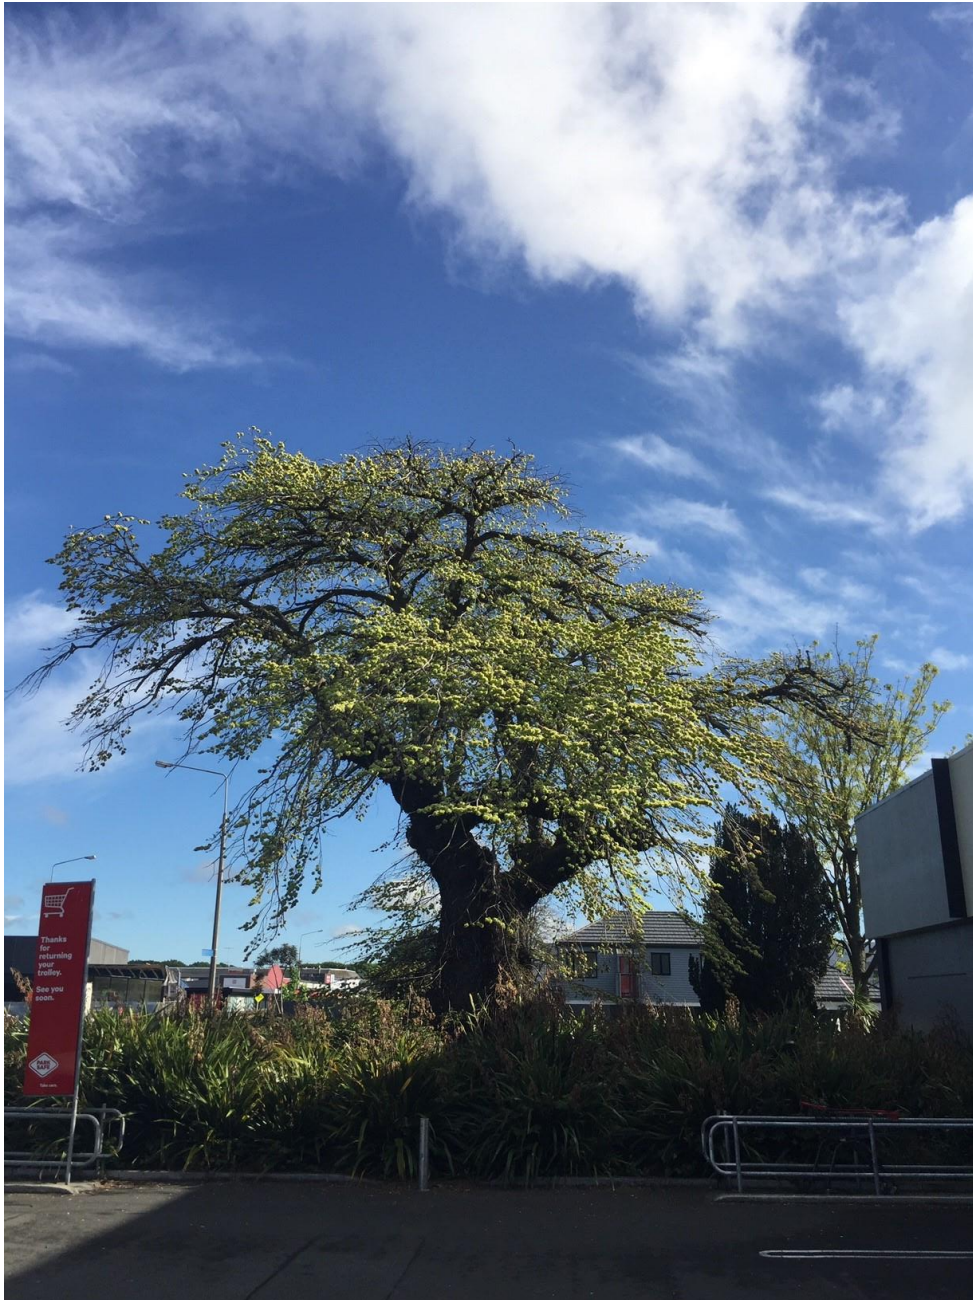
Photo 1: Stanmore Road New World: Ulmus glabra 'Horizontalis'

Questions	Answers
Overall Health of the tree	<i>Ulmus glabra</i> 'Horizontalis' (Burnley Plant Guide, University of Melbourne). Phyto-morphology; the subject tree's vitality can be adjudged 'fair' per both the Urban Visual Vitality Index (Callow et al. 2018) & (Mattheck & Breloer, 1994).
Flax variety	<i>Phormium cookianum</i> 'Green Dwarf' (Flora of New Zealand Volume 2).
Statement as to what may occur if the flaxes were all removed.	Please refer Conclusion & Recommendations.
Statement as to the flaxes and their affect if they were to remain in situ.	Please refer Conclusion & Recommendations.

- i. Noticeably several branches have been removed where the tree has been previously 'lift pruned' to facilitate the building. These pruning wounds are showing reasonable signs of compartmentalisation (callus or 'rams horn') with no visible signs of secondary infection (Shigo 1991).
- ii. The root collar is in good condition with no visible basal damage.
- iii. As a desirable trait of this species, the trunk is relatively straight with no visible adverse discoloration, bark peeling or codominant leaders (Gilman 2003).
