Statement of evidence of Kyle Brookland (building condition
assessment) on behalf of Carter Group Limited

- 7 I was asked by Mr Philip Carter to undertake an inspection of the Blue Cottage at 325 Montreal Street (on the corner of Gloucester and Montreal Street, noting the address is sometimes described as 32 Armagh Street, which is the rear entrance to the wider site).
- 8 I undertook an inspection on 25 August 2023. I carried out the inspection in accordance with NZS 4306:2005 Residential property inspection. I undertook a subsequent inspection for lead paint on 16 September 2023.
- 9 I produced a Building Inspection Report which is attached as **Appendix 1** to my evidence.

Name: Kyle Brookland
Phone: 021 298 7395
Email: kyletheinspector@gmail.com
Date: 25 August 2023.
16 September 2023. Lead Paint Testing.
Time: 9:00 am.
Weather Conditions: Fine.
Site Address: 325 Montreal Street - (Corner of Gloucester & Montreal).
Client: Shane Olivia Limited.

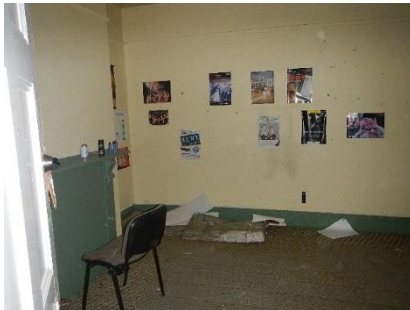
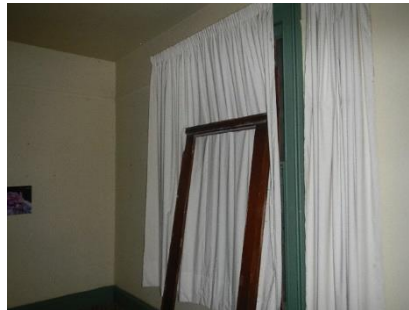
G1

Flooring:	Human excrement is present on the flooring and as a result all timbers will require removal – this may include sections of the subfloor as well.
Walls:	Lath and plaster, painted. Relining of the surfaces will be required due to the timber framing condition – sections of the exterior and interior framing will require replacement due to moisture damage.
Ceiling:	Lath and plaster, painted. Re-lining of the surfaces will be required due to mold present throughout the ceiling cavity.
Doors:	Due for replacement.
Windows:	Timber, single glazed. Due for replacement due to moisture damage.
Heating:	Old fireplace – bricks appear to be from the 1950's.

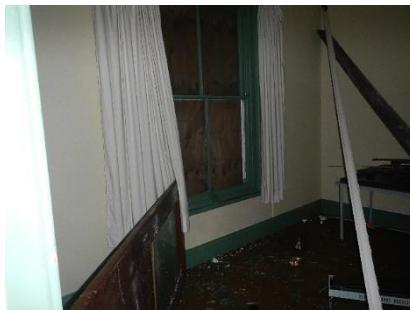
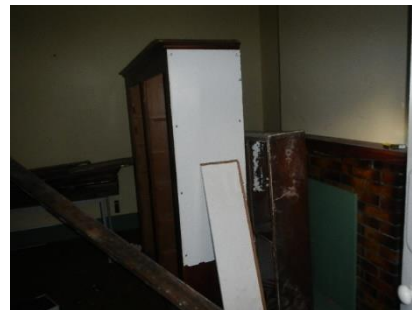
G2

Flooring:	Human excrement is present on the flooring and as a result all timbers will require removal – this may include sections of the subfloor as well.
Walls:	Lath and plaster, painted. Re-lining of the surfaces will be required due to the timber framing condition – sections of the exterior and interior framing will require replacement due to moisture damage.
Ceiling:	Lath and plaster, painted. Relining of the surfaces will be required due to mold present throughout the ceiling cavity.
Doors:	Due for replacement.
Windows:	Timber, single glazed. Due for replacement due to moisture damage.
Heating:	Old fireplace – bricks appear to be from the 1950's.

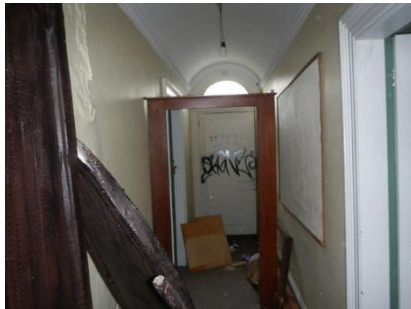
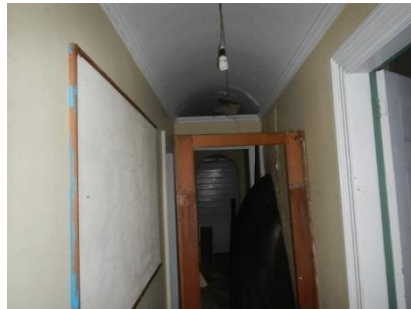
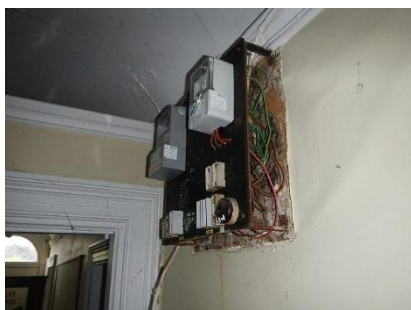
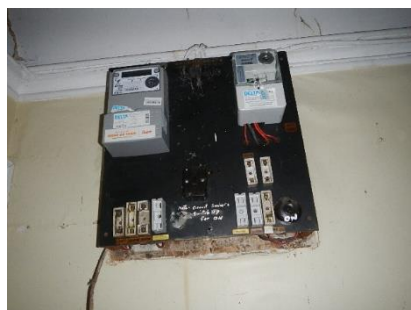
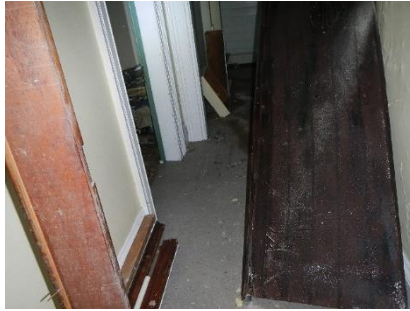
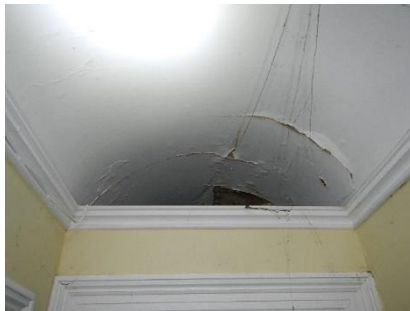
G3 – G8

Human excrement is present on the flooring and as a result all timbers will require removal – this may include sections of the subfloor as well. Section of moisture damage are present to the flooring and the subfloor timbers in this area – directly related to the condition of the roofing – the roof system is not draining correctly and is currently overflowing.

Very high moisture readings were recorded in the walls due to the water ingress from the roofing structure.

Re-lining of the surfaces will be required due to the timber framing condition – large sections of moisture damage are present with structural walls requiring replacement.

Relining of the surfaces will be required due to extensive moisture damage.

The main door leading to the exterior is due for replacement due to moisture damage.

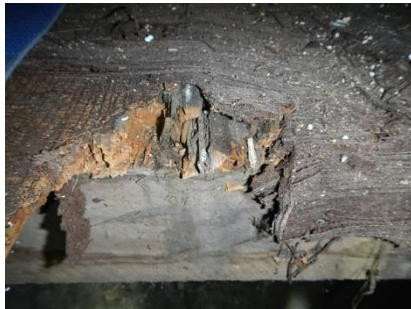
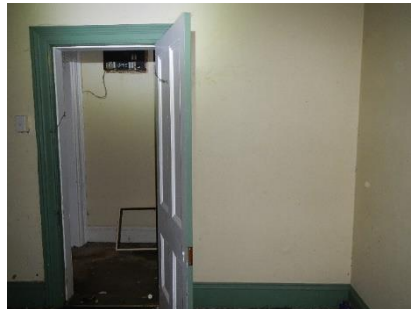
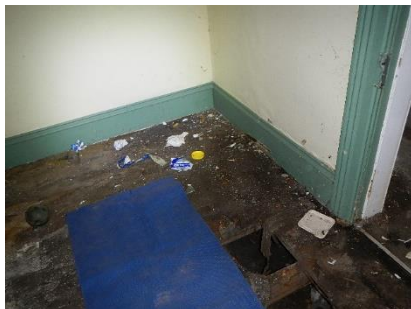
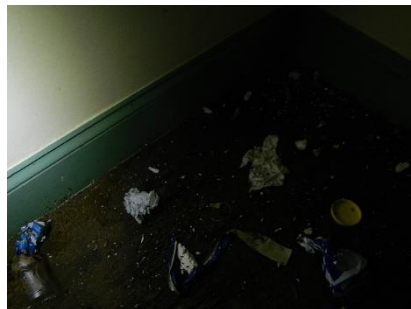
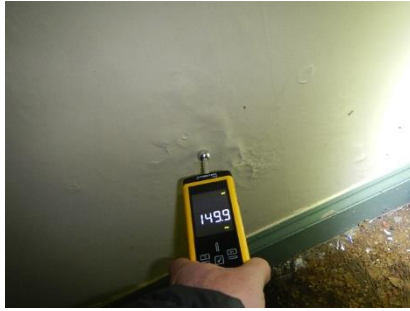
G4

Flooring:	Human excrement is present on the flooring and as a result all timbers will require removal – this may include sections of the subfloor as well. Sections of moisture damage are present to the flooring and the subfloor timbers in this area – directly related to the condition of the roofing – the roof system is not draining correctly and is currently overflowing. Very high moisture readings were recorded in the flooring due to the water ingress from the roofing structure.
Walls:	Lath and plaster, painted. Re-lining of the surfaces will be required due to the timber framing condition – large sections of moisture damage are present with structural walls requiring replacement. Very high moisture readings were recorded in the walls due to the water ingress from the roofing structure.
Ceiling:	Lath and plaster, painted. Relining of the surfaces will be required due to extensive moisture damage.

Doors:	Due for replacement due to moisture damage.

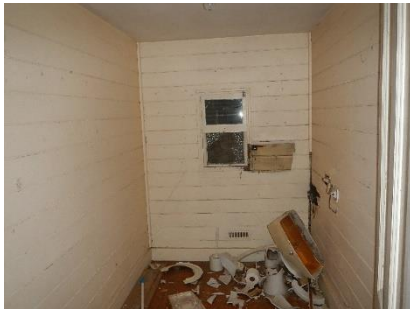
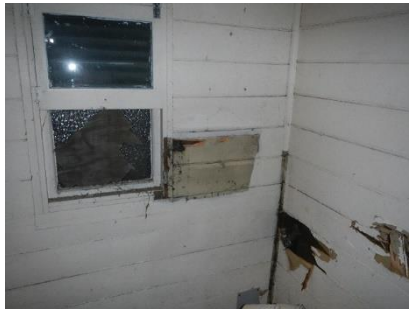
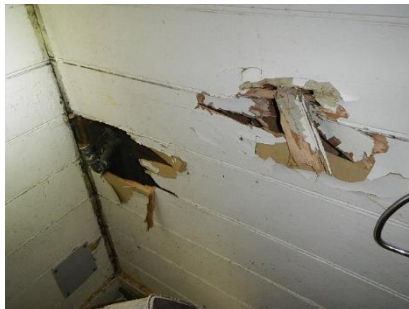
G6

Flooring:	Tiles over an assumed concrete substrate – this floor appears to have been installed in the 1950's.
Walls:	Painted timbers. Re-lining of the surfaces will be required due to the timber framing condition – large sections of moisture damage are present with structural walls requiring replacement.
Ceiling:	Painted timbers. Relining of the surfaces will be required due to extensive moisture damage.
Doors:	Due for replacement due to moisture damage.
Sewer:	The toilet is broken, and the line is currently open.

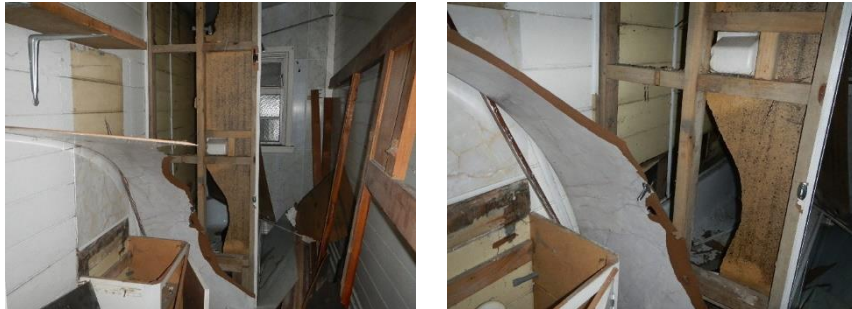
G7

This room requires a full re-fit and appears to have been installed in the 1950's and does not appear to be original to the property.

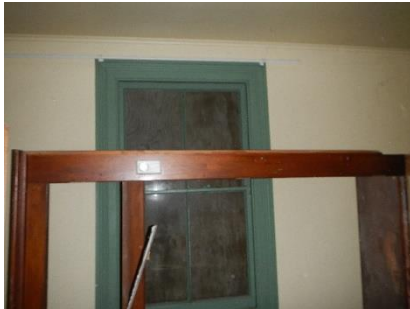
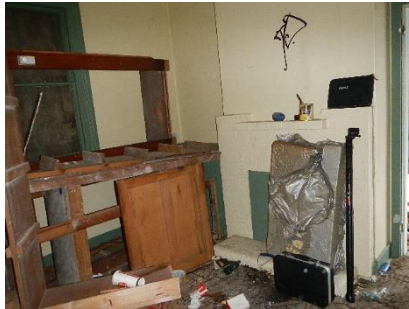
G10

Flooring:	Human excrement is present on the flooring and as a result all timbers will require removal – this may include sections of the subfloor as well.
Walls:	Lath and plaster, painted. Re-lining of the surfaces will be required due to the timber framing condition.
Ceiling:	Lath and plaster, painted. Relining of the surfaces will be required due to extensive moisture damage.
Heating:	Old fireplace – bricks appear to be from the 1950's.

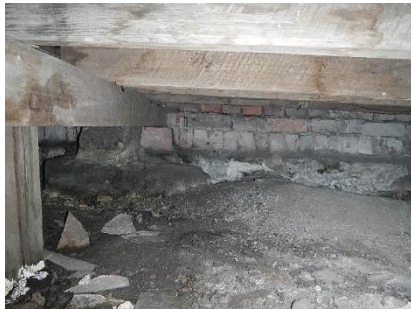
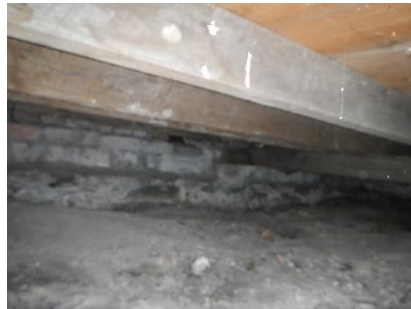
Foundation System

Construction Type:	Stone perimeter ring beam.
Condition:	There are sections of movement to the foundation with sections of re-levelling required.
Timber Flooring:	Numerous sections of the flooring will require removal and replacement due to moisture damage and contamination of the flooring.
Subfloor Timbers:	There are sections of borer damage present with sections of moisture damage also present around the center of the property due to water ingress.

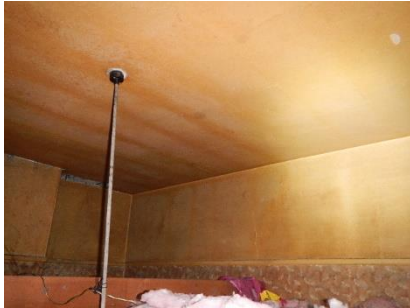
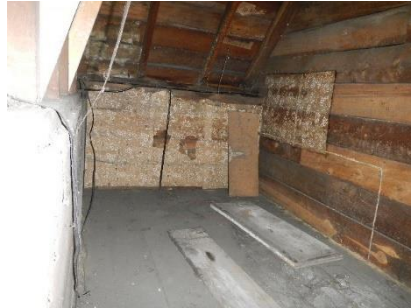
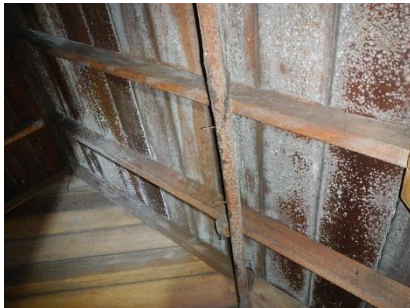
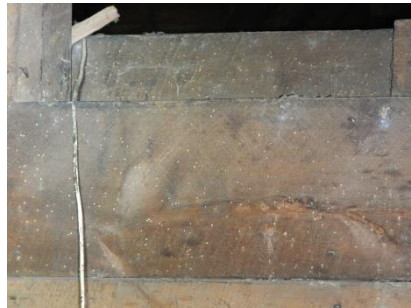
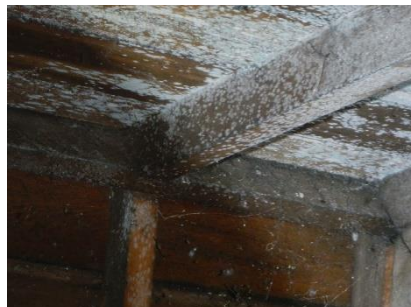
The timber framing is covered in mold and testing is required prior to any
Due to the mold and border present it is likely to require complete
replacement of all timbers above the top plate of the timber framing.

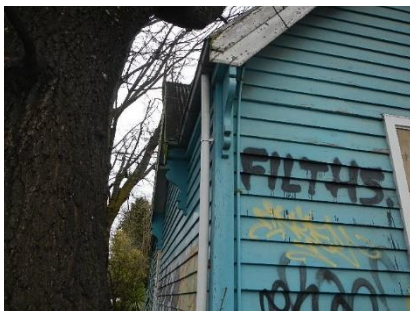
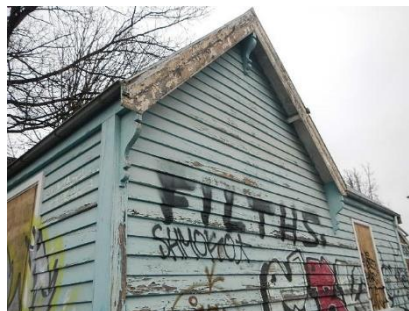
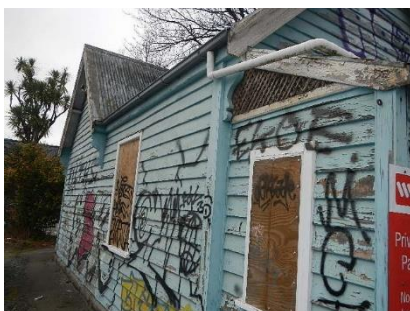
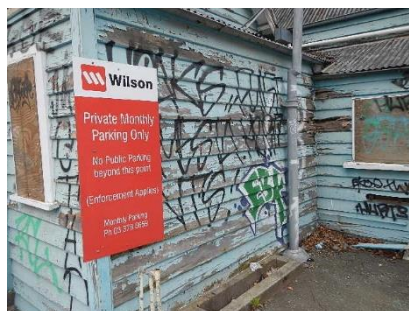
Wall Cladding

All of the doors to the exterior will require replacement due to extensive moisture and impact damage.

There is currently direct contact with the surrounding soils – this is likely to have caused damage to the cladding – framing and the subfloor timbers. ground clearance present.

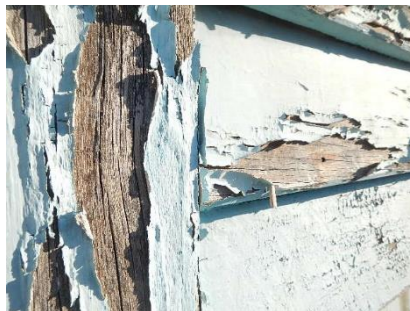
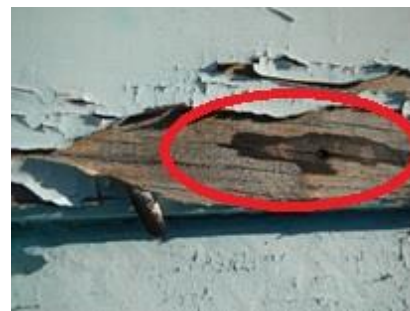
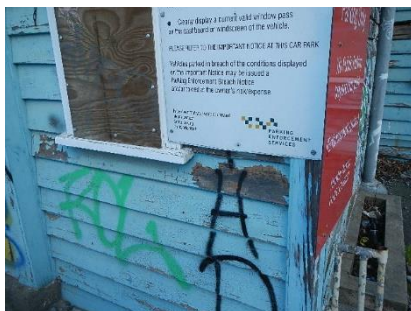
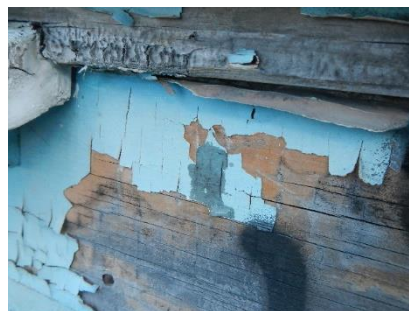
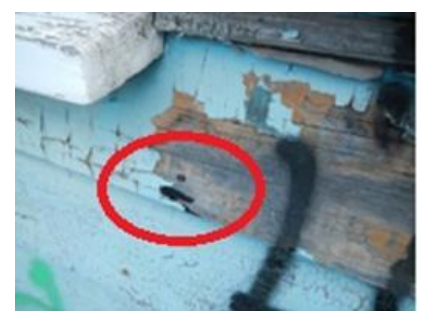
G1 G4 G7 Elevation.

Instant paint reaction confirming the presence of lead paint.

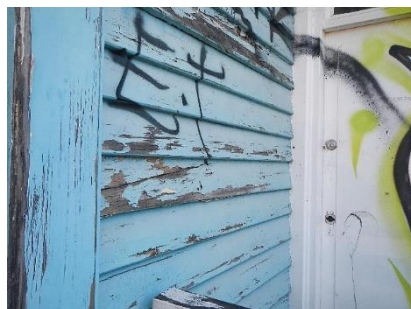
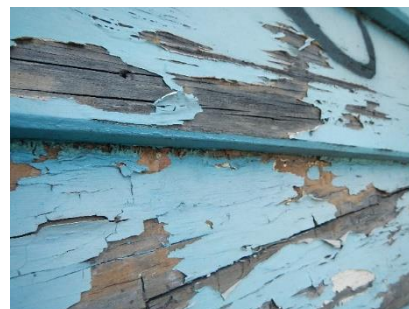
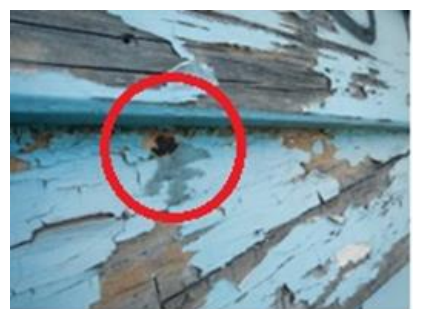
G1 G2 Elevation.

Instant paint reaction confirming the presence of lead paint.

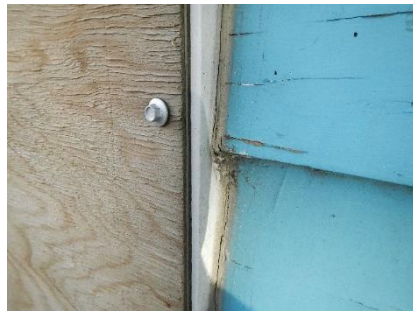
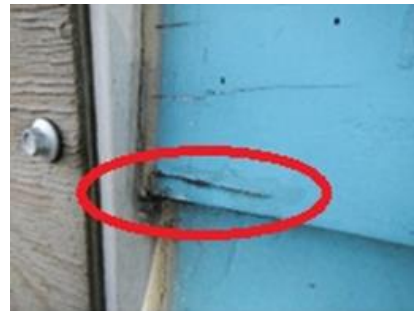
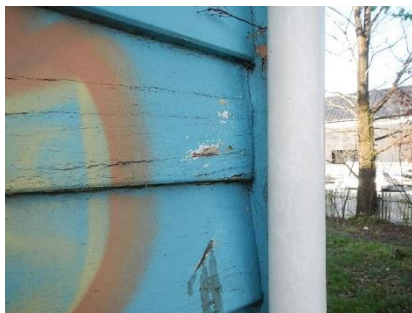
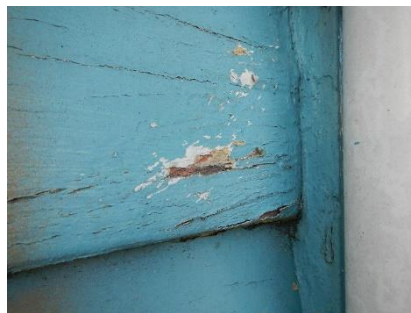
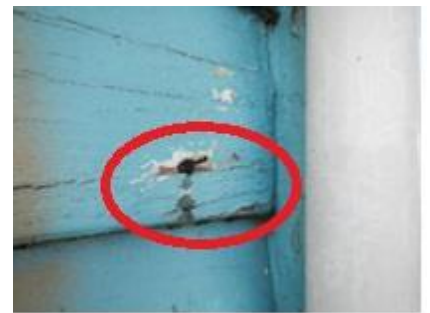
G2 G5 G6 G10 G11 Elevation.

Instant paint reaction confirming the presence of lead paint.

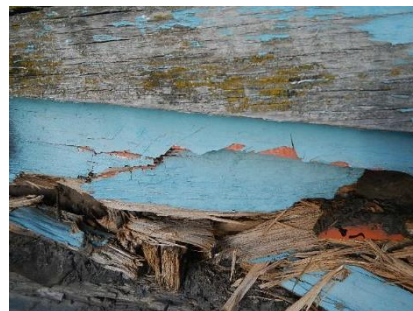
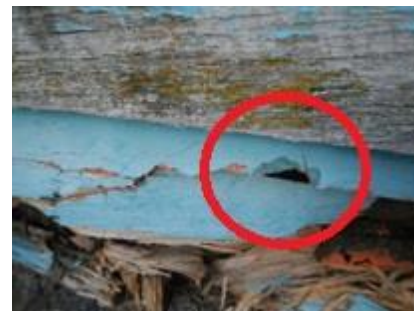
G7 G9 G11 Elevation.

Instant paint reaction confirming the presence of lead paint.
