STATEMENT OF EVIDENCE OF BRETT ANDREW GILMORE ON BEHALF OF CAMBRIDGE 137 LIMITED

HEARING TOPIC: QUALIFYING MATTER: HERITAGE (HERITAGE SITES)

Structural Report to Accompany Assessment of Environmental Effects & Resource Consent Application

Quoin Structural Consultants	Project	Harley Chambers & Worcester Chambers
Level 2, 138 Victoria Street Christchurch 8013 PO Box 25 438 Christchurch 8144		Buildings
03 968 4925 quoin.co.nz	Client	Lee Pee Limited
	Address	137 Cambridge Terrace, Christchurch & 69 Worcester Boulevard, Christchurch

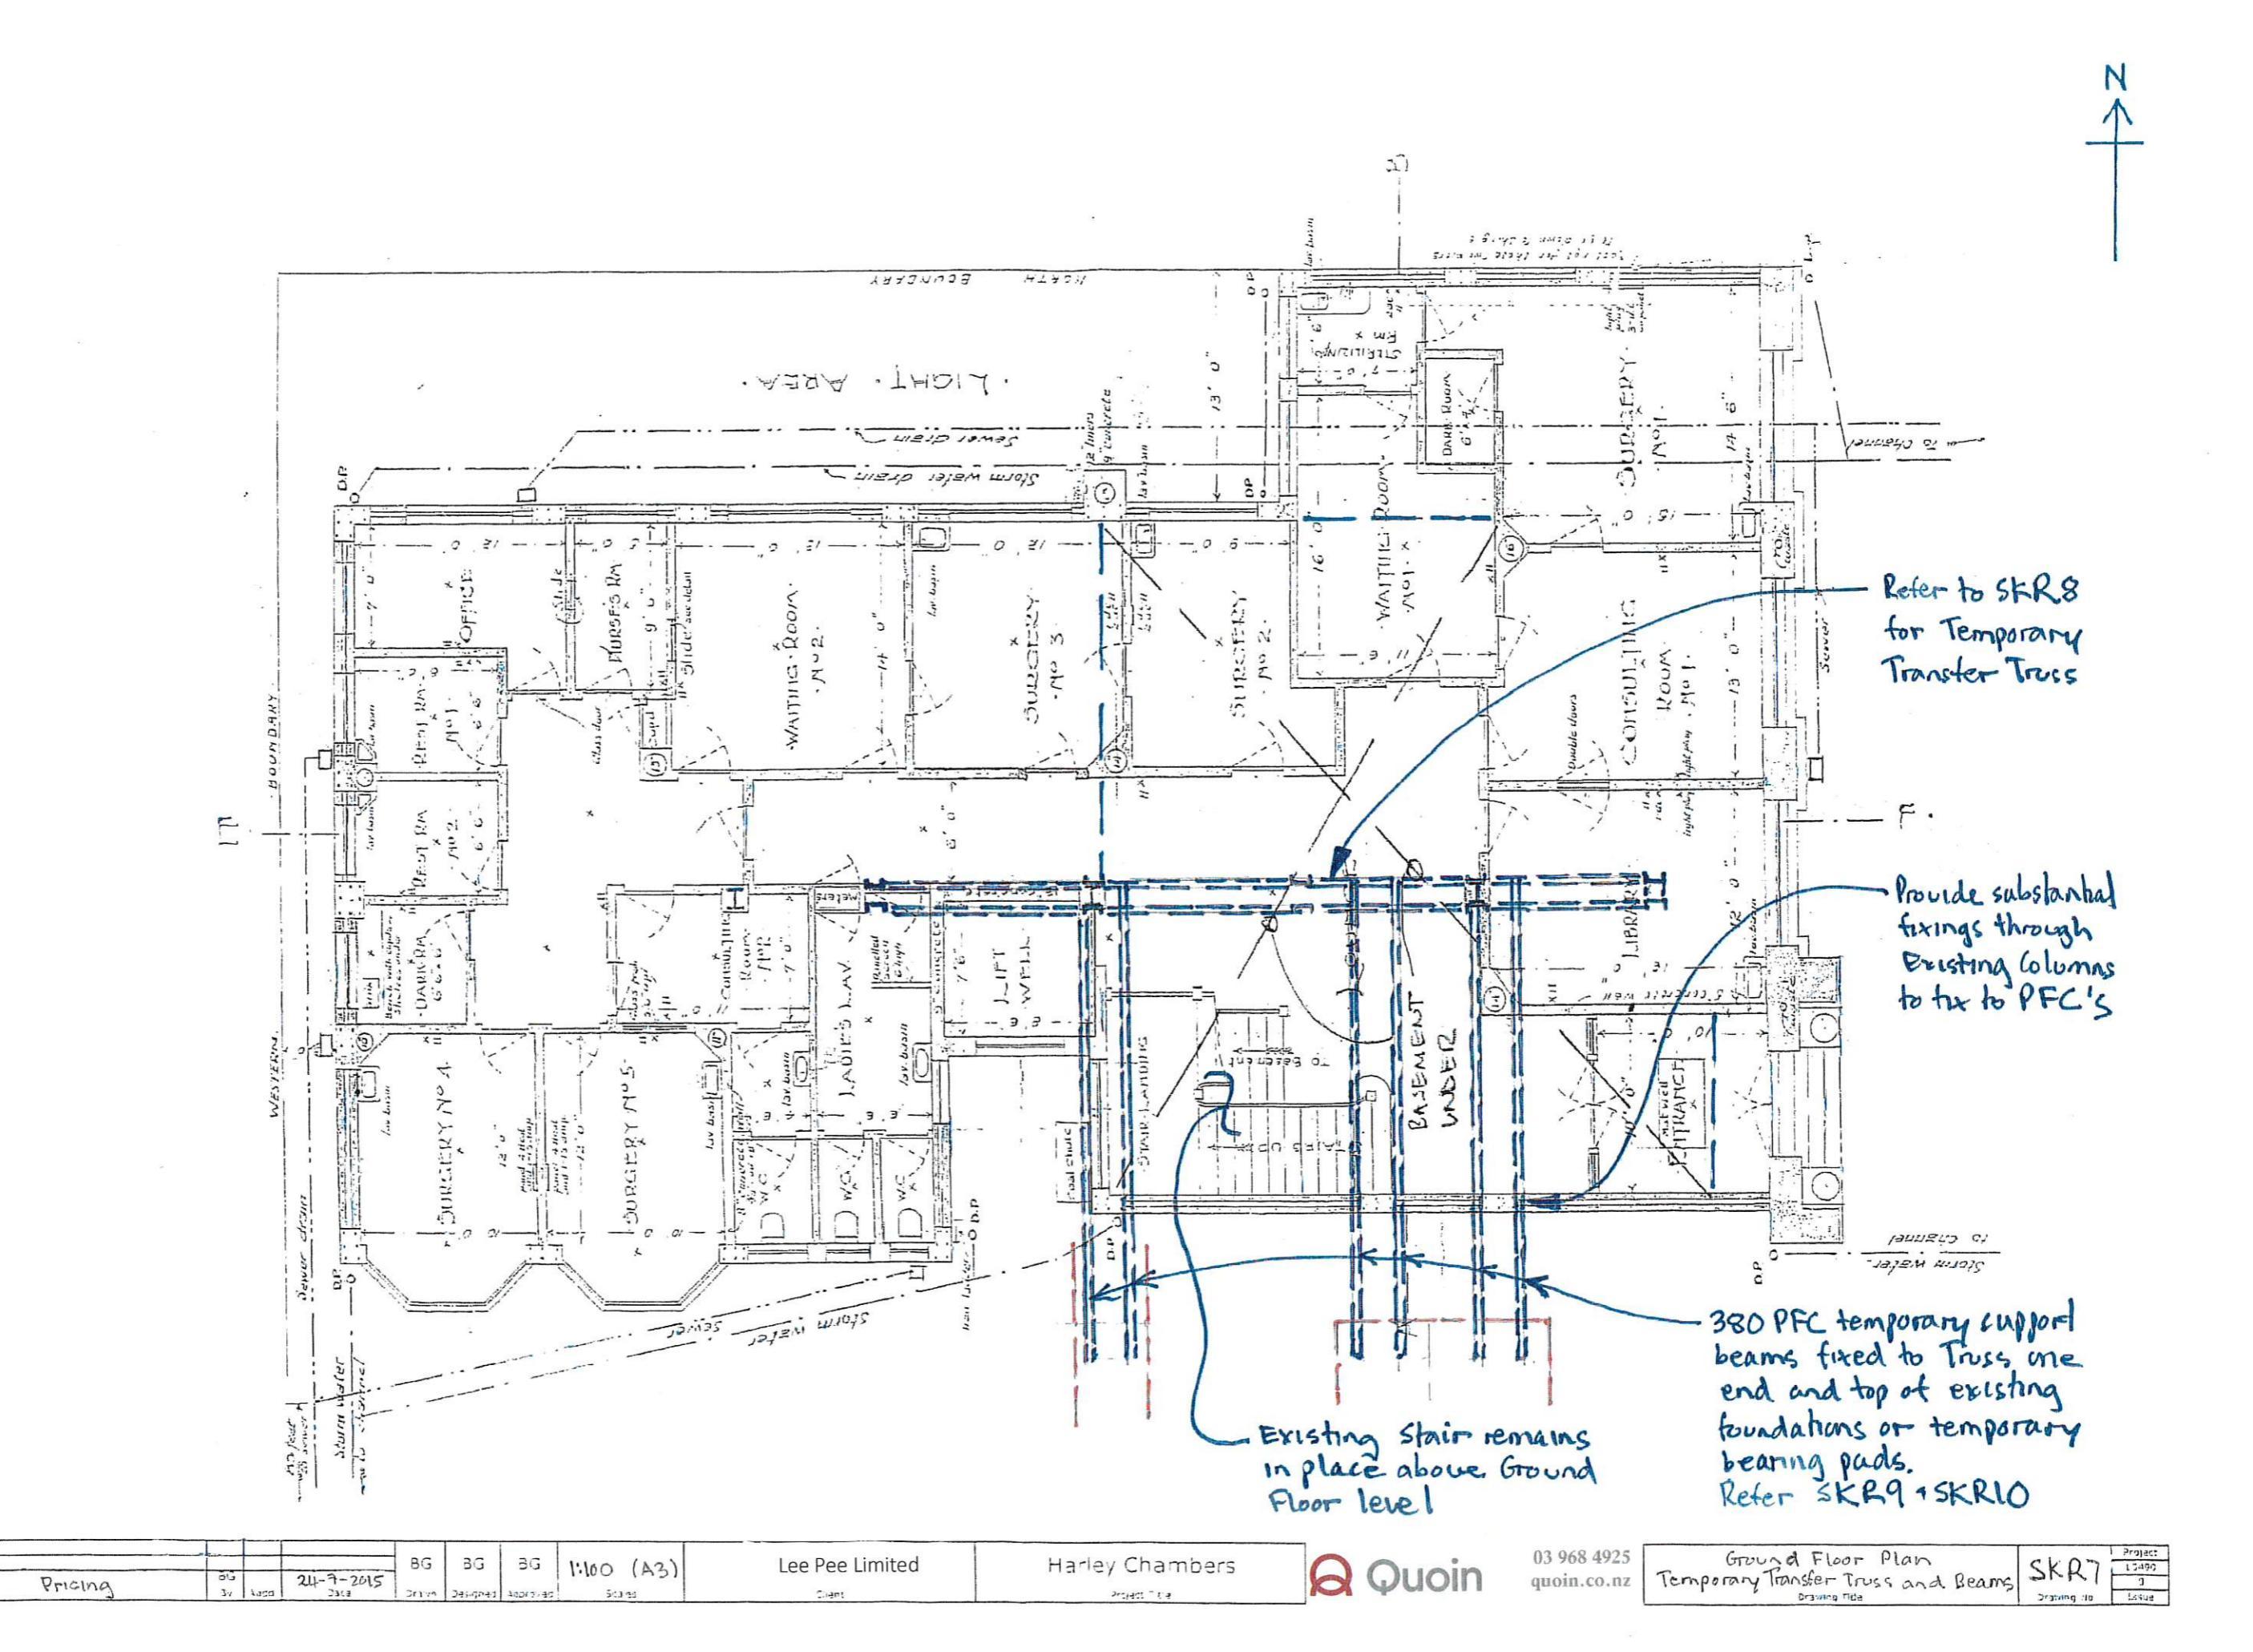
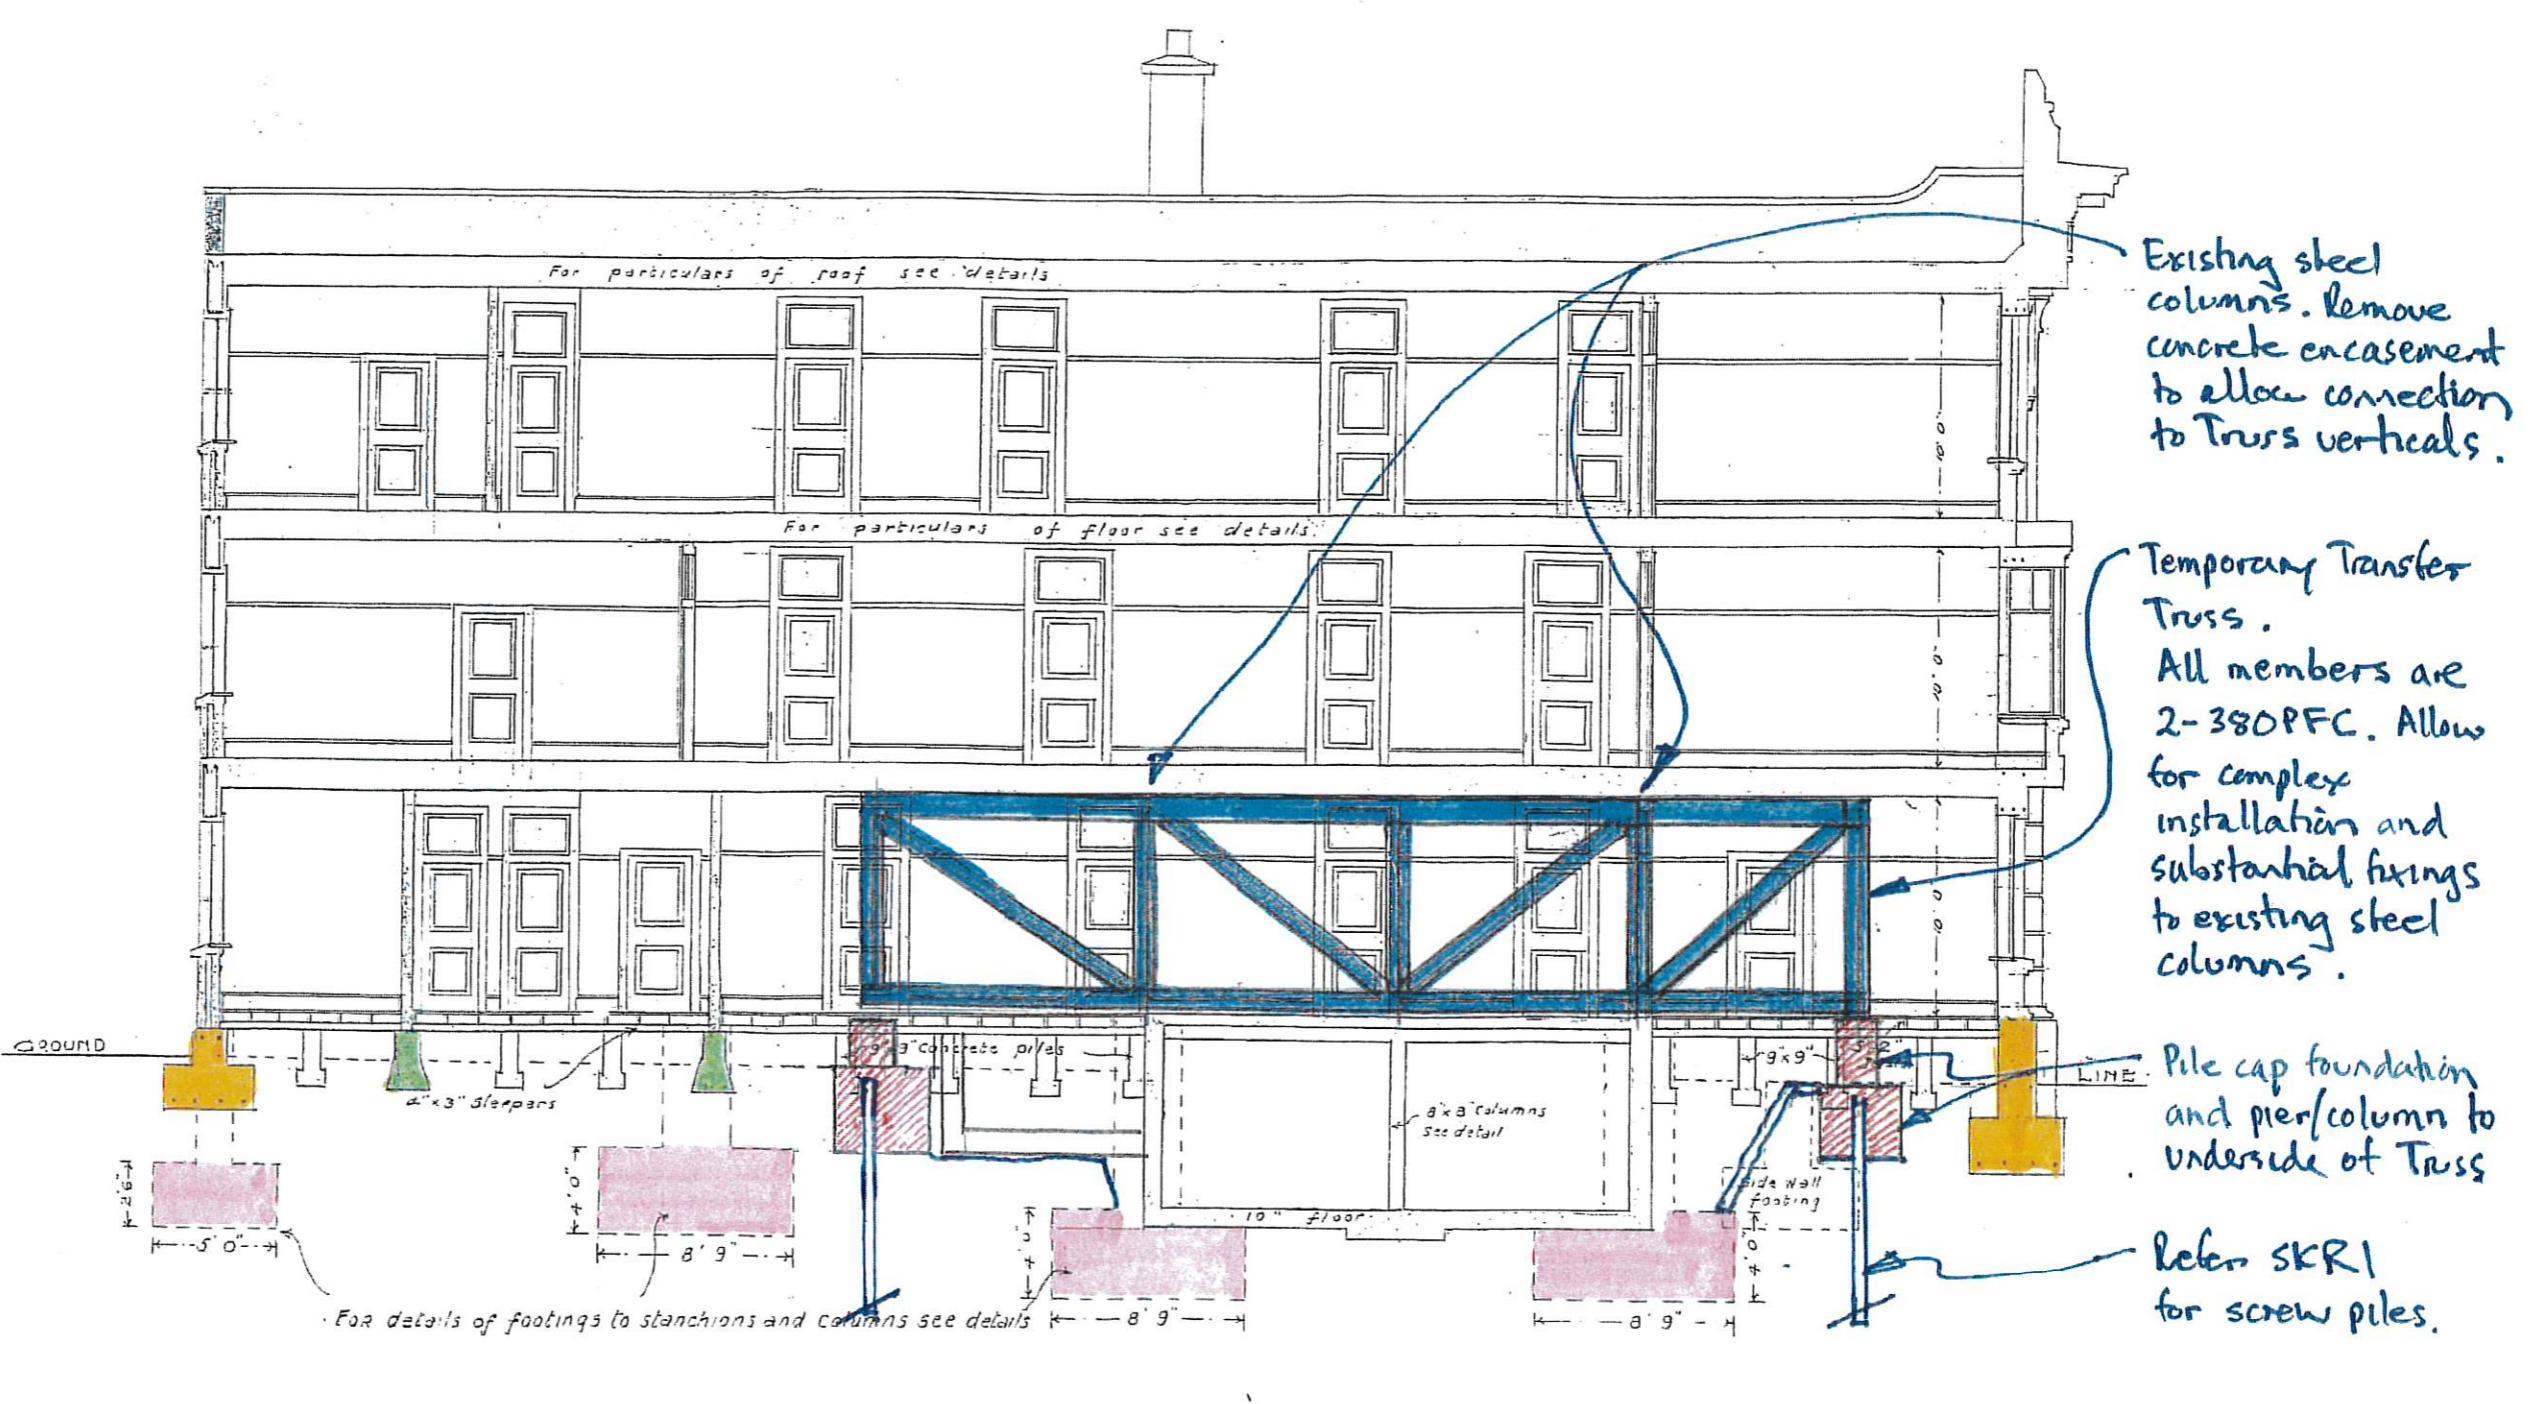
03 968 4925 quoin co nz	Basement Reconstruction Section E.F	SKR6 11490
quomicoinc	Drawing Title	Drawing lia 1 Issue ,

· LOHGITUDIMAL · SECTION · E.F.

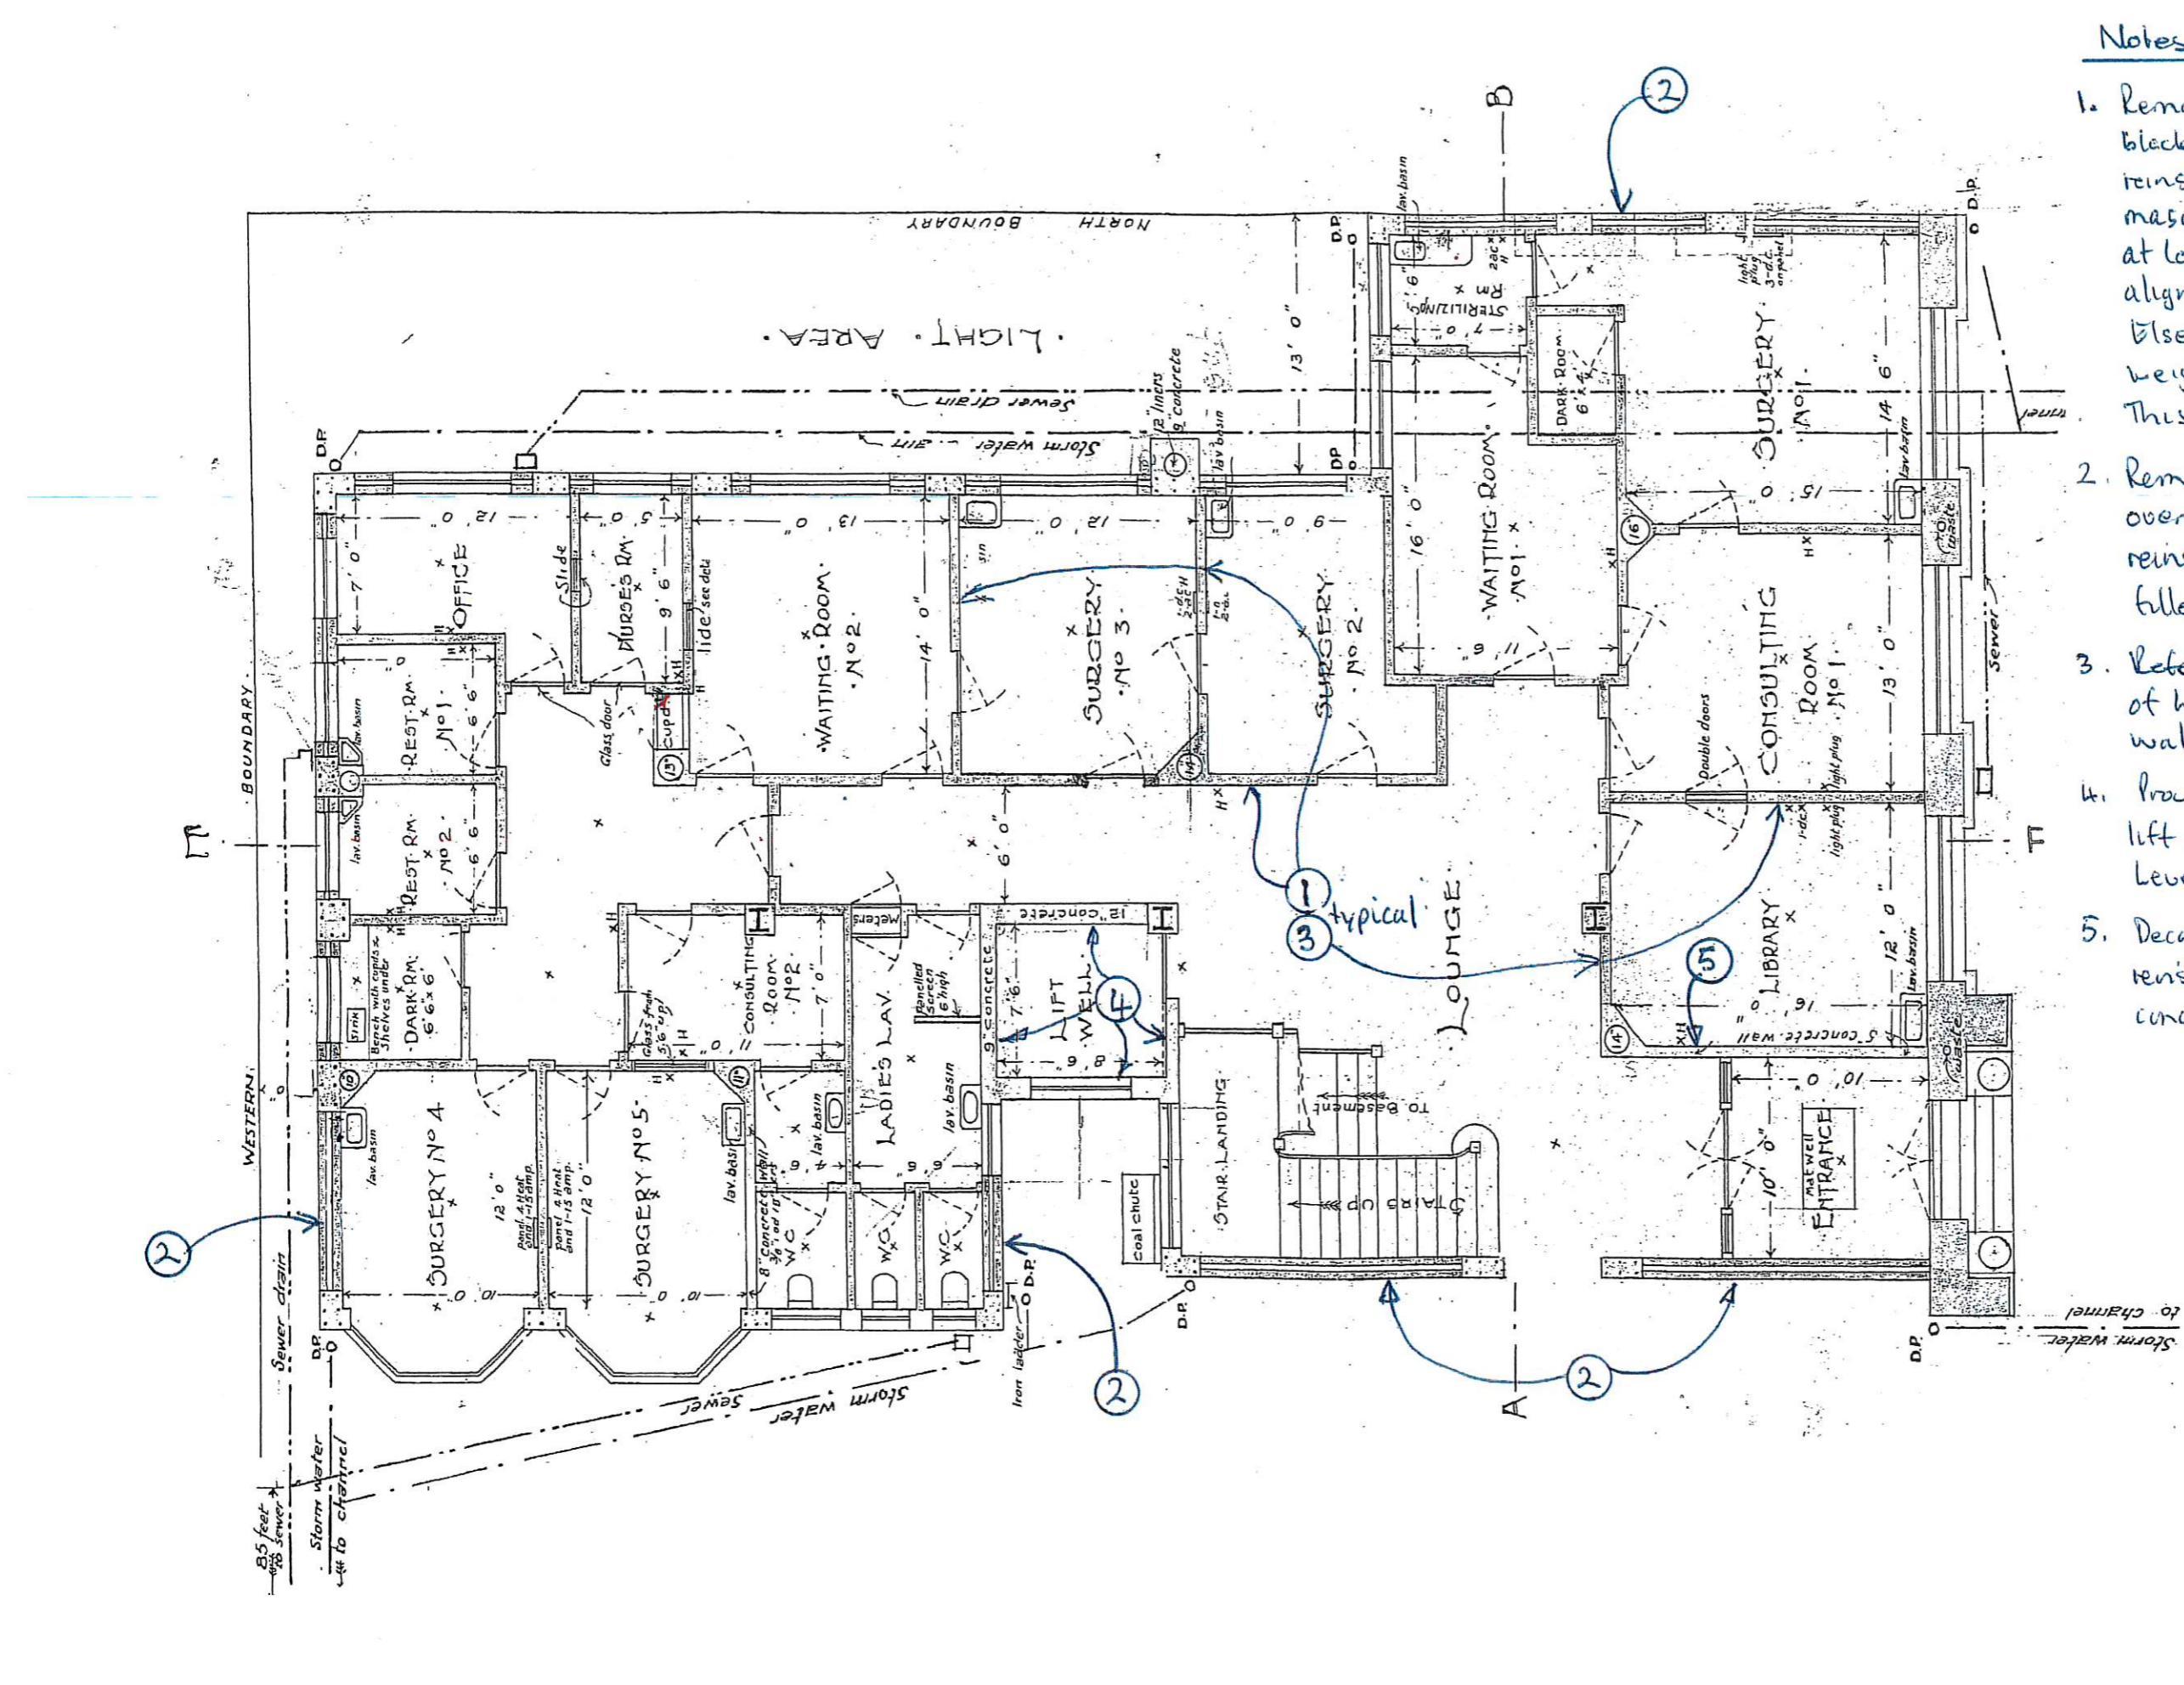
1. Renove all hollow masonry black partition walls and reinstate with 190 solid filled masing block, reinforced, at locations where the walls align above/below floors. Elsenhere, replace with light weight non-stouctural walls. This occurs at all floors,

- 2. Remove double bick walls over full height and reinstate with 240 solid filled masoning block, reinforced.
- 3. Leter to SKID for extent of hollow brick partition walls.
- 4. Proude new reinforced concrete lift shaft walls above Level 2 floor.
- 5. Decembract concrebe wall and revisibile with new 200 mm the concrete wall
