in the matter of: proposed Plan Change 14 to the Christchurch District
Plan

Statement of evidence of David Hill (architecture) on behalf of
Carter Group Limited

THE BLUE COTTAGE – ARMAGH STREET

PHOTOS OF EXISTING

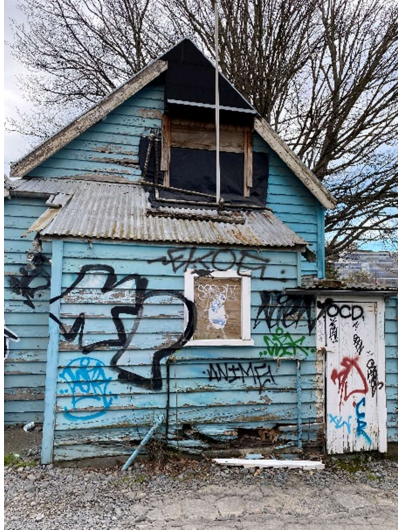
West Elevation (1st gable end where chimney collapsed in earthquake)

- 11.2 the original bullnose veranda sheltering the entry has been removed and an accessible ramp installed;
 - 11.3 two of the original chimneys have been removed and the third one that collapsed during the earthquake has not been replaced;

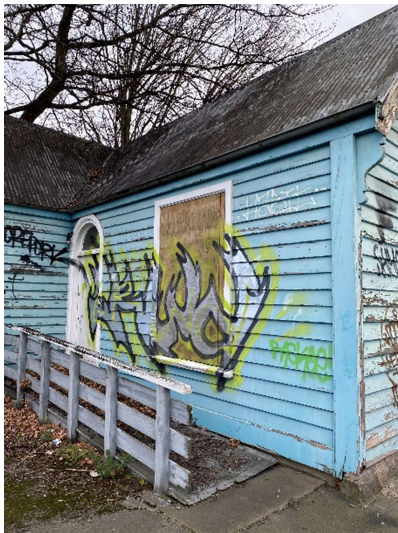
East Elevation

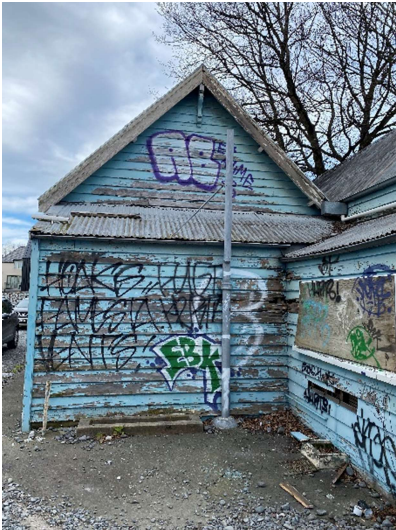
West Elevation (2nd gable end)

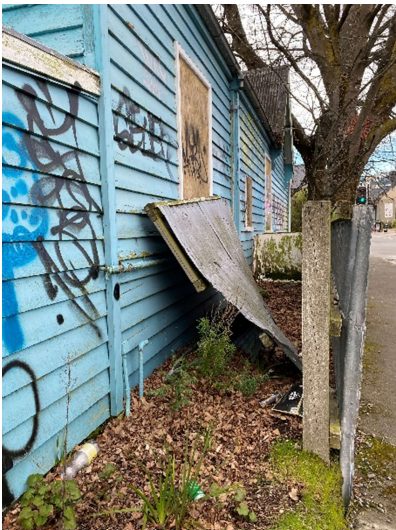
Gloucester St face

- 14 The ground levels on the Gloucester St side would need to be lowered to expose the sub floor foundation vents / foundation walls and the floor relevelled.

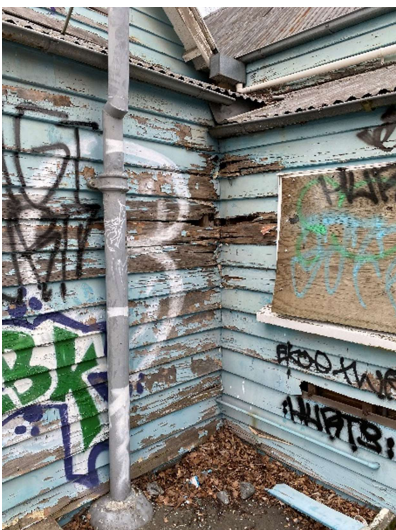
Cladding deterioration

- 9 The building is currently in an advanced state of deterioration. It suffered significant damage that compromised its weather tightness in the 2011 earthquakes that has not been repaired and has remained unoccupied since then.

- 10 The building has suffered significant damage from water ingress and from people squatting in it. Its kitchen and bathroom have been vandalised and it has suffered some damage from a fire set in one of the rooms. I have included photos of the existing state of the building as an appendix to this evidence.

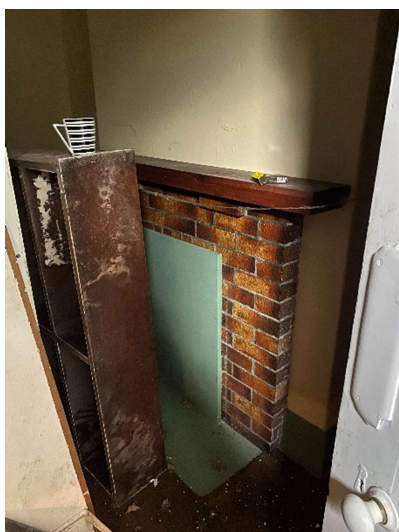
Fireplace that replaced one of the original

- 11.4 two of the three original fireplaces have been replaced with more modern fireplaces;
 - 11.5 a number of the original doors, ceiling cornices and other interior trim has been removed;

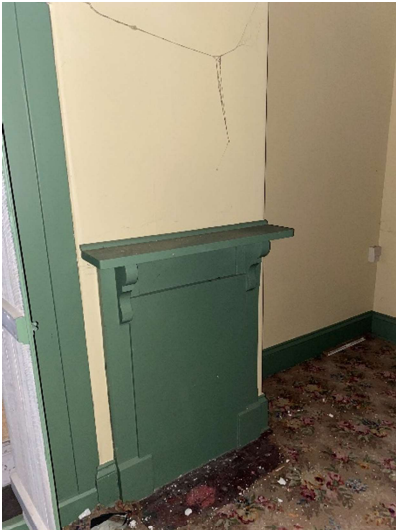
Original fireplace

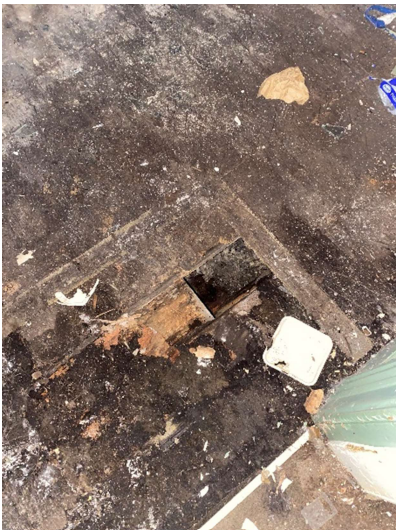
Fire damage to floor

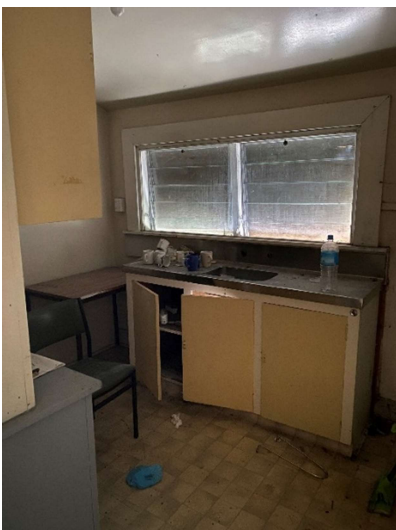
Kitchen

- 15.3 existing & new timber framed windows will need to be double glazed;
 - 15.4 a new kitchen, bathroom & laundry facilities will need to be installed;

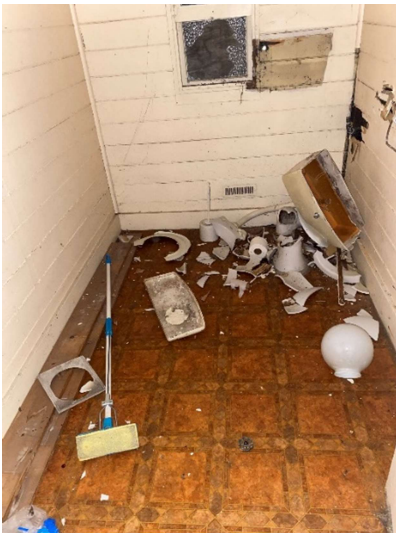
Bathroom
