UNDER the Resource Management Act 1991
IN THE MATTER of proposed Plan Change 14: Housing and Business
Choice to the Christchurch District Plan
AND
IN THE MATTER of Cambridge 137 Limited (Submitter 1092)

**JOINT STATEMENT OF EVIDENCE OF JONATHAN LYTTLE AND MICHAEL
DOIG ON BEHALF OF CAMBRIDGE 137 LIMITED**

QUALIFYING MATTER: HERITAGE (HERITAGE SITES)

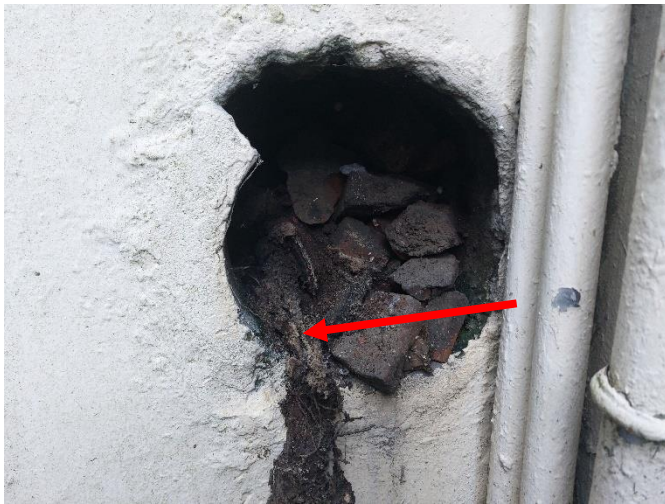
Product Type	AIB, millboards, textiles, gaskets, ropes	2	Material Score
Extent of Damage	High Damage	3	8
Surface Treatment	Unsealed	2	Risk
Asbestos Type	Chrysotile	1	Medium

Comments: Restrict access.
Quantity unknown due to limited visual access to the chimney, but could be located up the entire height of the chimney.

Recommendation: Remove prior to refurbishment / demolition works.
(Class A material)

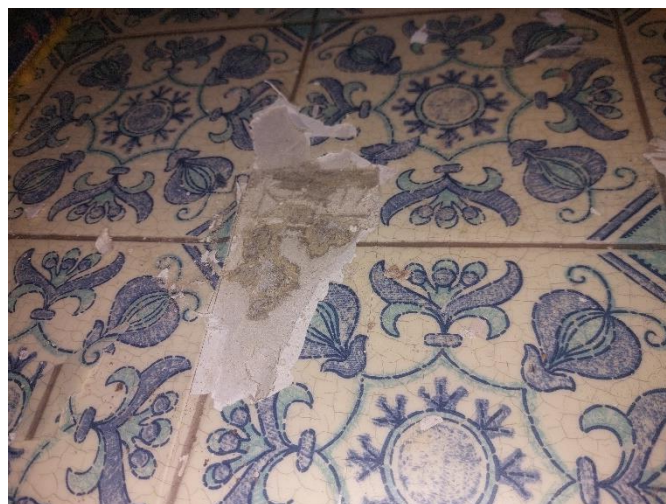
Comments: Blue and white vinyl

Recommendation: Remove prior to refurbishment / demolition works. (Class A material)

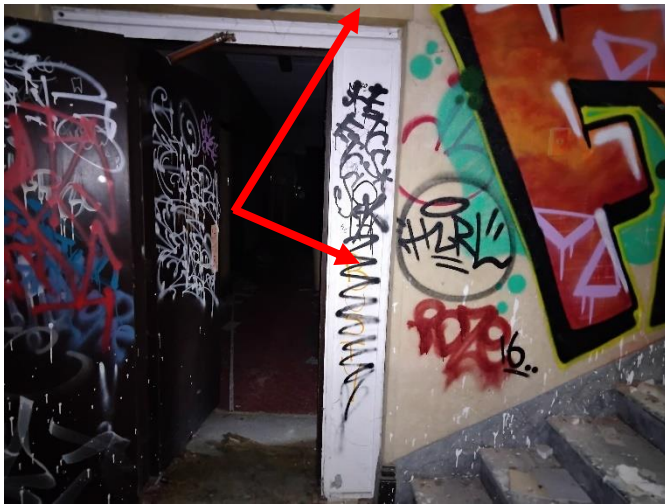
Product Type	Asbestos reinforced composites	1	Material Score
Extent of Damage	Low Damage	1	5
Surface Treatment	Enclosed	1	Risk
Asbestos Type	Amosite	2	Low

Remove prior to refurbishment / demolition works.
(Class B material)

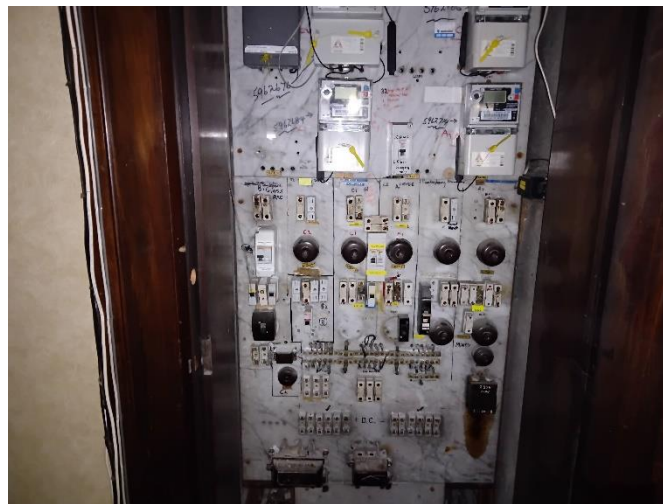
Product Type	AIB, millboards, textiles, gaskets, ropes	2	Material Score
Extent of Damage	Low Damage	1	5
Surface Treatment	Enclosed	1	Risk
Asbestos Type	Presumed Chrysotile	1	Low

Comments: Presumed to be within all porcelain fuse holders

Recommendation: Remove prior to refurbishment / demolition works.
(Class B material)

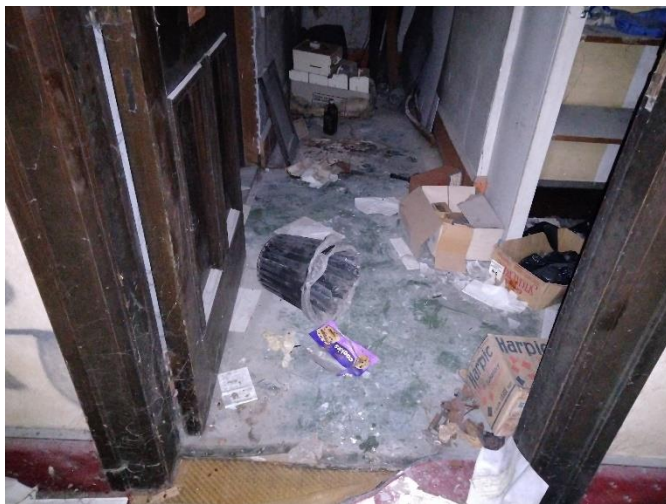
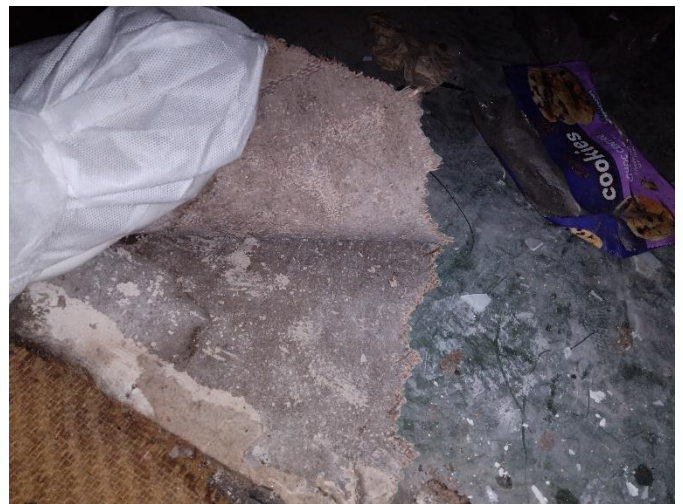
Product Type	AIB, millboards, textiles, gaskets, ropes	2	Material Score
Extent of Damage	Low Damage	1	5
Surface Treatment	Enclosed	1	Risk
Asbestos Type	Presumed Chrysotile	1	Low

Remove prior to refurbishment / demolition works.
(Class A material)

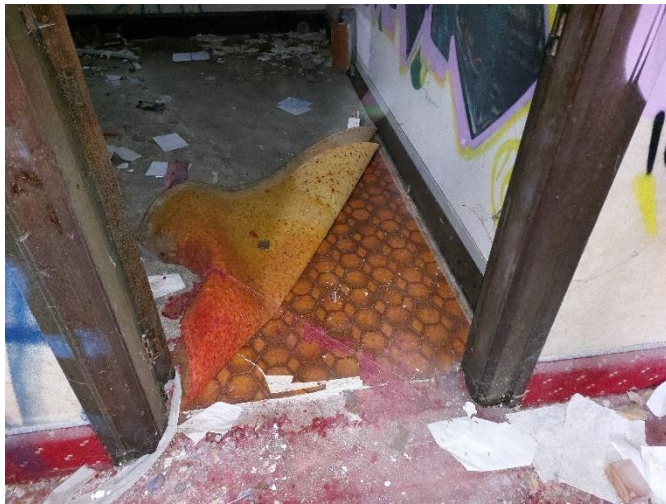
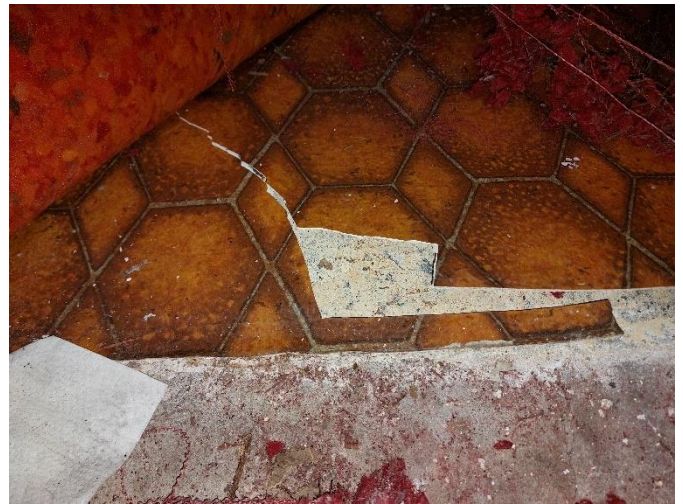
Product Type	AIB, millboards, textiles, gaskets, ropes	2	Material Score
Extent of Damage	Low Damage	1	5
Surface Treatment	Enclosed	1	Risk
Asbestos Type	Chrysotile	1	Low

Remove prior to refurbishment / demolition works.
(Class A material)

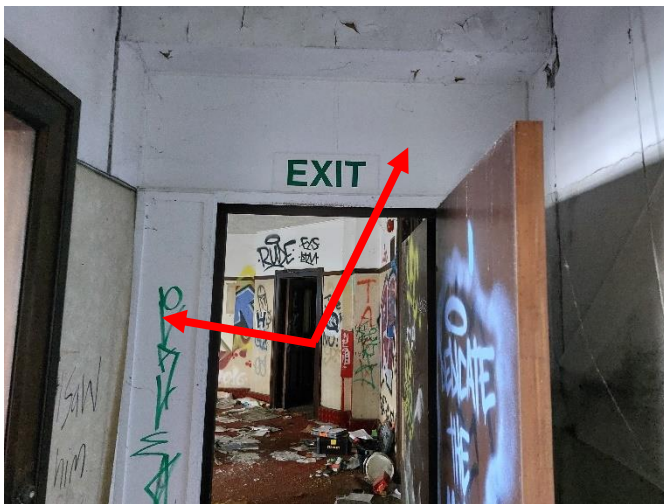
Comments: As per S03
Located around 2 x doorways leading to lobby area

Recommendation: Remove prior to refurbishment / demolition works. (Class B material)

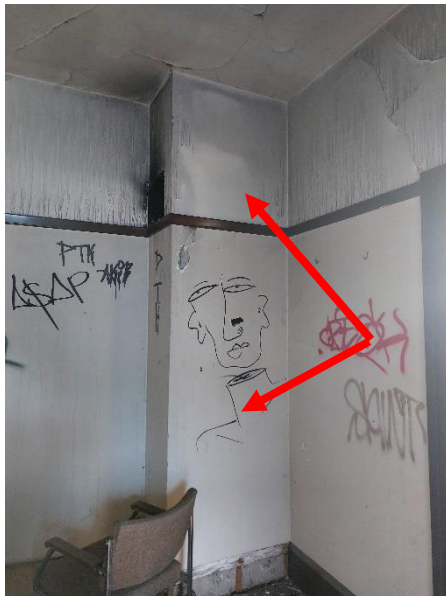
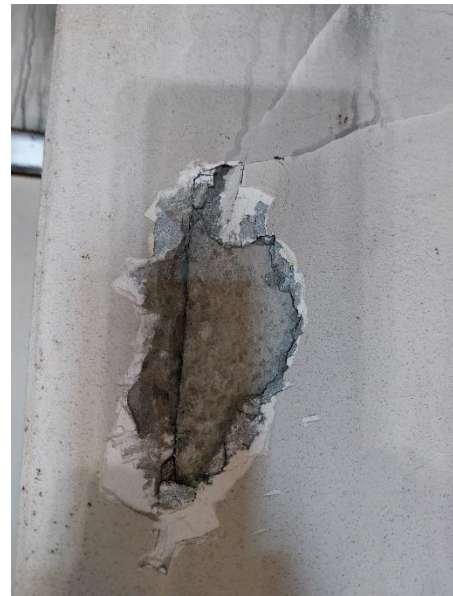
Product Type	Asbestos reinforced composites	1	Material Score
Extent of Damage	Low Damage	1	4
Surface Treatment	Enclosed	1	Risk
Asbestos Type	Chrysotile	1	Very Low

Comments: Floor to ceiling panels behind plaster

Recommendation: Remove prior to refurbishment / demolition works.
(Class B material)

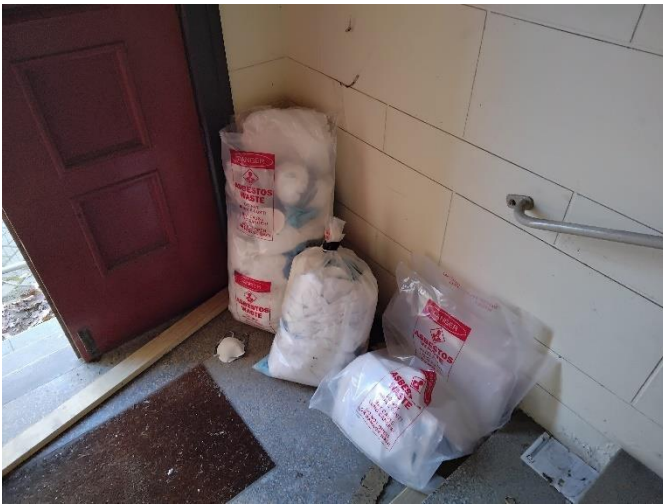
Product Type	Asbestos reinforced composites	1	Material Score
Extent of Damage	Good condition	0	4
Surface Treatment	Enclosed	1	Risk
Asbestos Type	Presumed Amosite	2	Very Low

Comments: Waste bags with used PPE

Recommendation: Remove prior to refurbishment / demolition works. (Class B material)

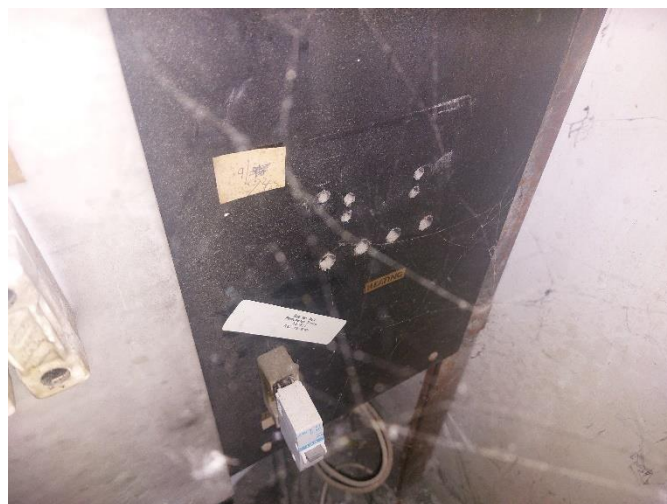
Product Type	Asbestos reinforced composites	1	Material Score
Extent of Damage	Low Damage	1	3
Surface Treatment	Composite	0	Risk
Asbestos Type	Presumed Chrysotile	1	Very Low

Remove prior to refurbishment / demolition works.
(Class B material)

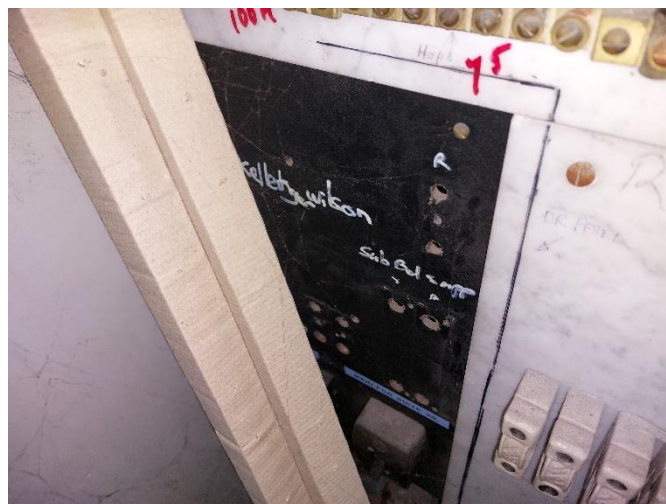
Product Type	Asbestos reinforced composites	1	Material Score
Extent of Damage	Low Damage	1	3
Surface Treatment	Composite	0	Risk
Asbestos Type	Presumed Chrysotile	1	Very Low

Comments: Two units, one in each cupboard.

Recommendation: Remove prior to refurbishment / demolition works.
(Class B material)

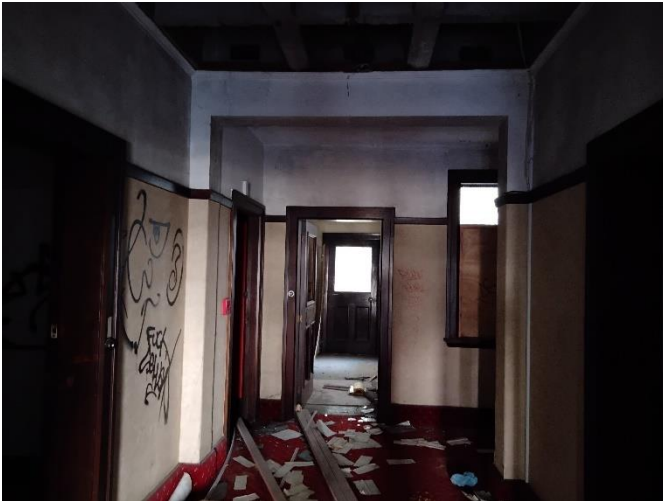
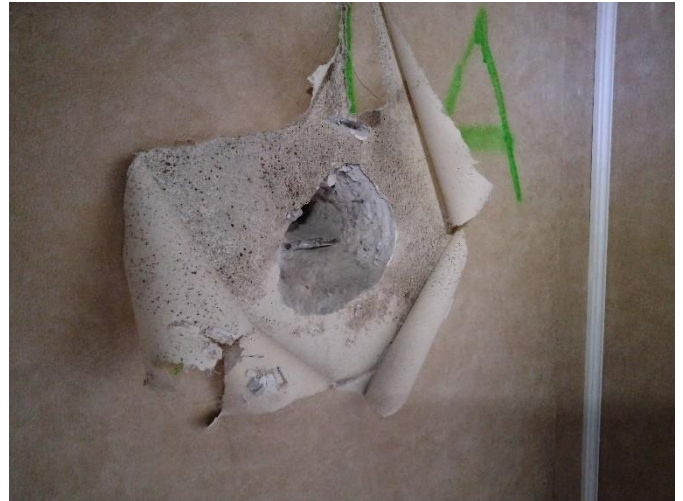
Product Type	N/A	Material Score
Extent of Damage	N/A	N/A
Surface Treatment	N/A	Risk
Asbestos Type	No Asbestos Detected	N/A

Comments: Lath & plaster. Sample includes skim coat

Recommendation: No action required

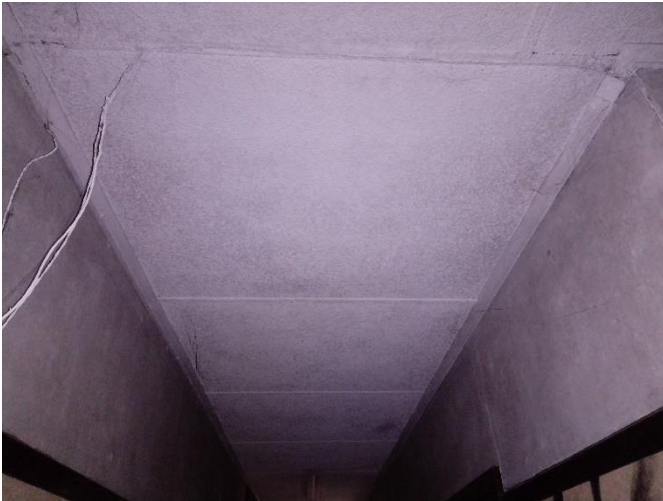
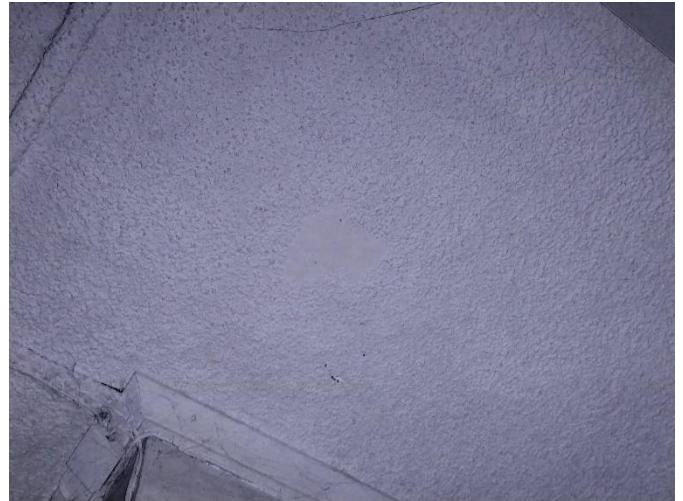
Product Type	N/A	Material Score
Extent of Damage	N/A	N/A
Surface Treatment	N/A	Risk
Asbestos Type	No Asbestos Detected	N/A

Comments: Coating to softboard panels. Located in Hallways and Lobby area.

Recommendation: No action required

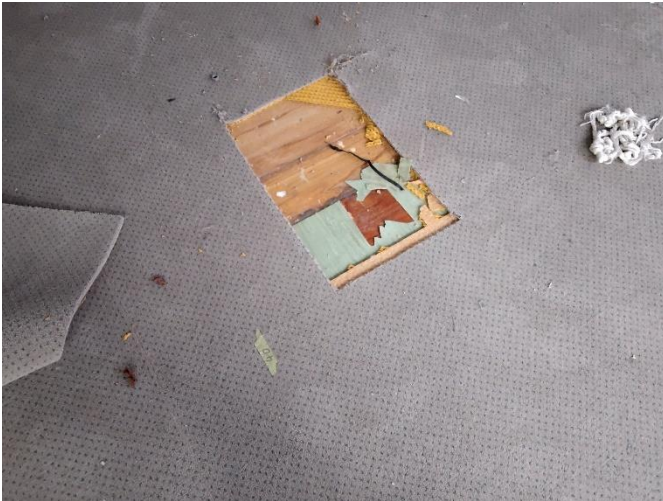
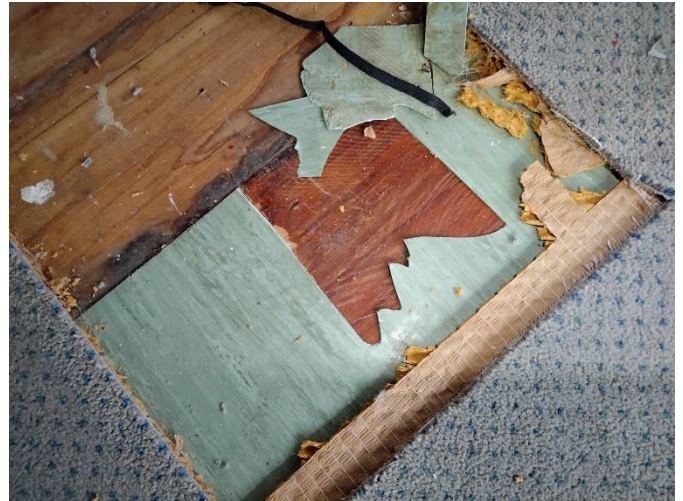
Product Type	N/A	Material Score
Extent of Damage	N/A	N/A
Surface Treatment	N/A	Risk
Asbestos Type	No Asbestos Detected	N/A

Comments: Green vinyl

Recommendation: No action required

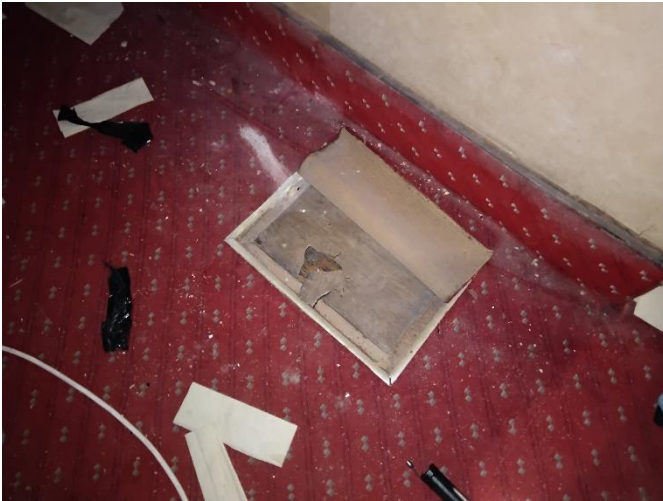
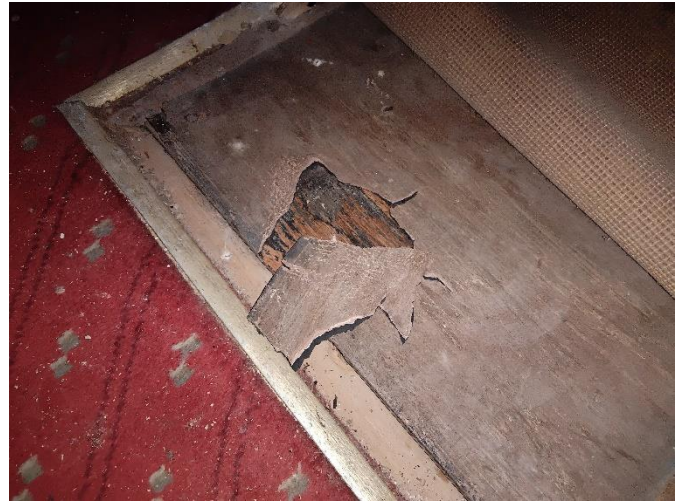
Product Type	N/A	Material Score
Extent of Damage	N/A	N/A
Surface Treatment	N/A	Risk
Asbestos Type	No Asbestos Detected	N/A

Comments: Floor hatch to Subfloor

Recommendation: No action required

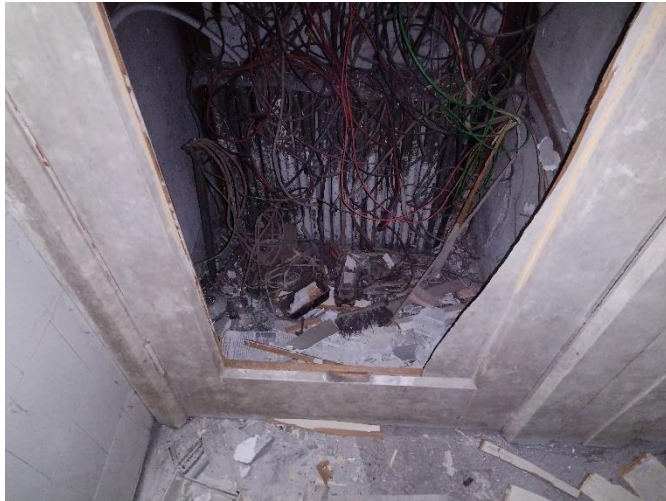
Product Type	N/A	Material Score
Extent of Damage	N/A	N/A
Surface Treatment	N/A	Risk
Asbestos Type	No Asbestos Detected	N/A

Comments: Wiring

Recommendation: No action required

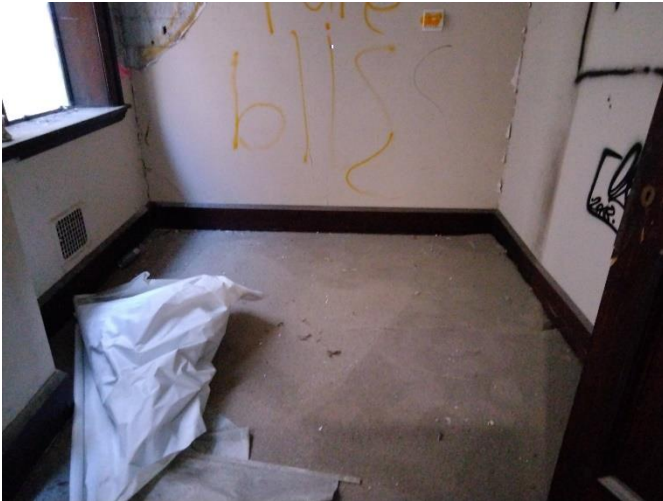
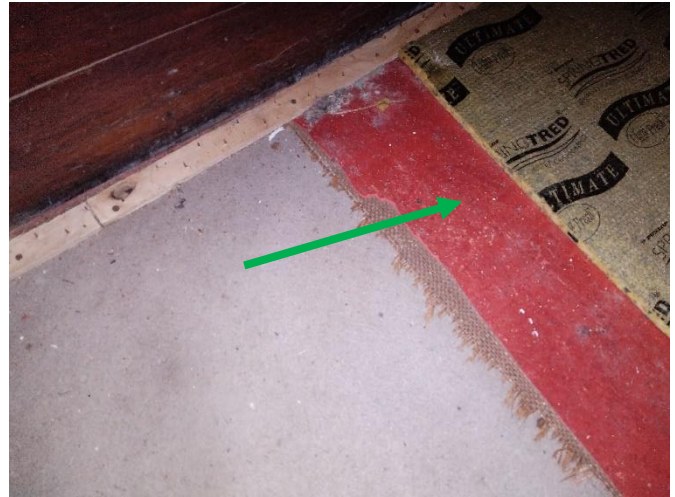
Product Type	N/A	Material Score
Extent of Damage	N/A	N/A
Surface Treatment	N/A	Risk
Asbestos Type	No Asbestos Detected	N/A

Comments: Red colour with hessian backing on top of positive paper/felt backing. Green coloured material also observed.

Recommendation: No action required

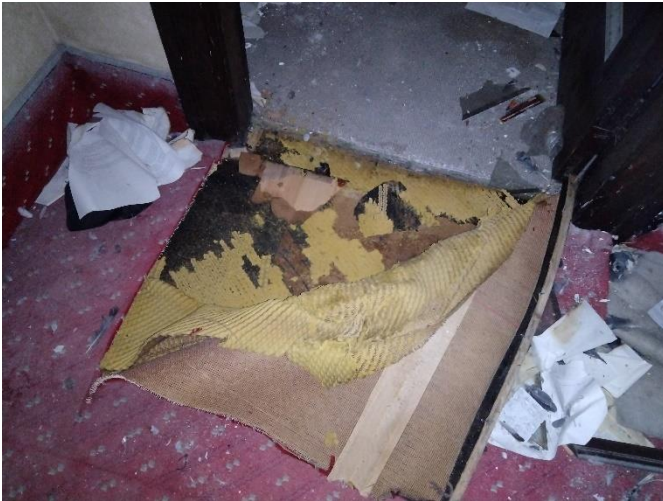
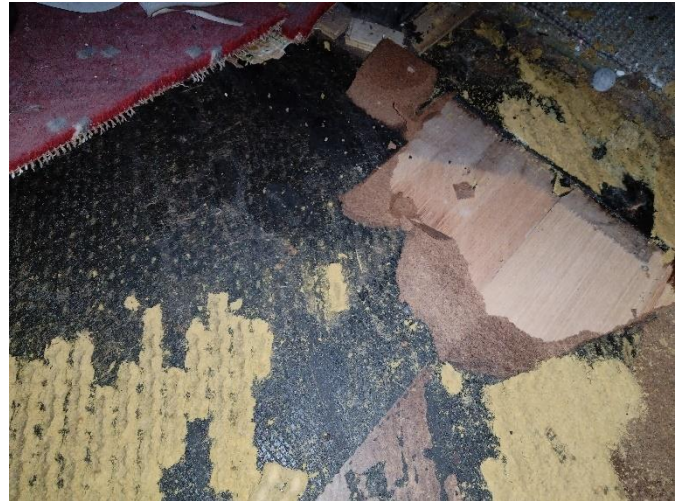
Product Type	N/A	Material Score
Extent of Damage	N/A	N/A
Surface Treatment	N/A	Risk
Asbestos Type	No Asbestos Detected	N/A

Comments: Beneath underlay on ply

Recommendation: No action required

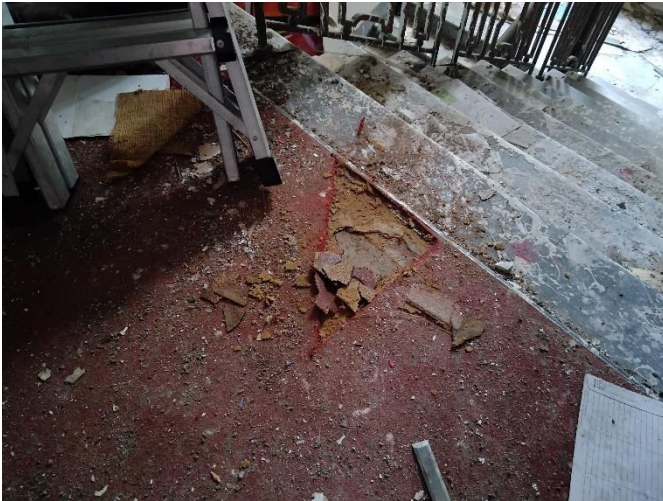
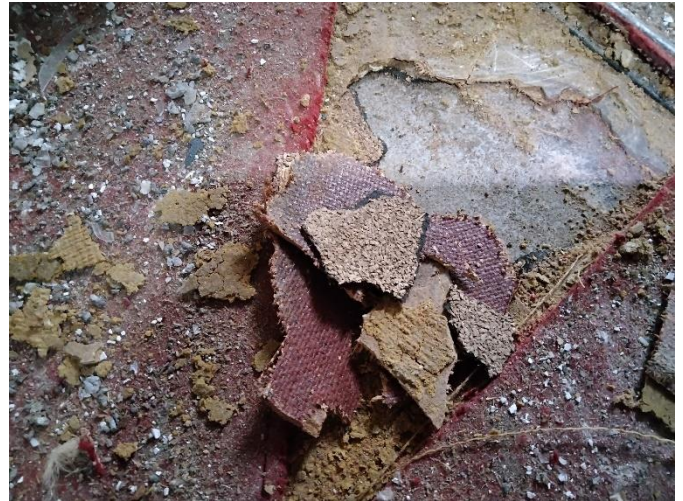
Product Type	N/A	Material Score
Extent of Damage	N/A	N/A
Surface Treatment	N/A	Risk
Asbestos Type	No Asbestos Detected	N/A

Recommendation: No action required

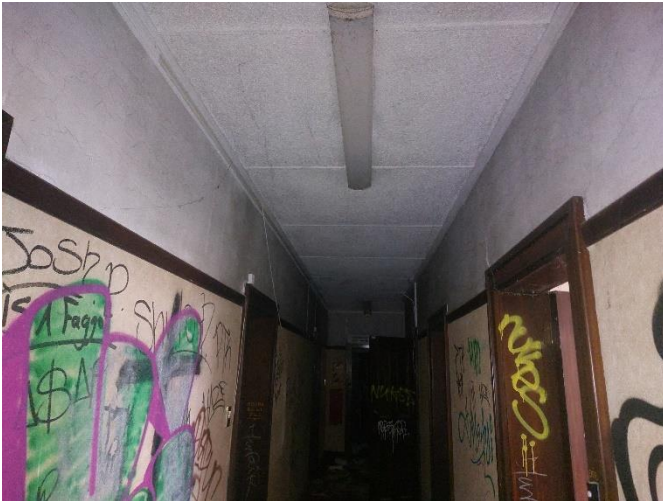
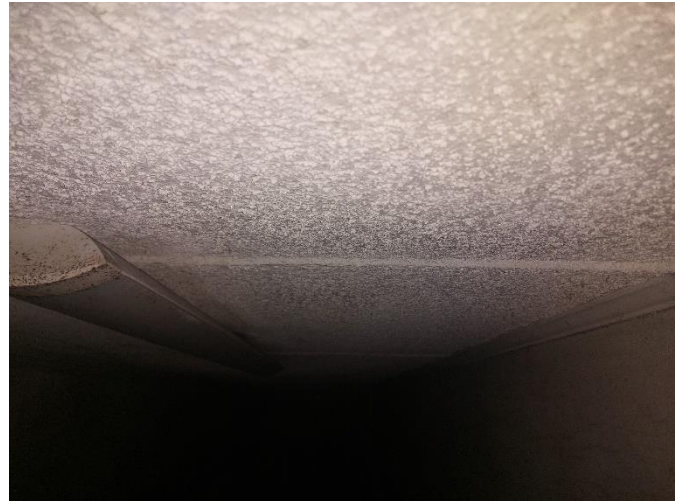
Product Type	N/A	Material Score	
Extent of Damage	N/A		N/A
Surface Treatment	N/A	Risk	
Asbestos Type	No Asbestos Detected		N/A

Comments: Located in Hallways and Landing

Recommendation: No action required

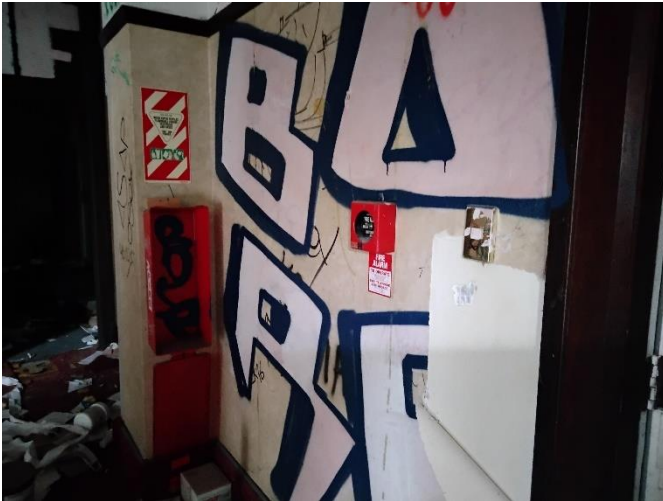
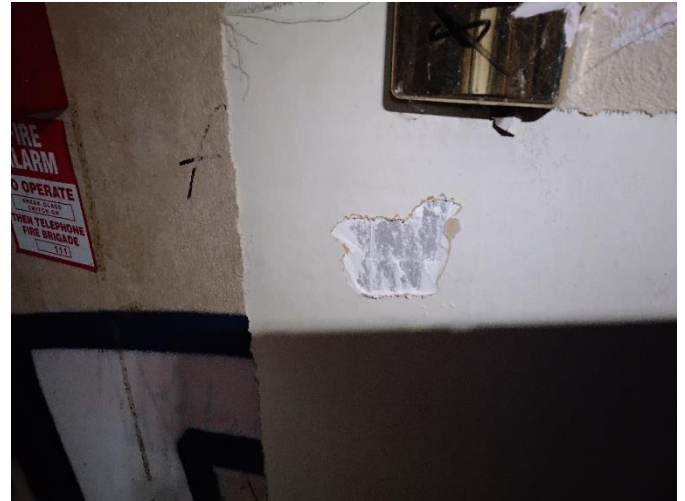
Product Type	N/A	Material Score	N/A
Extent of Damage	N/A	Risk	N/A
Surface Treatment	N/A	Asbestos Type	No Asbestos Detected

Comments: Skim coat to all walls

Recommendation: No action required

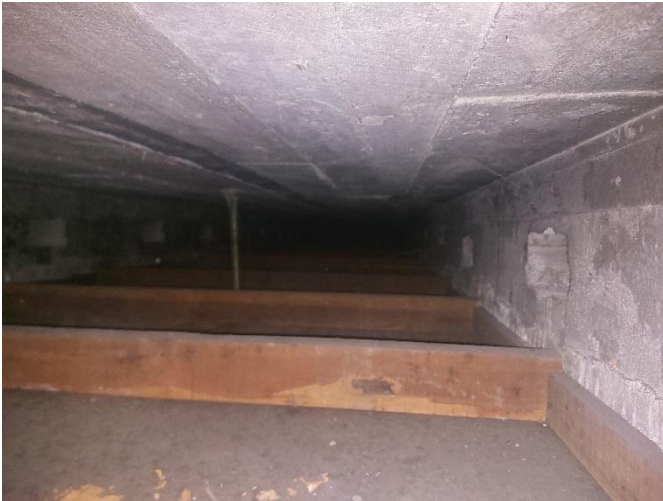
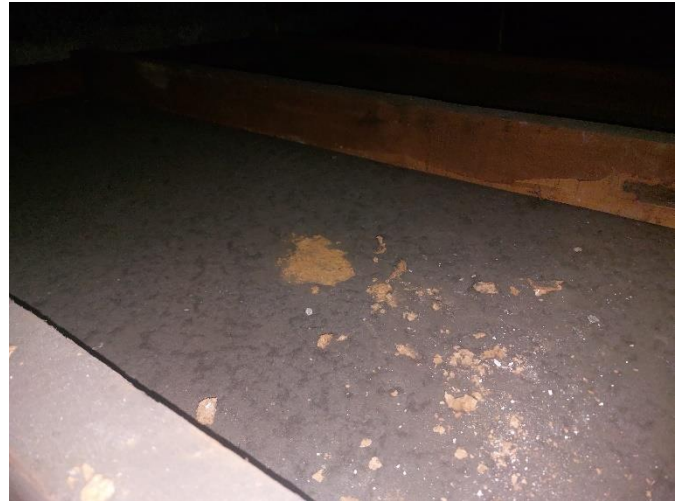
Product Type	N/A	Material Score	
Extent of Damage	N/A		N/A
Surface Treatment	N/A	Risk	
Asbestos Type	No Asbestos Detected		N/A

Comments: Material to top side of softboard tiles

Recommendation: No action required

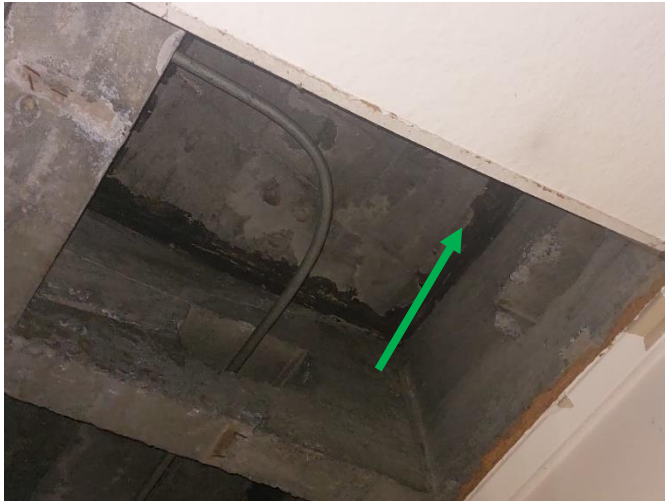
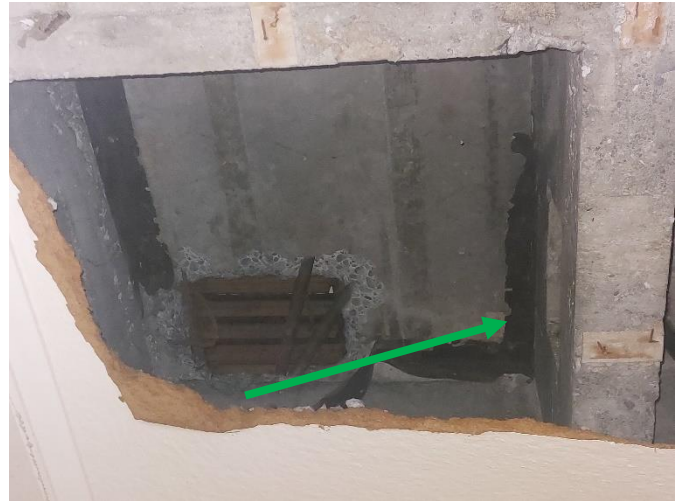
Product Type	N/A	Material Score	N/A
Extent of Damage	N/A	Risk	N/A
Surface Treatment	N/A	Asbestos Type	No Asbestos Detected

Comments: Sample collected from accessible floor, walls, ledges, and fixtures.

Recommendation: No action required

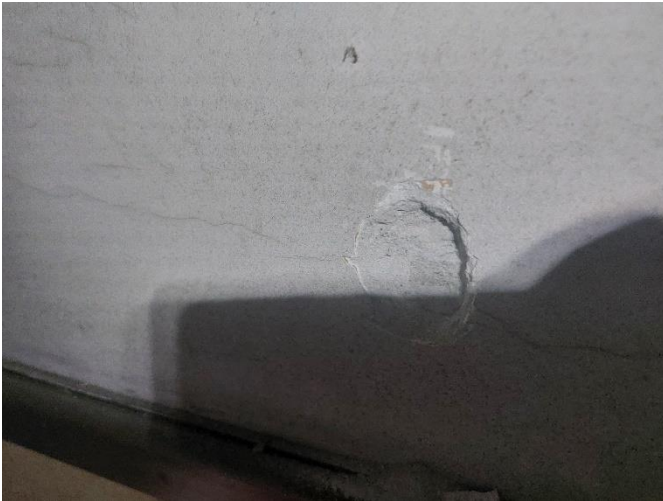
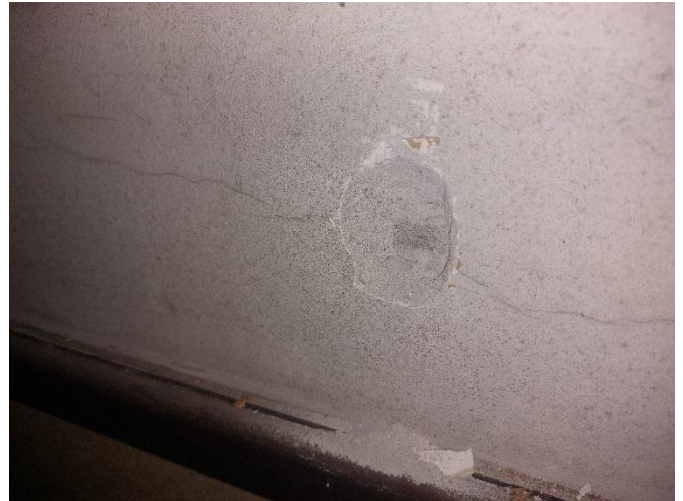
Product Type	N/A	Material Score
Extent of Damage	N/A	N/A
Surface Treatment	N/A	Risk
Asbestos Type	No Asbestos Detected	N/A

Comments: Older, grey lath & plaster type plaster.

Recommendation: No action required

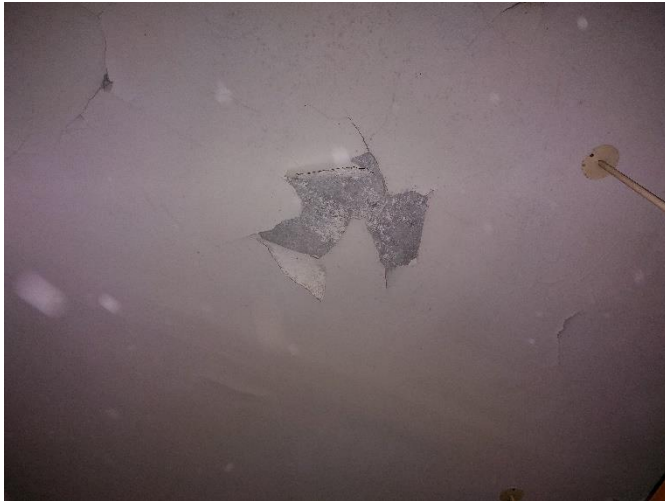
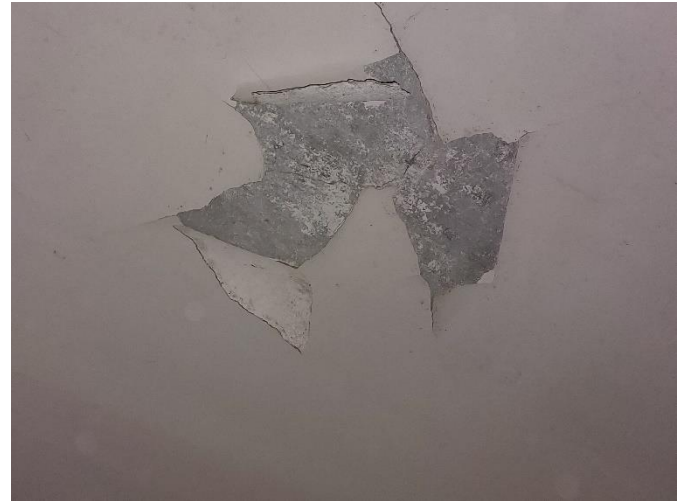
Product Type	N/A	Material Score
Extent of Damage	N/A	N/A
Surface Treatment	N/A	Risk
Asbestos Type	No Asbestos Detected	N/A

Comments: Skim coat

Recommendation: No action required

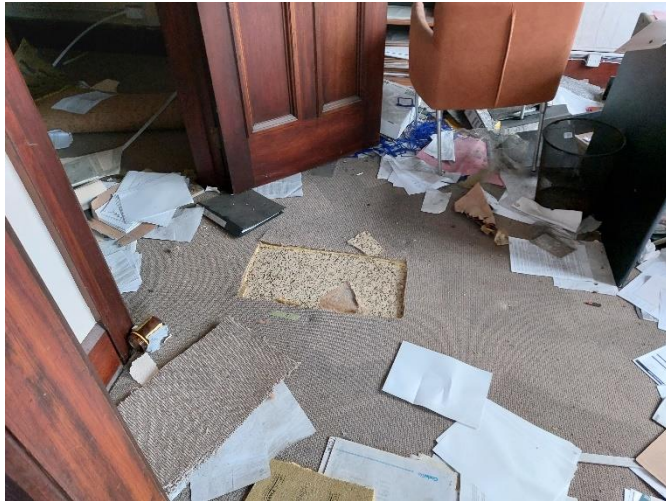
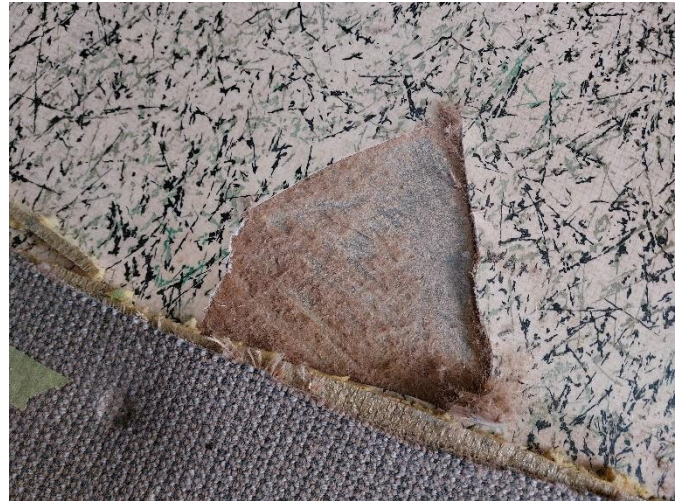
Product Type	N/A	Material Score
Extent of Damage	N/A	N/A
Surface Treatment	N/A	Risk
Asbestos Type	No Asbestos Detected	N/A

Recommendation: No action required

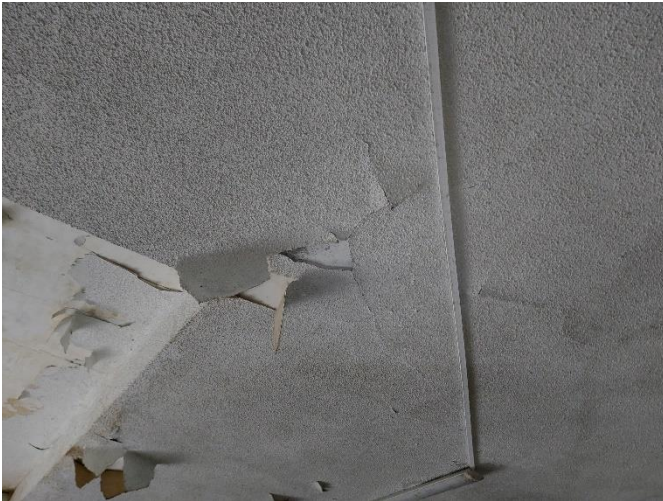
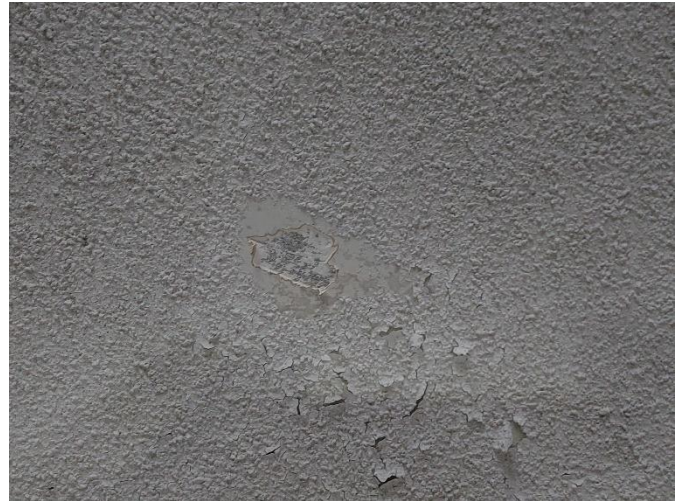
Product Type	N/A	Material Score
Extent of Damage	N/A	N/A
Surface Treatment	N/A	Risk
Asbestos Type	No Asbestos Detected	N/A

Recommendation:	No action required
Comments:	Located in Hallways and Landing

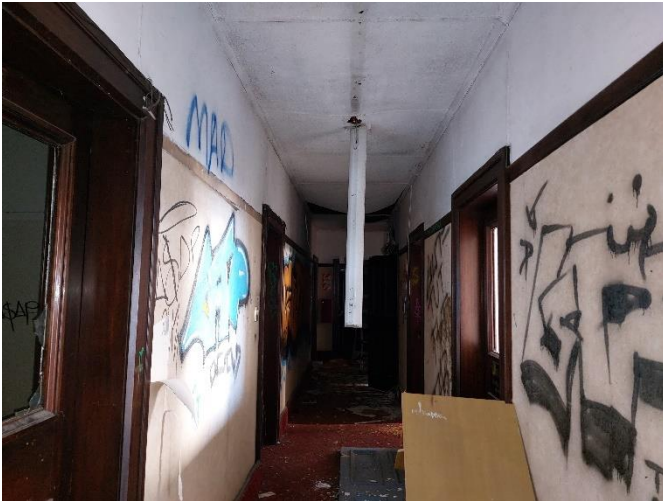
Comments: Skim coat to all walls

Recommendation: No action required

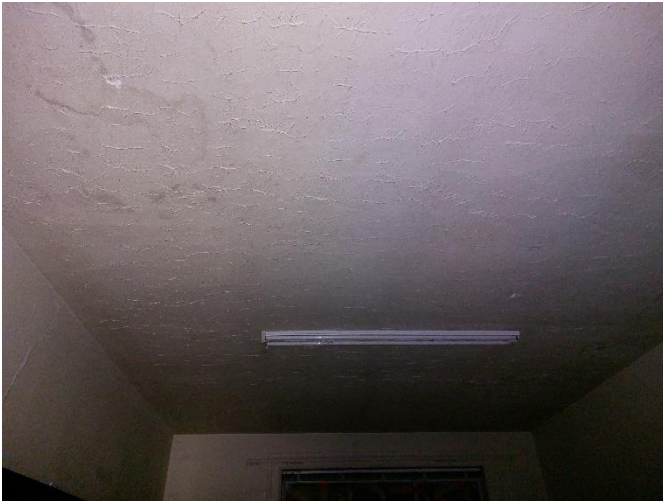
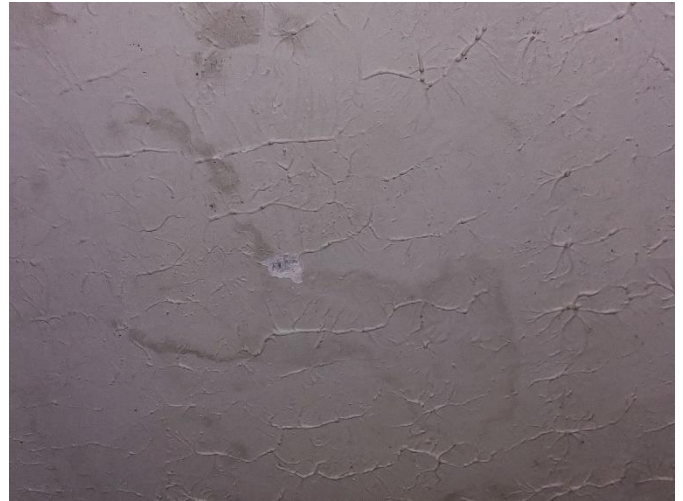
Comments: Different pattern to Hallway T/C and less friable

Recommendation: No action required

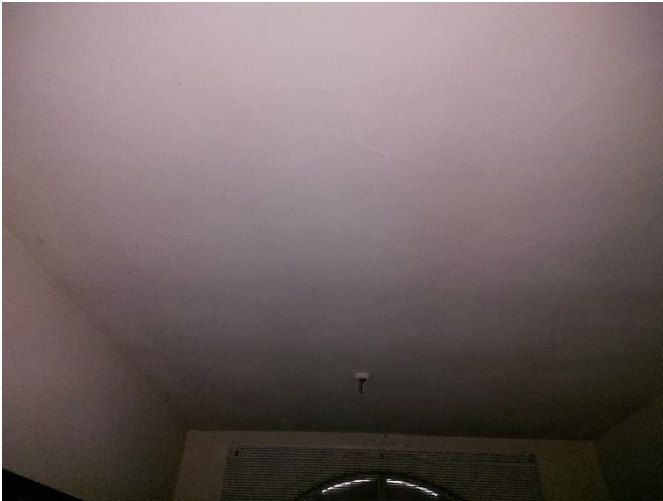
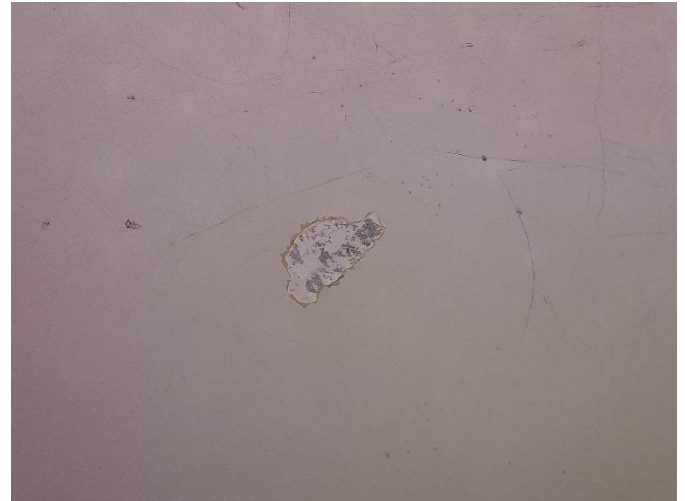
Comments: Sample collected from accessible floor, walls, ledges, and fixtures.

Recommendation: No action required

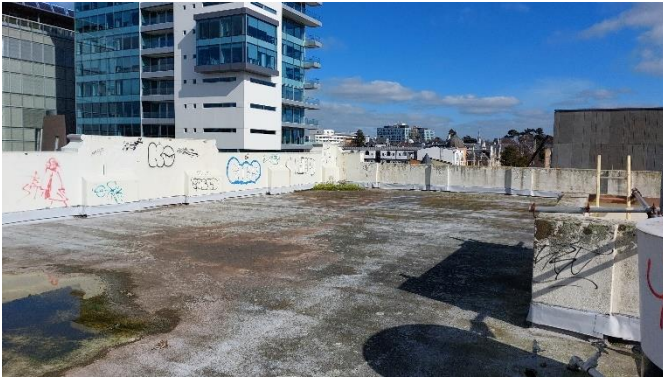
Comments: Top layer

Recommendation: No action required

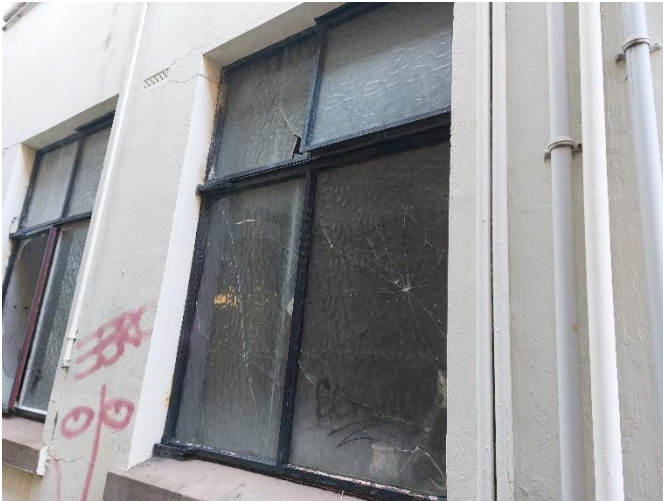
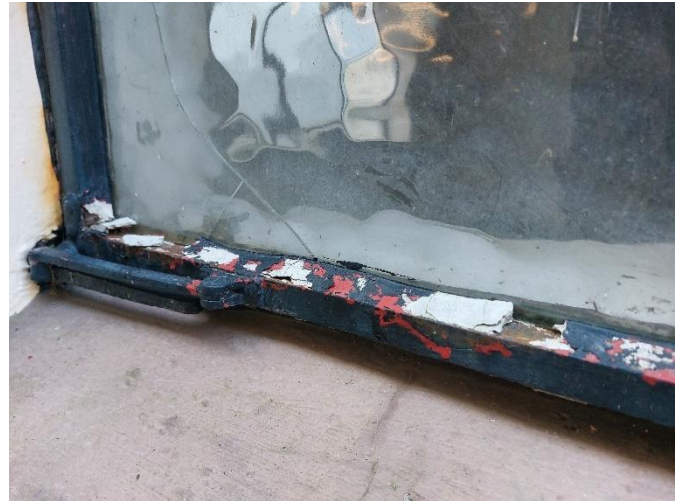
Comments: Composite sample from numerous windows

Recommendation: No action required

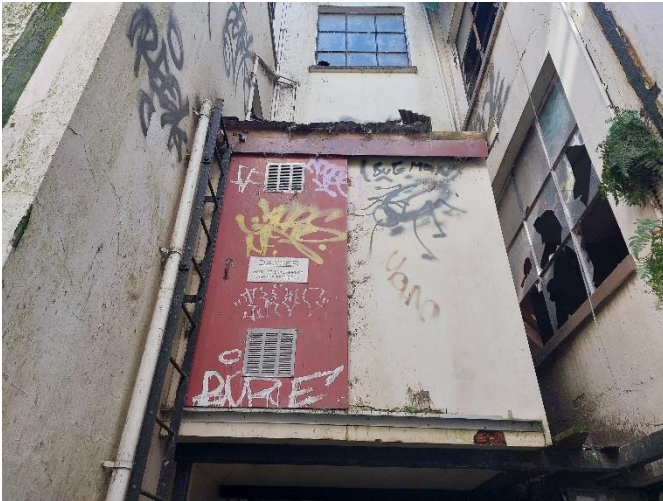
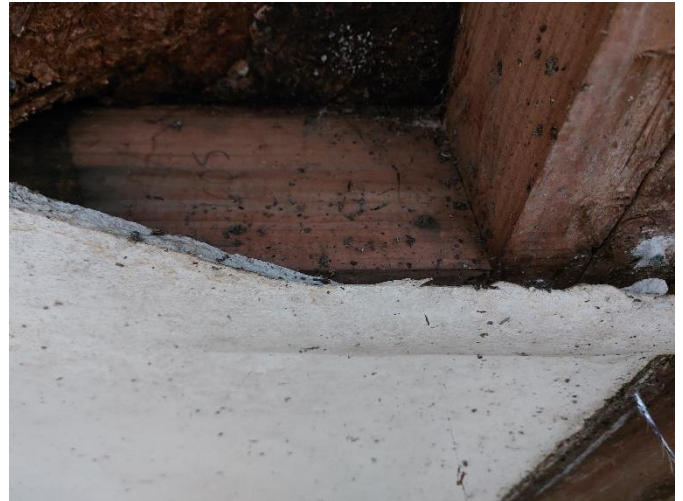
Comments: Internal and external linings

Recommendation: No action required

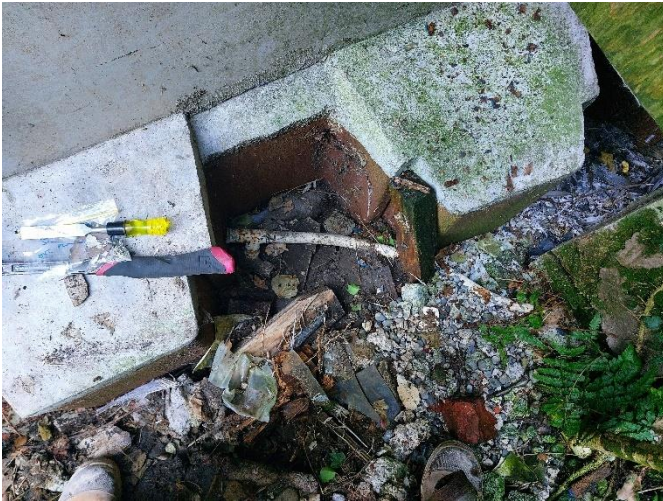
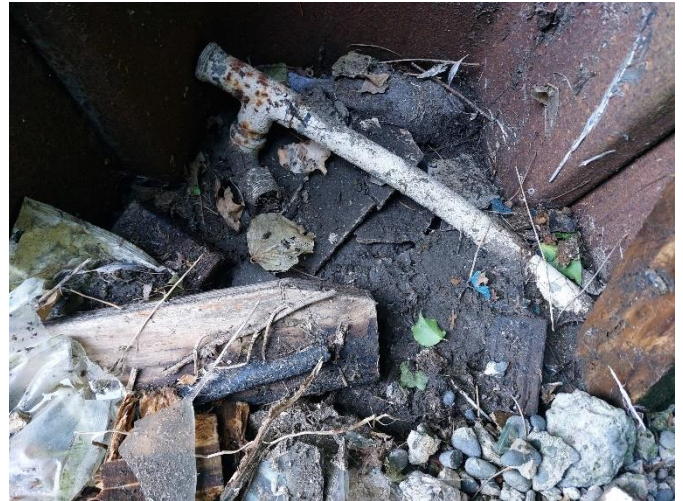
Comments: Debris along edge of property.

Recommendation: No action required

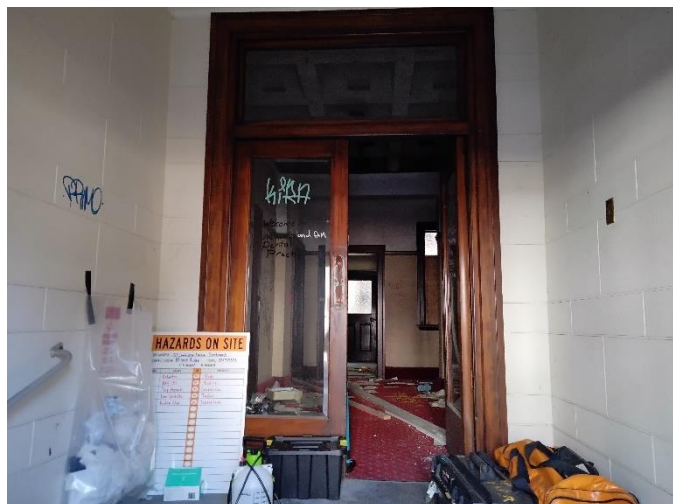
Photo 1: Entrance – no suspect materials

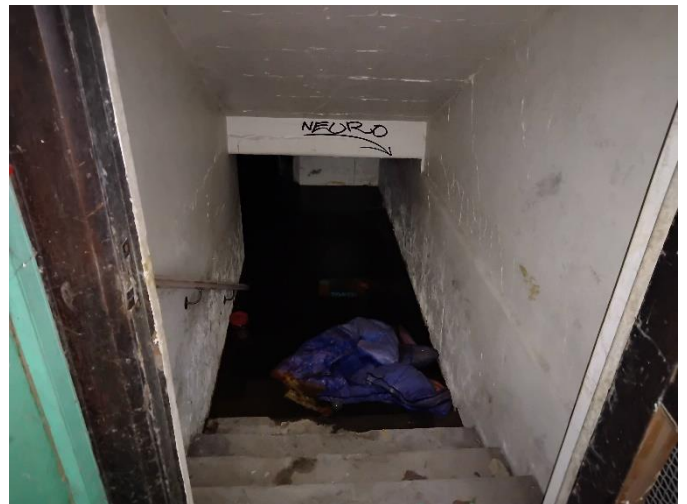
Photo 10: Flooded Basement
