*in the matter of:* proposed Plan Change 14 to the Christchurch District  
Plan

*and:* **Daresbury Limited**  
(Submitter 874)

Statement of evidence of Brett Andrew Gilmore for Daresbury  
Limited (Structural Engineering)

Dated: 20 September 2023

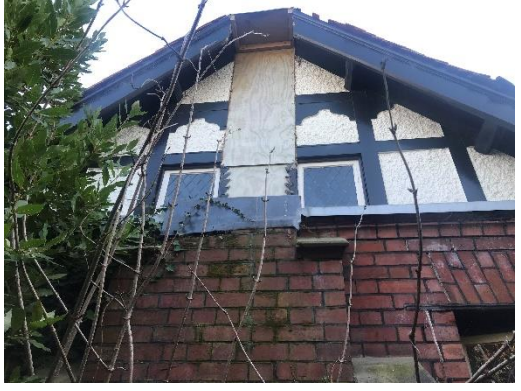
7.	South elevation (part) to Dining Hall, with collapsed chimney above eaves level

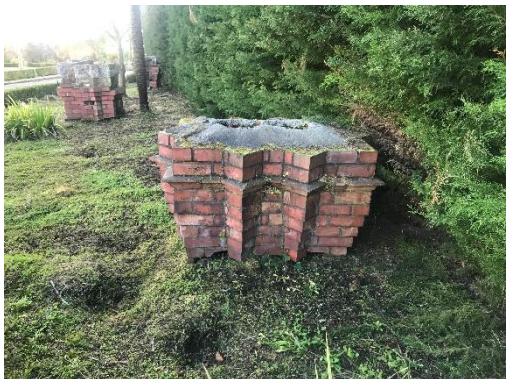
18.	Collapsed chimney stack

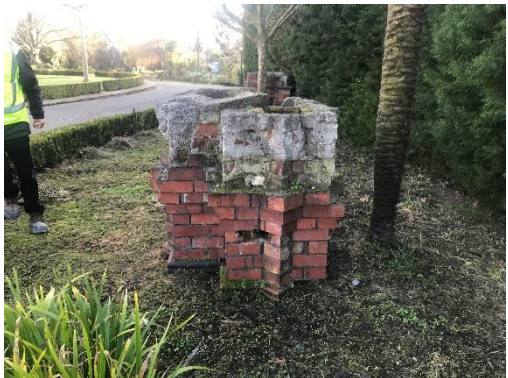
19.	Collapsed chimney stack

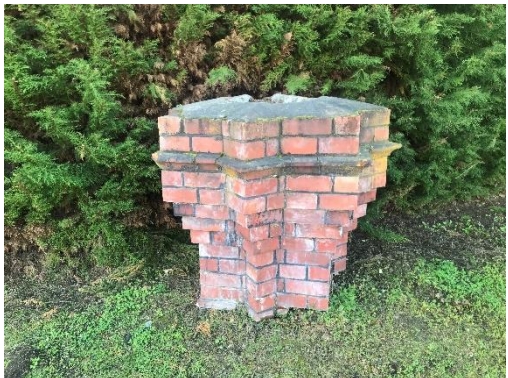
20.	Collapsed chimney stack

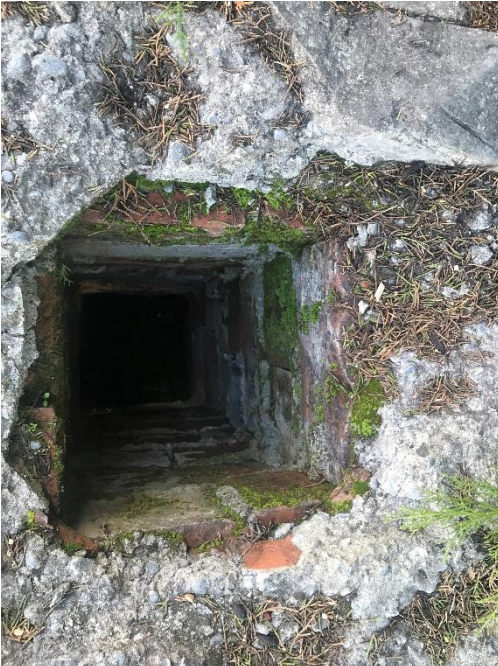
21.	Collapsed chimney stack flue

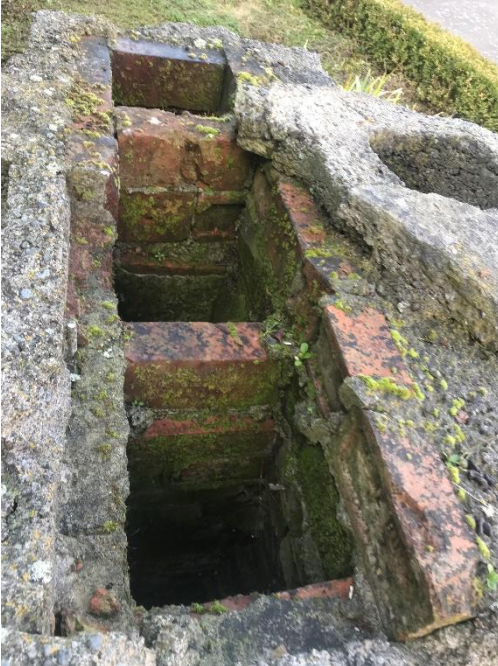
22.	Collapsed chimney stack flues

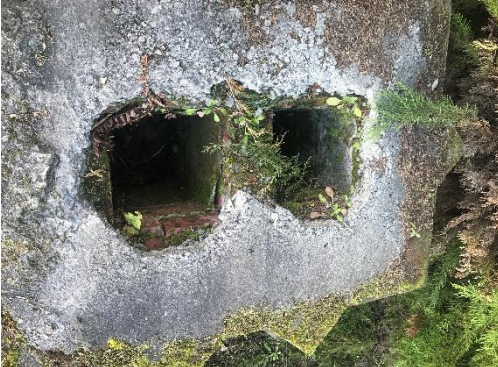
23.	Collapsed chimney stack flues

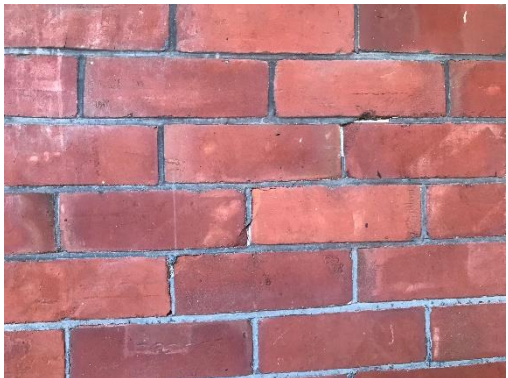
25.	Stepped cracking in south brick wall mortar to Office 2

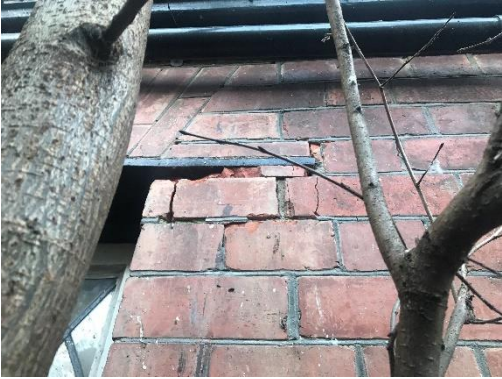
31.	Cracks in west brick wall to Tech/Data

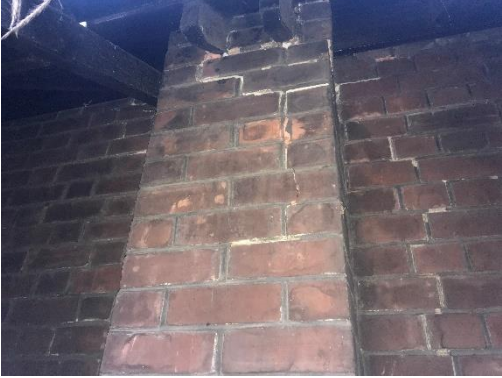
32.	Cracked bricks to east pier to Dining Hall

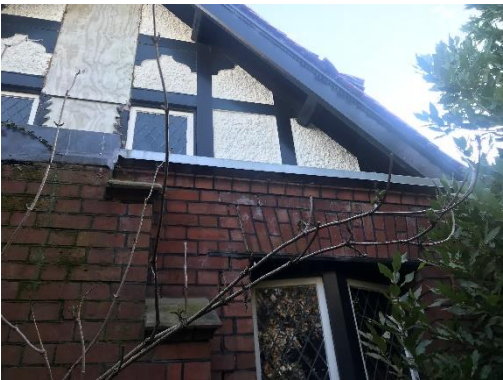
39.	Cracks and slippage gaps in south brick wall to Dining Hall at jamb to window, and movement gaps/tearing of plaster at junctions with timber framing

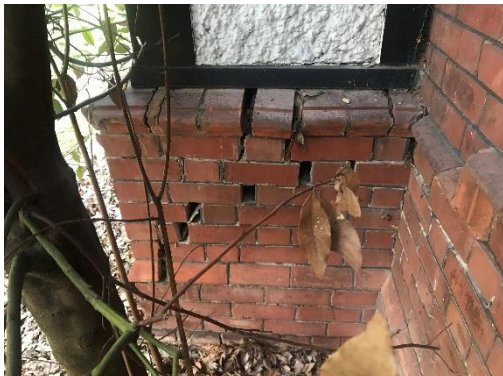
<p>40.</p>	<p>Failure of brick wall beneath west side bay window to the Dining Hall</p>

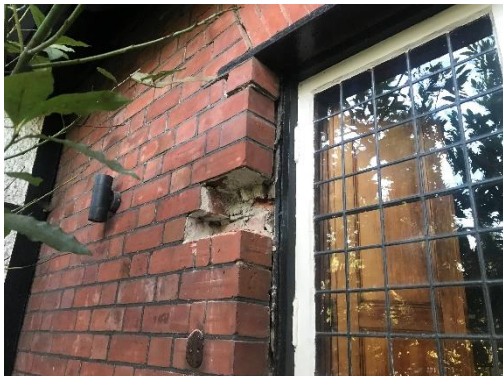
<p>42.</p>	<p>Localised failure and large 10 – 25mm movement of brick wall adjacent to west window to Dining Hall</p>

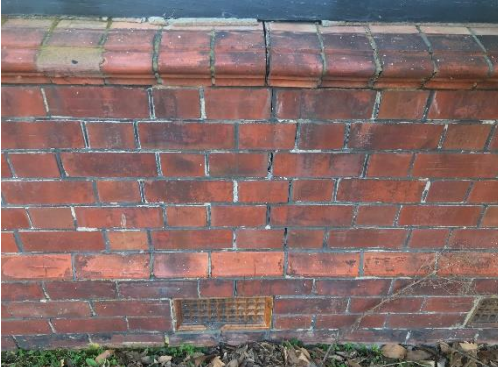
<p>47.</p>	<p>Cracks and large slippage gaps in brick wall beneath west side bay window to Dining Hall</p>

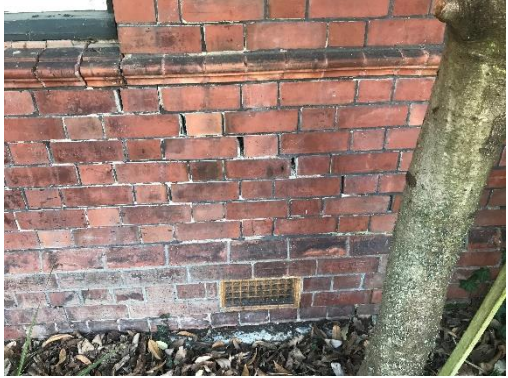
49.	Cracks and large slippage gaps in brick wall beneath west side bay window to Dining Hall

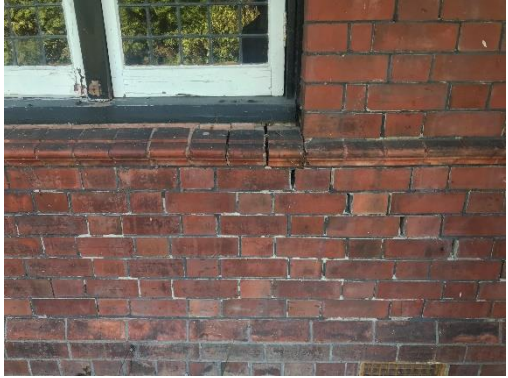
50.	Cracks and large slippage gaps in brick wall beneath west side bay window to Dining Hall

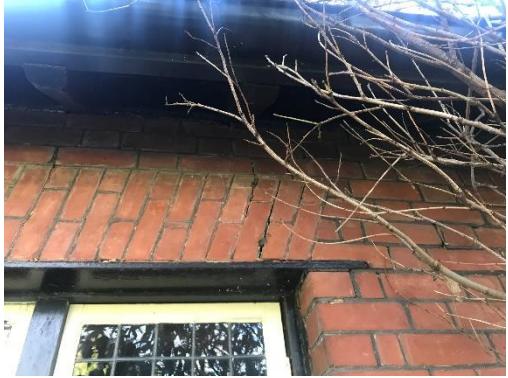
51.	Cracks and slippage gaps in brick wall above west side windows to Dining Hall

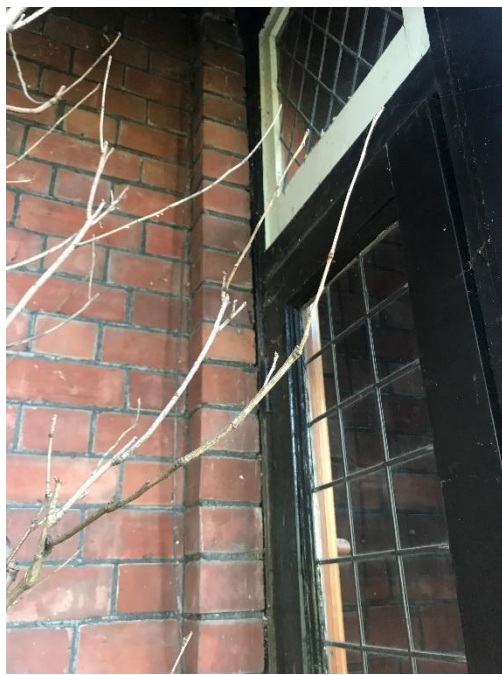
52.	Large 10mm movement of west brick wall to Dining Hall, adjacent to door

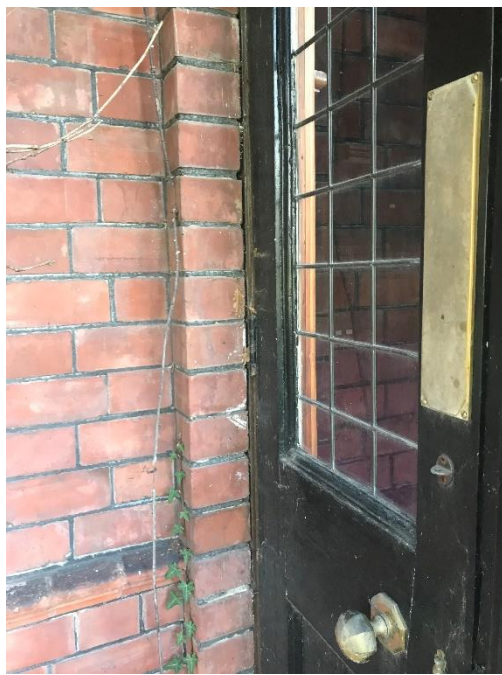
53.	Large 10mm movement of west brick wall to Dining Hall, adjacent to door

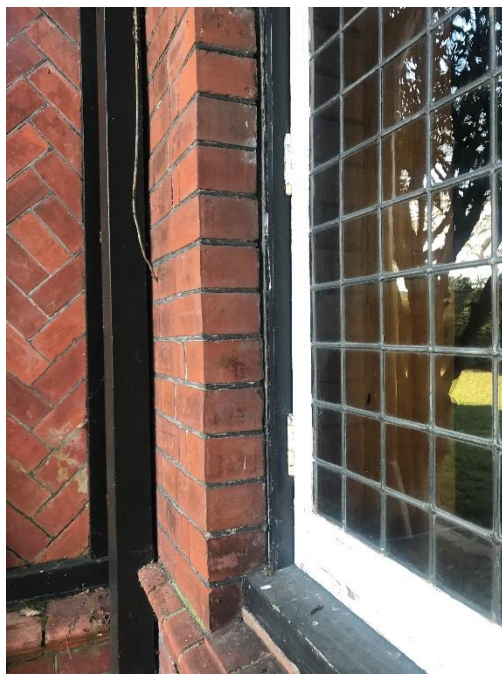
<p>55.</p>	<p>Large 15 – 25mm movement of west brick wall at window to Dining Hall</p>

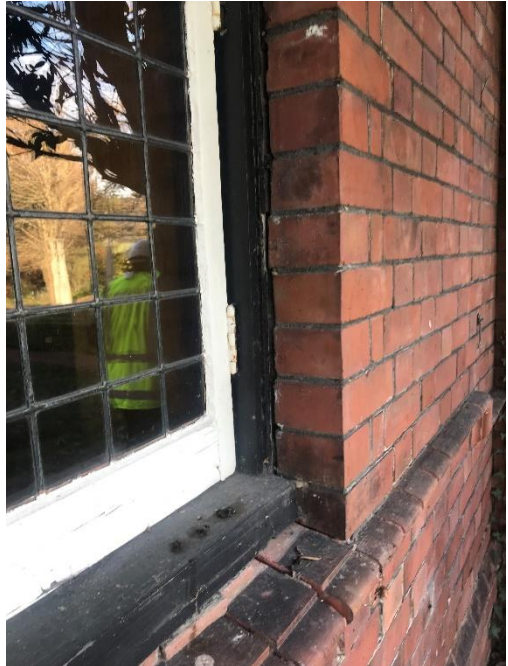
<p>56.</p>	<p>Large 15 – 25mm movement of west brick wall at window to Dining Hall</p>

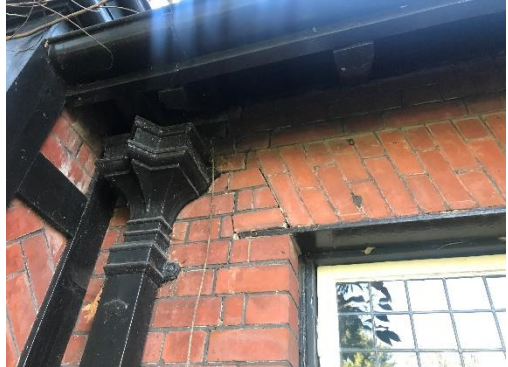
<p>58.</p>	<p>Cracks and slippage gaps in brick wall above west side windows to Dining Hall</p>

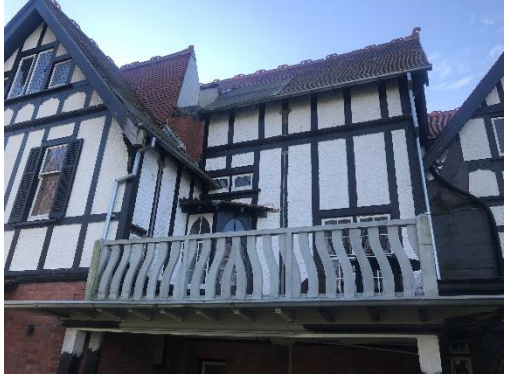
<p>61.</p>	<p>Collapse of brick chimney to south-west corner of Bed 8 plus movement damage to tile roofing</p>

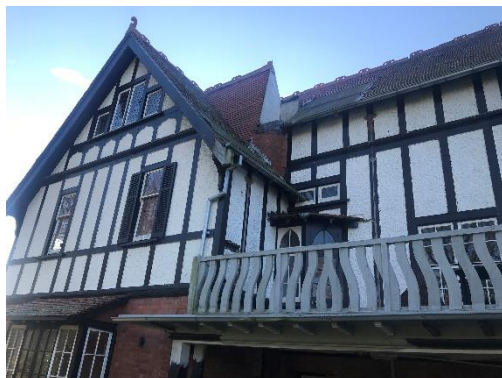
<p>62.</p>	<p>Collapse of brick chimney to south-west corner of Bed 8 plus movement damage to tile roofing</p>

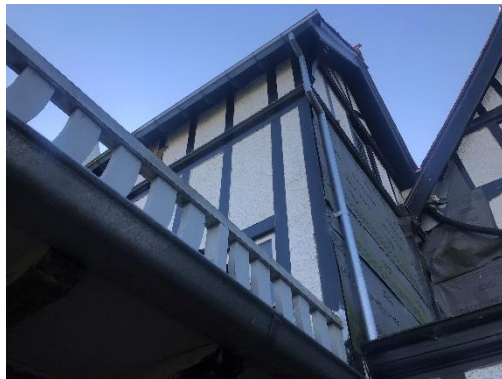
<p>64.</p>	<p>Cracks in plaster/brick infill, and movement gaps/tearing between plaster and timber studs/transoms to west wall of stairs, Bed 1, Bed 6, and Bed 8</p>

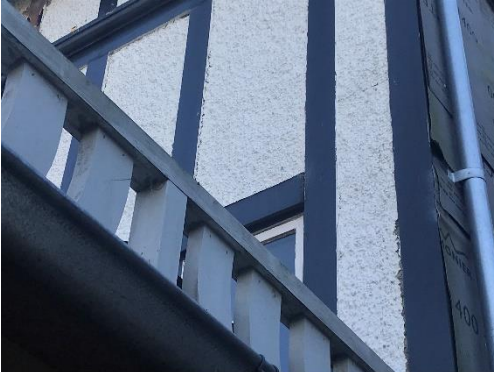
65.	Cracks in plaster/brick infill, and movement gaps/tearing between plaster and timber studs/transoms to west wall of stairs, Bed 1, Bed 6, and Bed 8

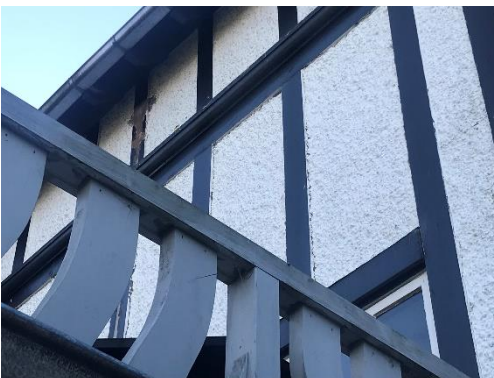
66.	Cracks in plaster/brick infill, and movement gaps/tearing between plaster and timber studs/transoms to west wall of stairs, Bed 1, Bed 6, and Bed 8

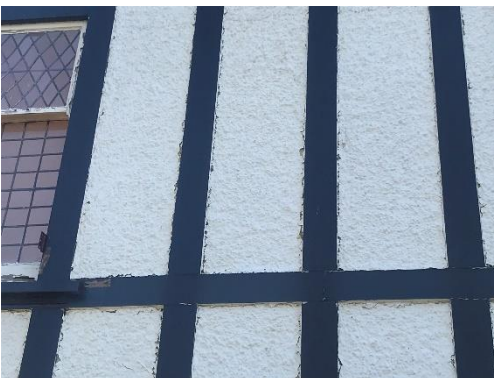
67.	Cracks in plaster/brick infill, and movement gaps/tearing between plaster and timber studs/transoms to west wall of stairs, Bed 1, Bed 6, and Bed 8

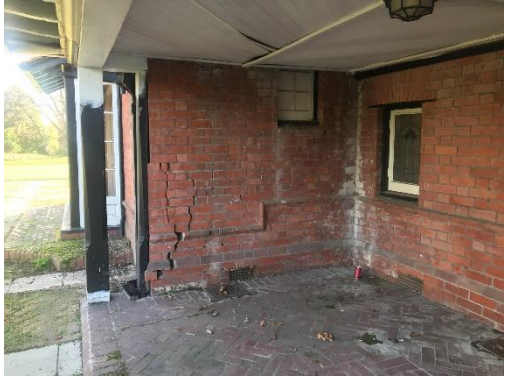
69.	Failure of south side brick wall to Lounge, at south-west corner

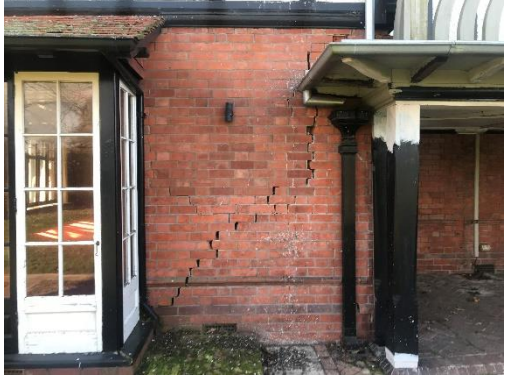
70.	Failure of west side back wall to Lounge – south end

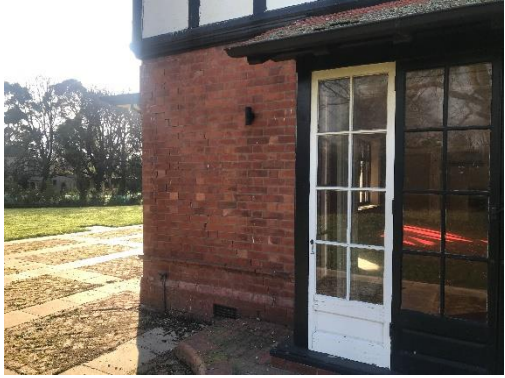
71.	Failure of west side brick wall to Lounge – north end

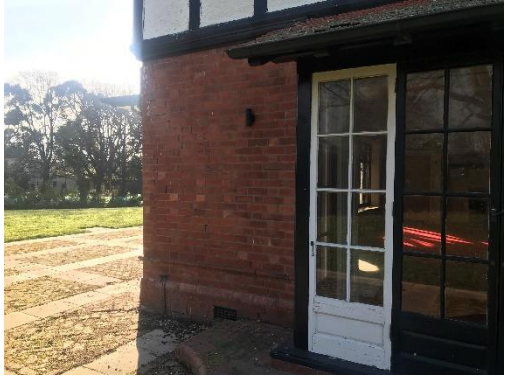
72.	Failure of west side brick wall to Lounge – north end

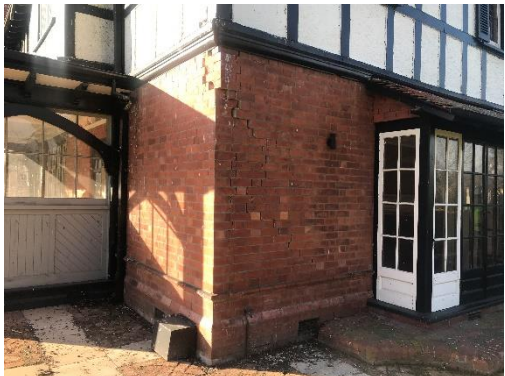
73.	Failure of west side brick wall to Lounge – north end

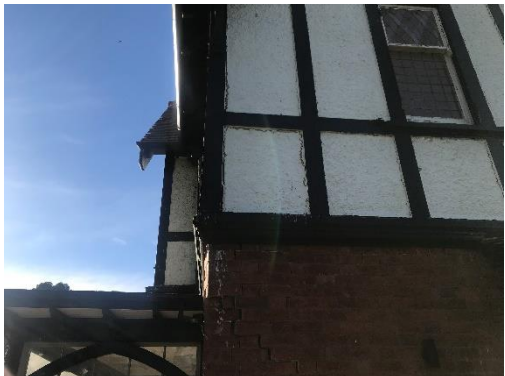
74.	Failure of west side brick wall to Lounge – north end, plus damage to plaster and brick infill above

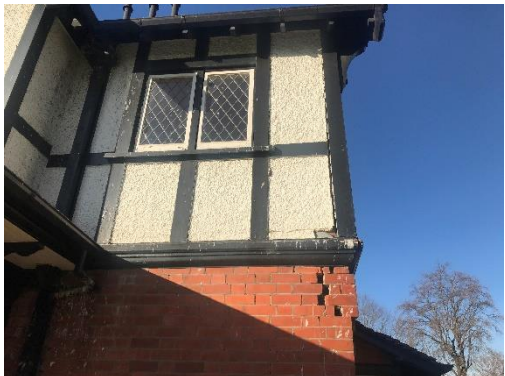
75.	Failure of west side brick wall to Lounge – north end, plus damage to plaster and brick infill above

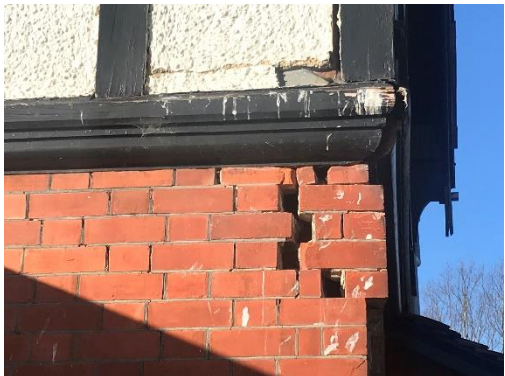
76.	Failure of west side brick wall to Lounge – north end, plus damage to plaster and brick infill above

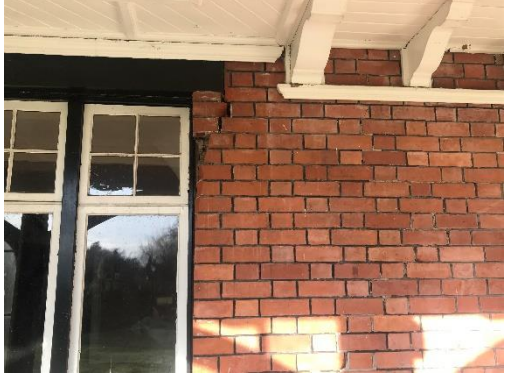
79.	Cracks in brick walls to north wall of Lounge, plus large movement gaps between timber framing elements

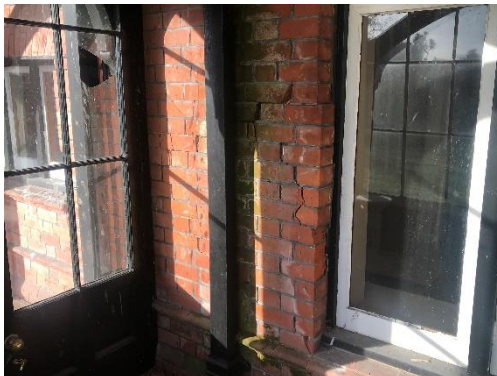
80.	Localised failure in north brick wall to Lounge, adjacent to window

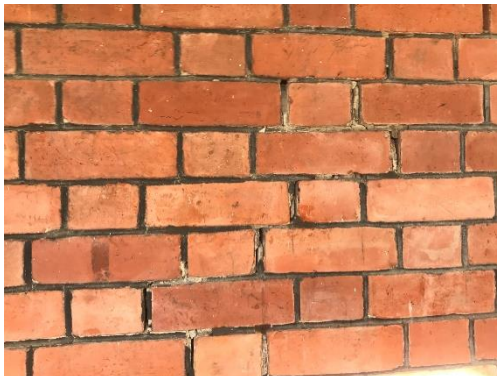
81.	Cracks in north brick wall to Lounge, including slippage gaps

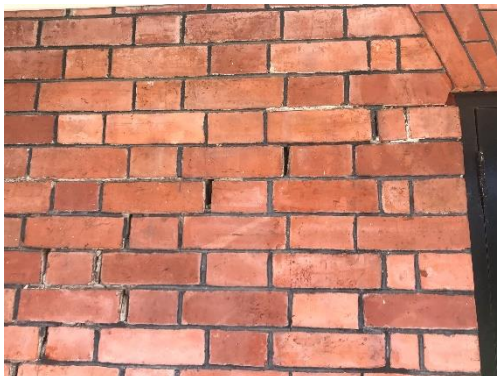
82.	Cracks in north brick wall to Lounge, including slippage gaps

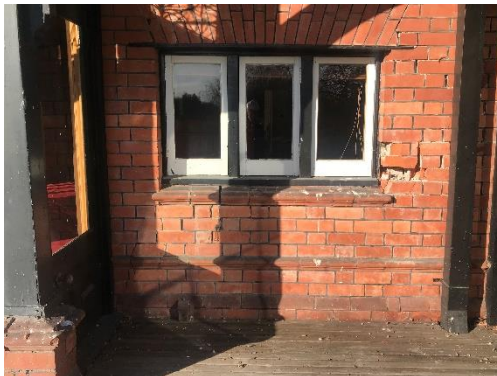
83.	Cracks and localised failure of north brick wall to Family Room

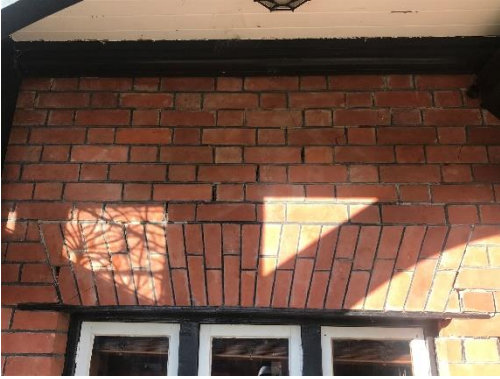
84.	Cracks and localised failure of north brick wall to Family Room

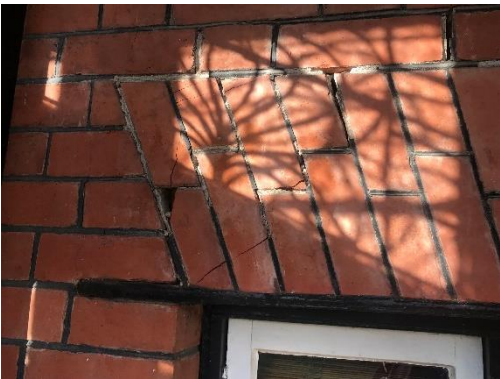
86.	Cracks and localised failure of north brick wall to Family Room

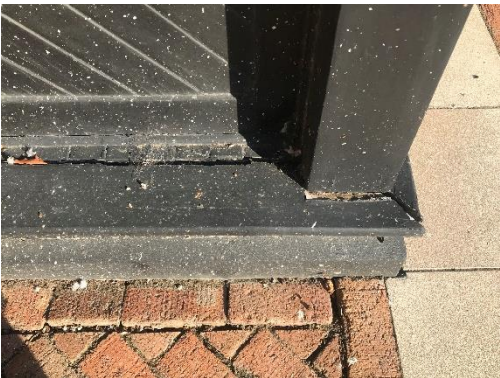
87.	Large movement gap in timber wall framing at base of north wall at terrace

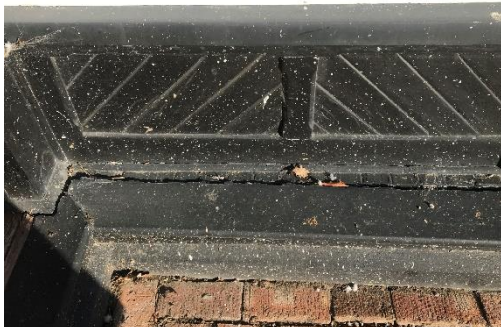
88.	Large movement gap in timber wall framing at base of north wall at terrace

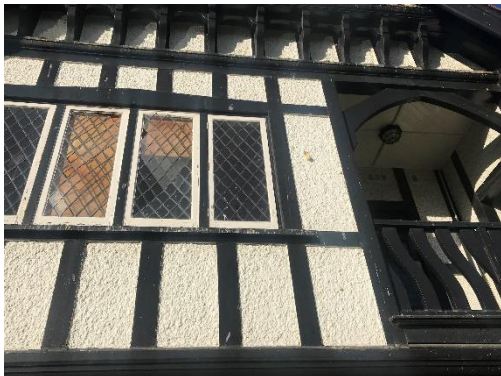
89.	Movement gaps between plaster and timber studs/transoms to north wall

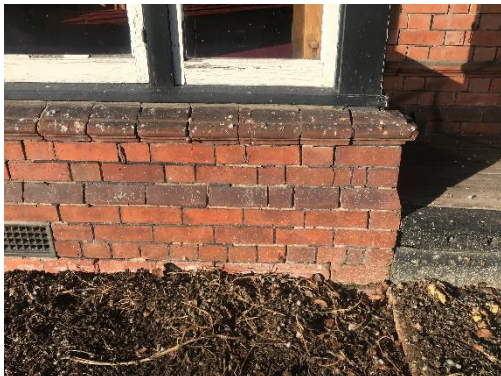
90.	Cracks and movement gaps in brick wall beneath north bay window to Family

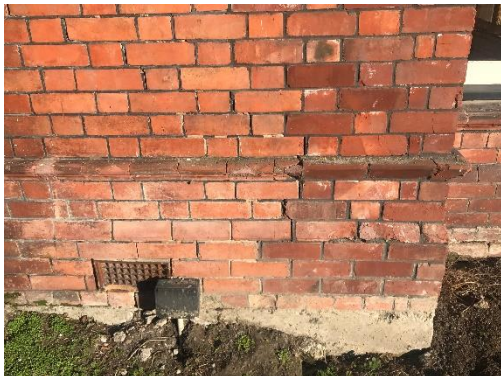
91.	Cracks and slippage gaps in east brick wall to Family

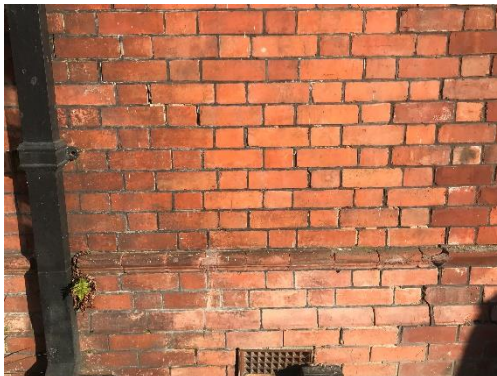
92.	Cracks and slippage gaps in east brick wall to Family

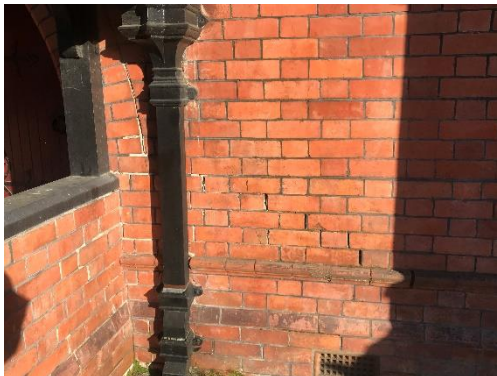
93.	Cracks and slippage gaps in east brick wall to Family

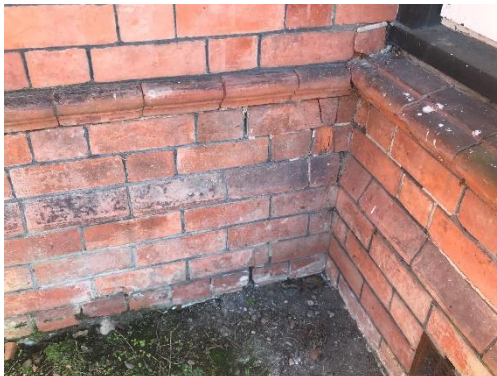
94.	Cracks and slippage gaps in east brick wall to Family

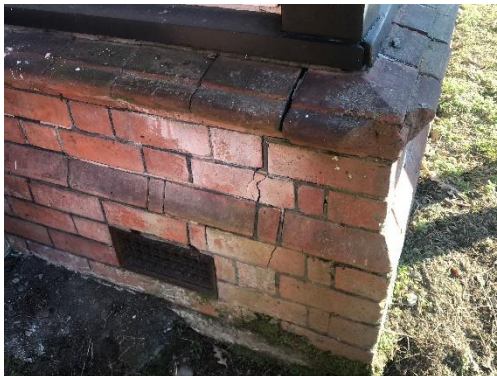
95.	Cracks and slippage gaps in east brick wall to Family beneath bay window

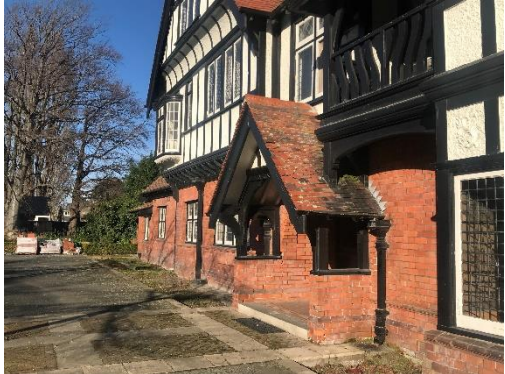
96.	Damaged roof tiles to east entry roof

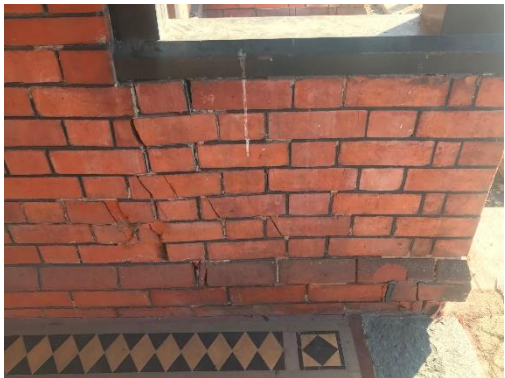
97.	Cracked brick north wing wall to east entry

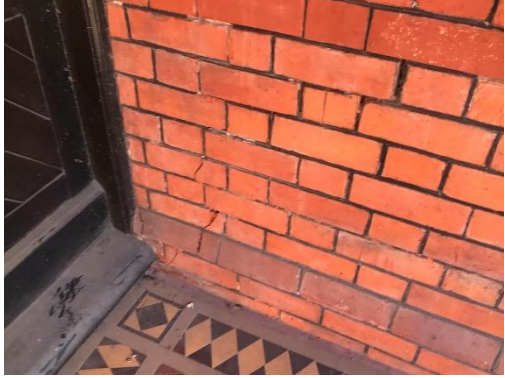
98.	Cracked brick north wing wall to east entry

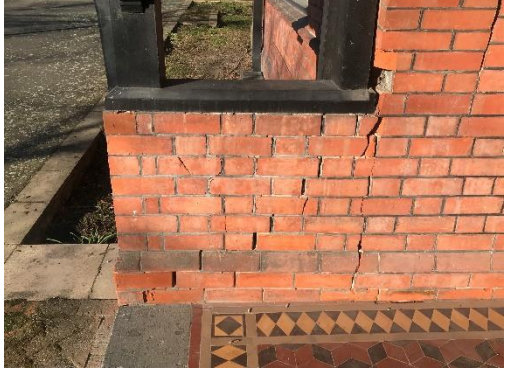
99.	Failed brick south wing wall to east entry

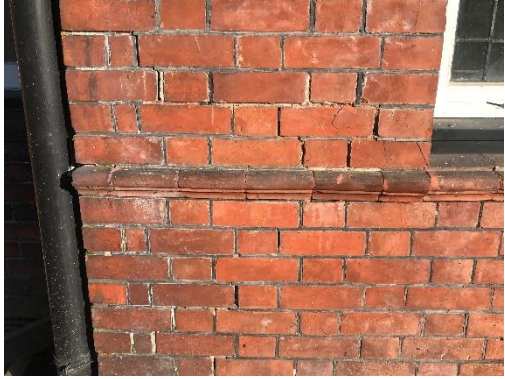
104.	Cracks and slippage gaps in east brick wall to Kitchen

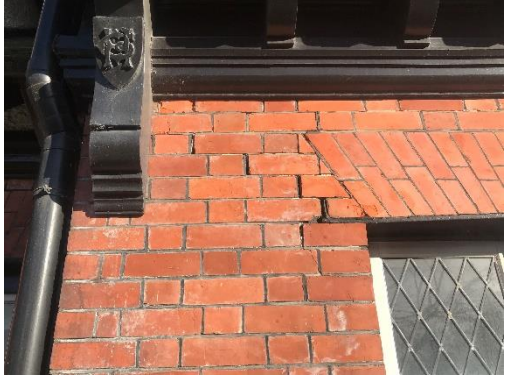
105.	Cracks and slippage gaps in east brick wall to Kitchen

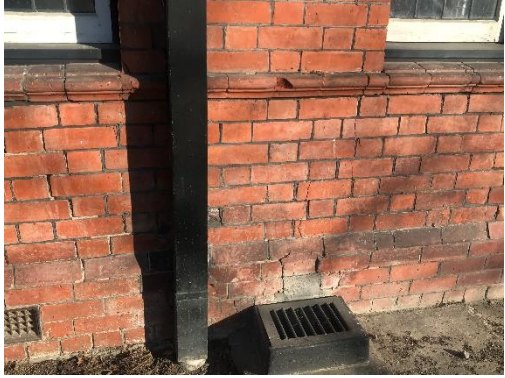
106.	Cracks and slippage gaps in east brick wall to Kitchen

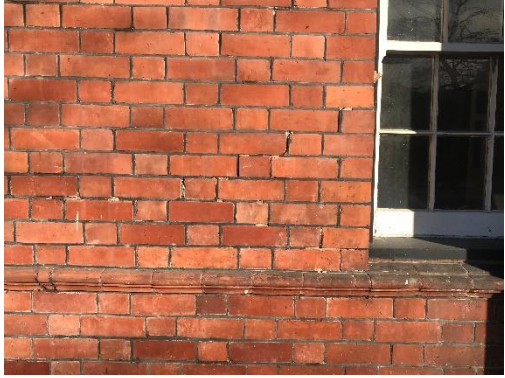
107.	Cracks in east brick wall to Office 1

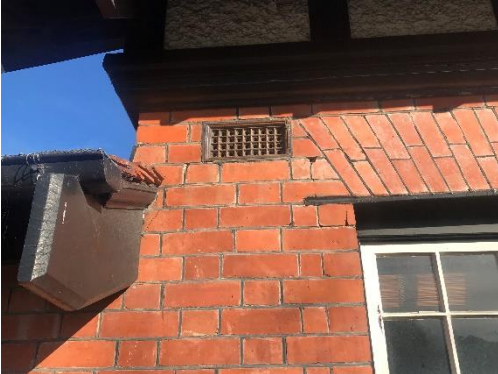
108.	Cracks in east brick wall to Office 1

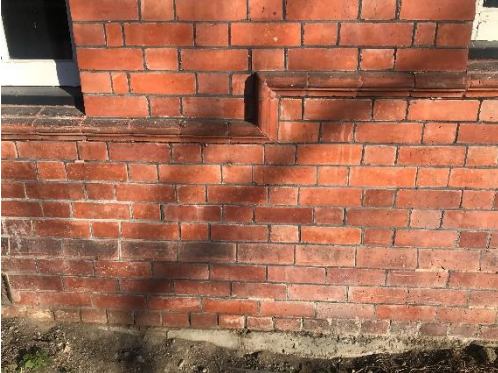
A photograph showing a close-up of a red brick wall. A window with white trim is visible on the right side. Above the window, there is a small, square, metal vent or grille. The bricks are laid in a standard running bond pattern.
109.	Cracks in east brick wall to Office 1

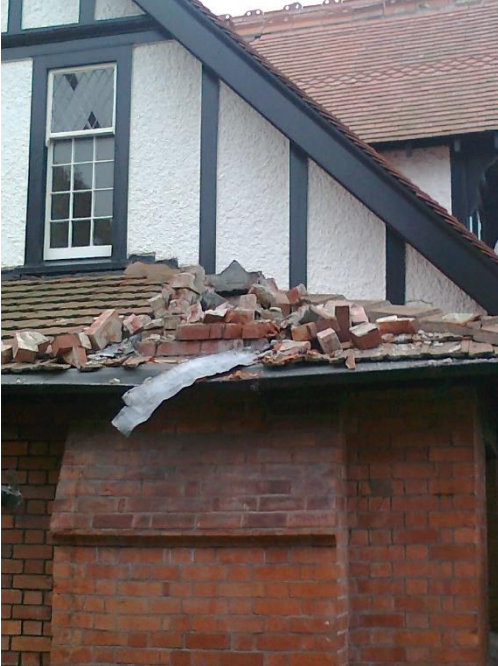
A close-up photograph of a red brick wall. The bricks are laid in a running bond pattern. There is a small, rectangular opening or niche in the wall, possibly for a pipe or vent. The wall appears to be part of a larger structure.
110.	Collapsed chimney to south wall of Office 1

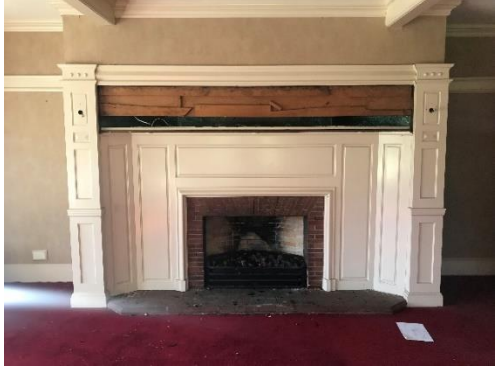
<p>116.</p>	<p>Chimney fireplace in Lounge (east wall) looking east, with cracks/gaps in bricks</p>	 
<p>117.</p>	<p>Crack/gap in concrete lintel above east fireplace in Lounge</p>

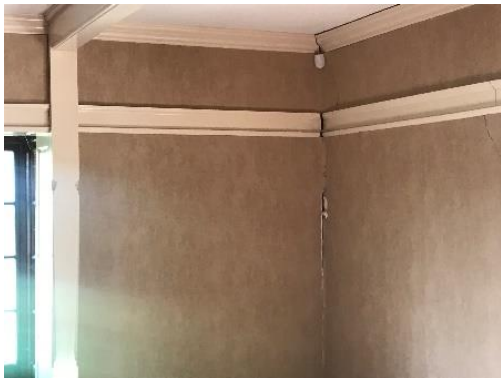
119.	Chimney fireplace in Lounge (south-west) looking south, with extensive damage to wall and ceiling finishes and cracks/gaps in brick walls

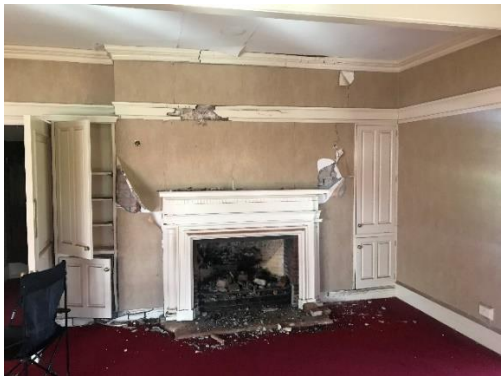
120.	Chimney fireplace in Lounge (south-west) looking south, with extensive damage to wall and ceiling finishes and cracks/gaps in brick walls

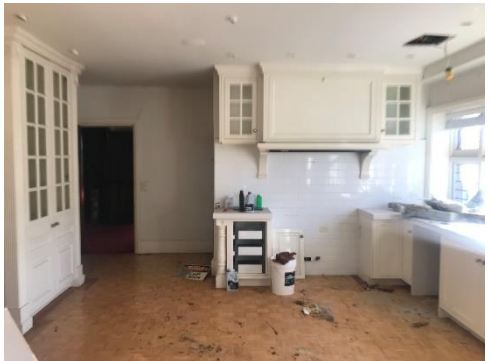
125.	General view of Kitchen, looking south towards fireplace, with significant ceiling damage

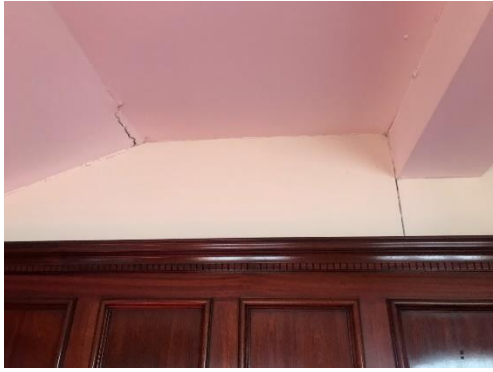
128.	Wall damage in Office 1

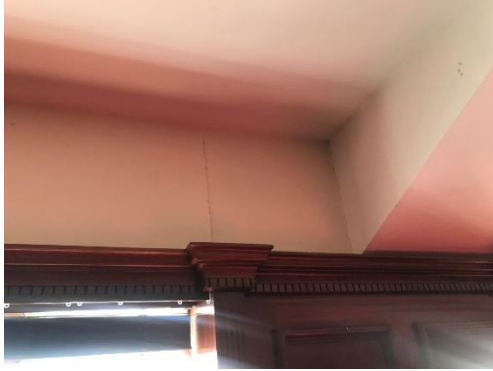
129.	Wall damage in Office 1

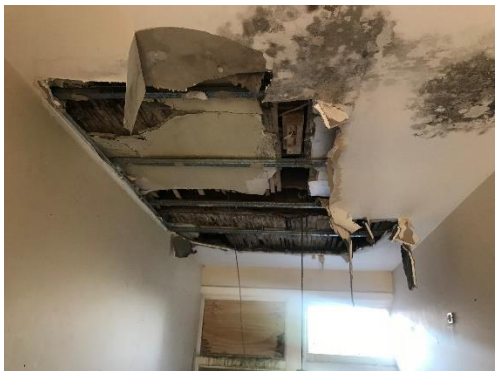
133.	Failure of wall finishes to middle Stairwell

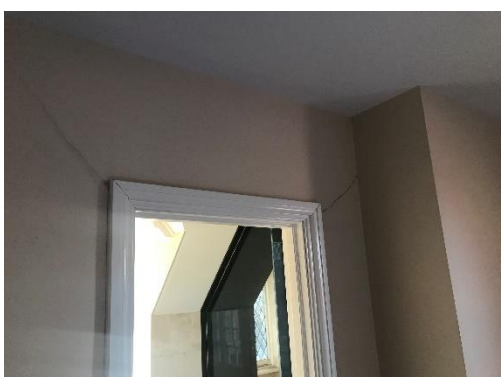
136.	Crack in wall finishes in south-west wardrobe

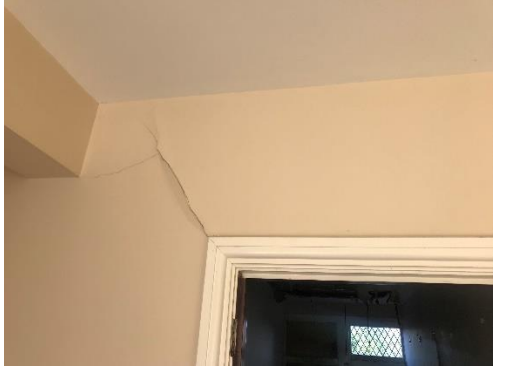
139.	Significant cracks in wall finishes to Bed 4

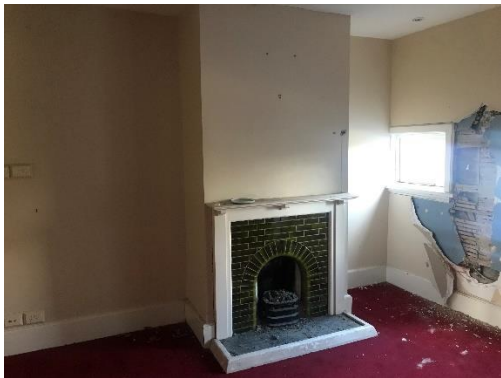
142.	Significant cracks in wall finishes to Bed 6

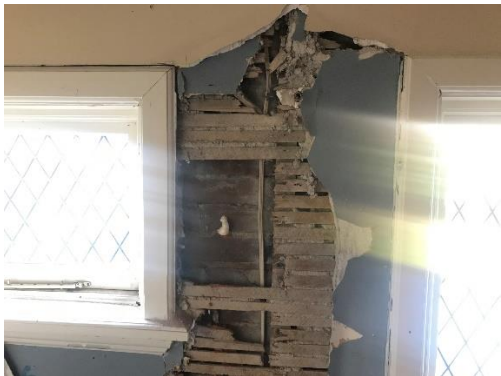
143.	Significant cracks in wall finishes to Bed 6

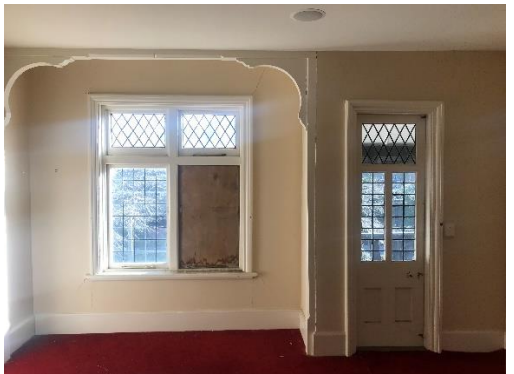
148.	Cracks in wall finishes to Bed 3	 
149.	Cracks in wall finishes to First Floor Hall	 
150.	General view of Foyer, looking west	 
151.	Cracks in wall finishes in Foyer above door to Bed 2

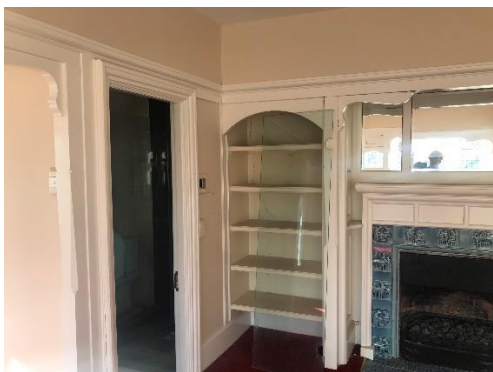
154.	Cracks in wall finishes to Bed 2 including large movement gaps at window frame

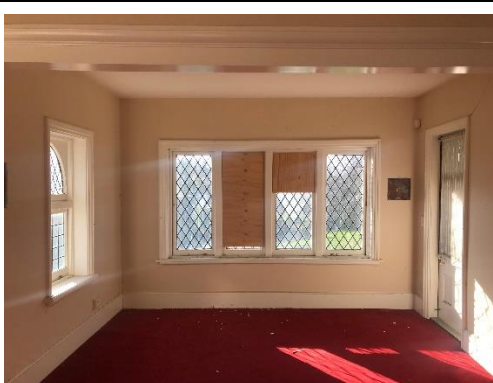
155.	Cracks in wall finishes to Bed 2 including large movement gaps at window frame

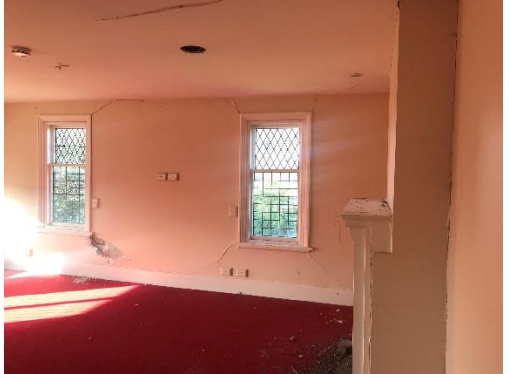
157.	Bed 1 extensive and severe cracking damage to wall and ceiling finishes

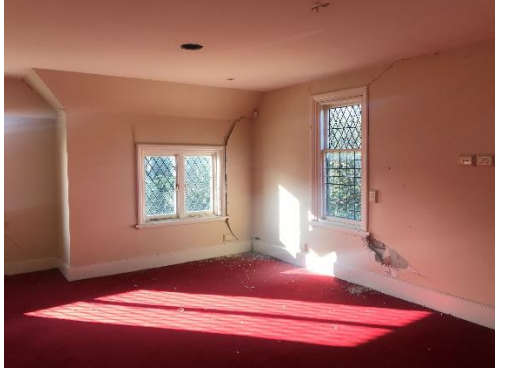
158.	Bed 1 extensive and severe cracking damage to wall and ceiling finishes

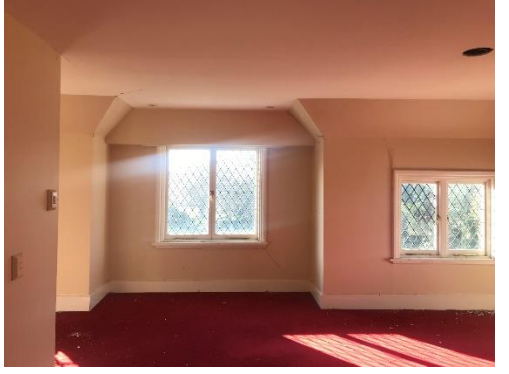
159.	Bed 1 extensive and severe cracking damage to wall and ceiling finishes

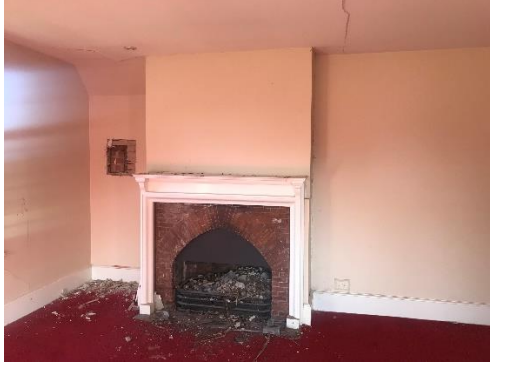
160.	Bed 1 extensive and severe cracking damage to wall and ceiling finishes

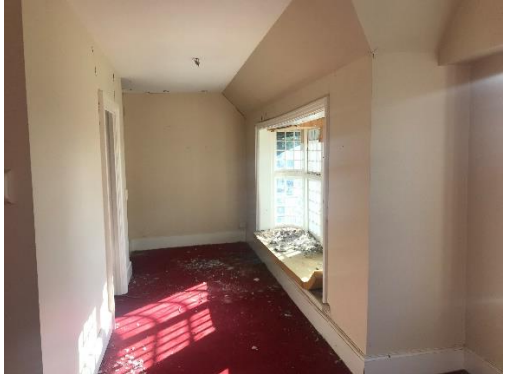
161.	Bed 1 extensive and severe cracking damage to wall and ceiling finishes

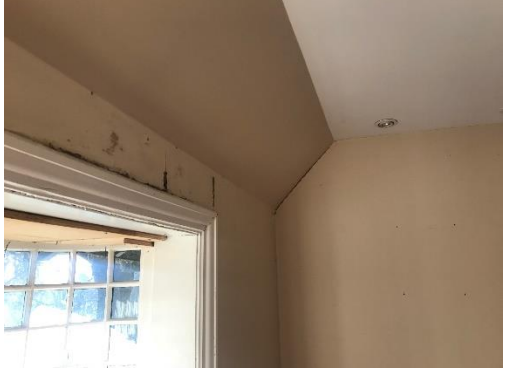
164.	Bed 1 extensive and severe cracking damage to wall and ceiling finishes

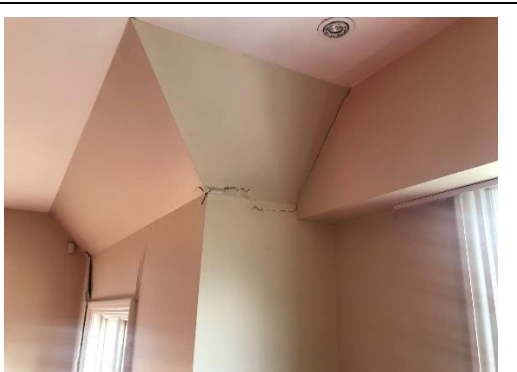
168.	Bed 1 extensive and severe cracking damage to wall and ceiling finishes

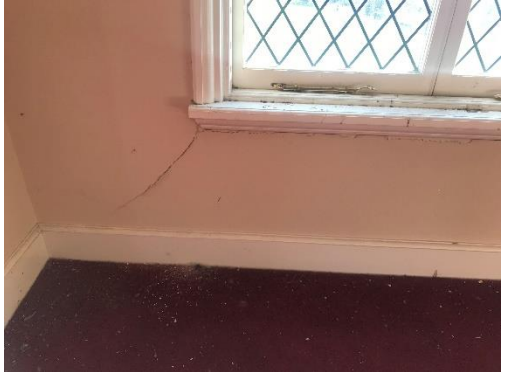
169.	Bed 1 extensive and severe cracking damage to wall and ceiling finishes

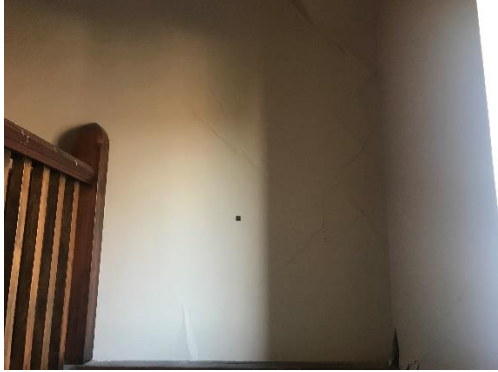
174.	Cracks in wall and ceiling finishes to main north Stairwell, including temporary replacement of some linings

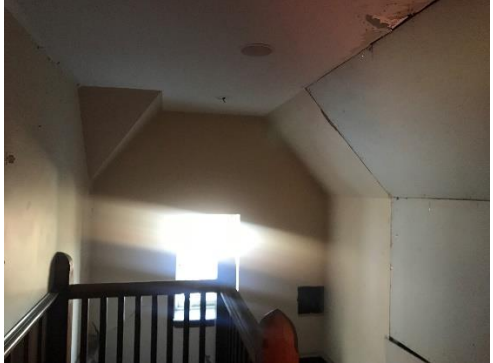
175.	Cracks in wall finishes to Bed 8

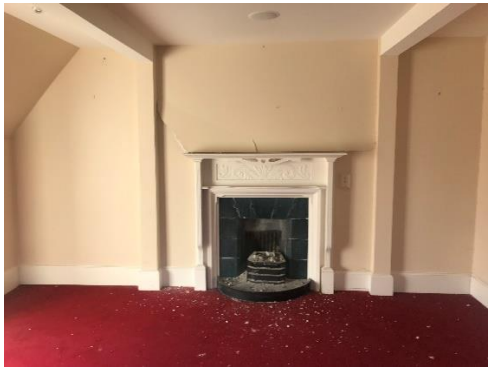
176.	Cracks in wall finishes to Bed 8

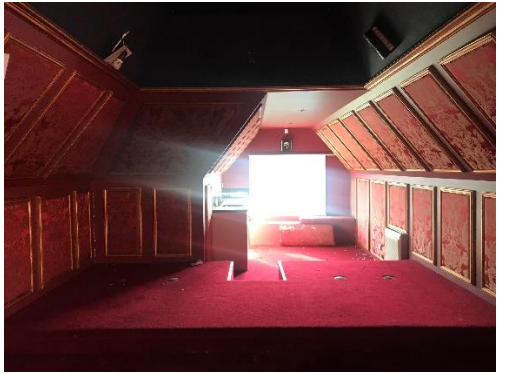
179.	General view of Entertainment Room looking south, including cracks and movement gaps to wall/ceiling finishes

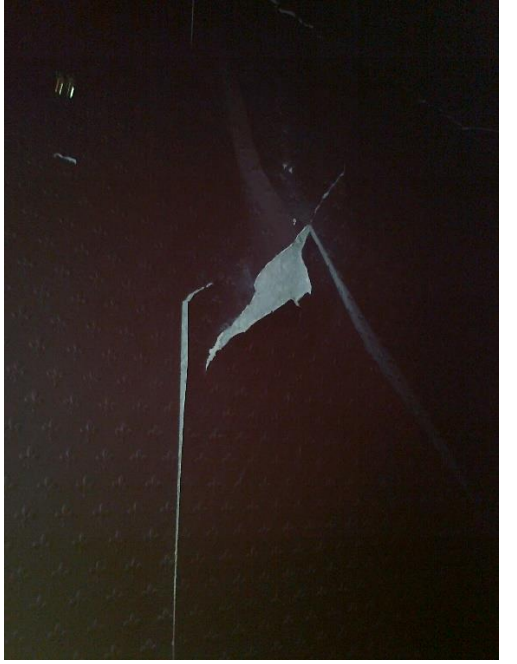
181.	General view of Bed 7

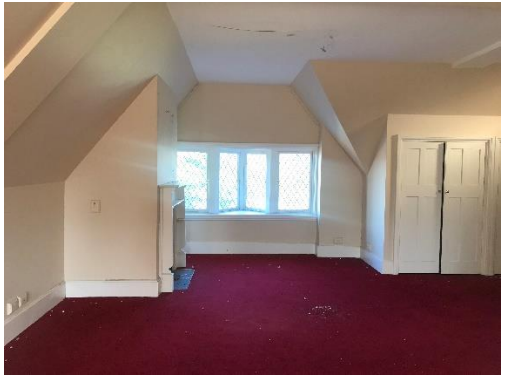
182.	General view of Bed 7

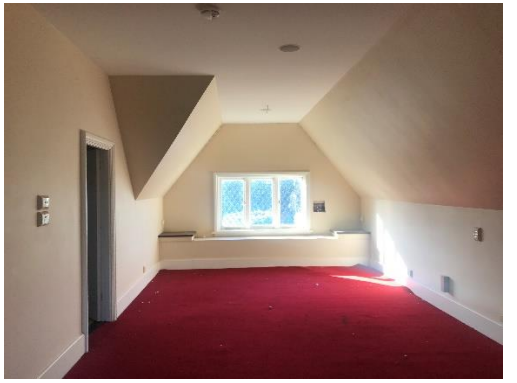
183.	General view of Bed 7

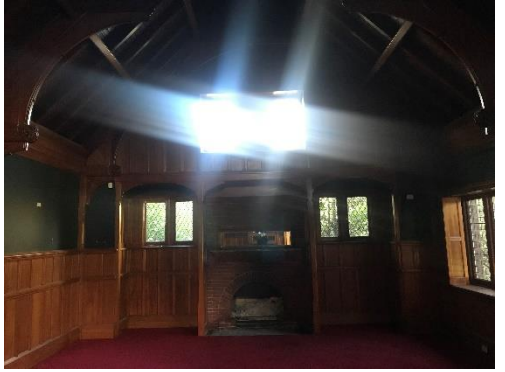
188.	General view of Dining Hall looking south

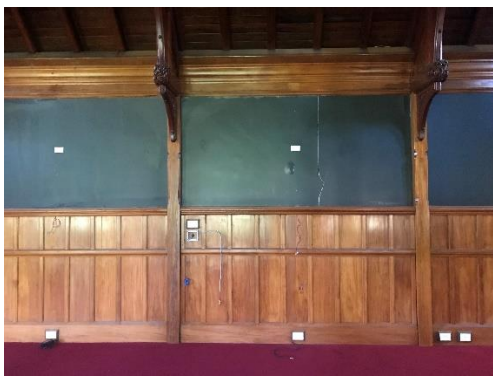
192.	General view of Dining Hall roof framing	 
193.	Cracks in wall finishes to Dining Hall

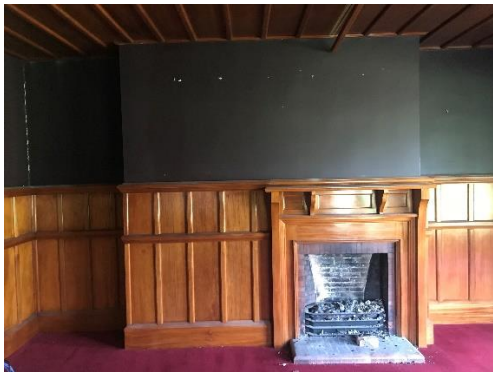
200.	Cracks to wall finishes to Library

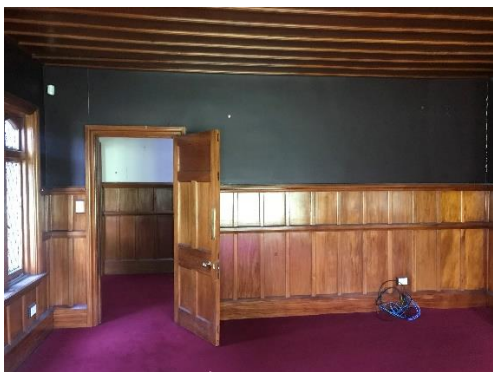
201.	Cracks to wall finishes to Library

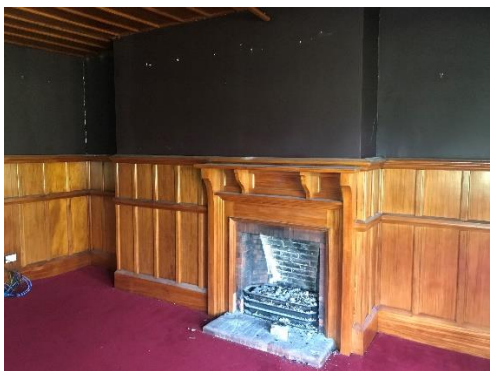
202.	Cracks to wall finishes to Library

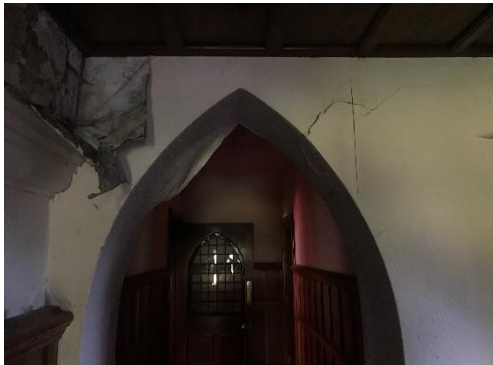
203.	Cracks in wall to Hall 2, looking east
